Physical vulnerability of buildings to flooding in Lilongwe City, Malawi

Chresceuntia Matambo Msasa^{1*} and Mtafu A. Z. Chinguwa Manda²

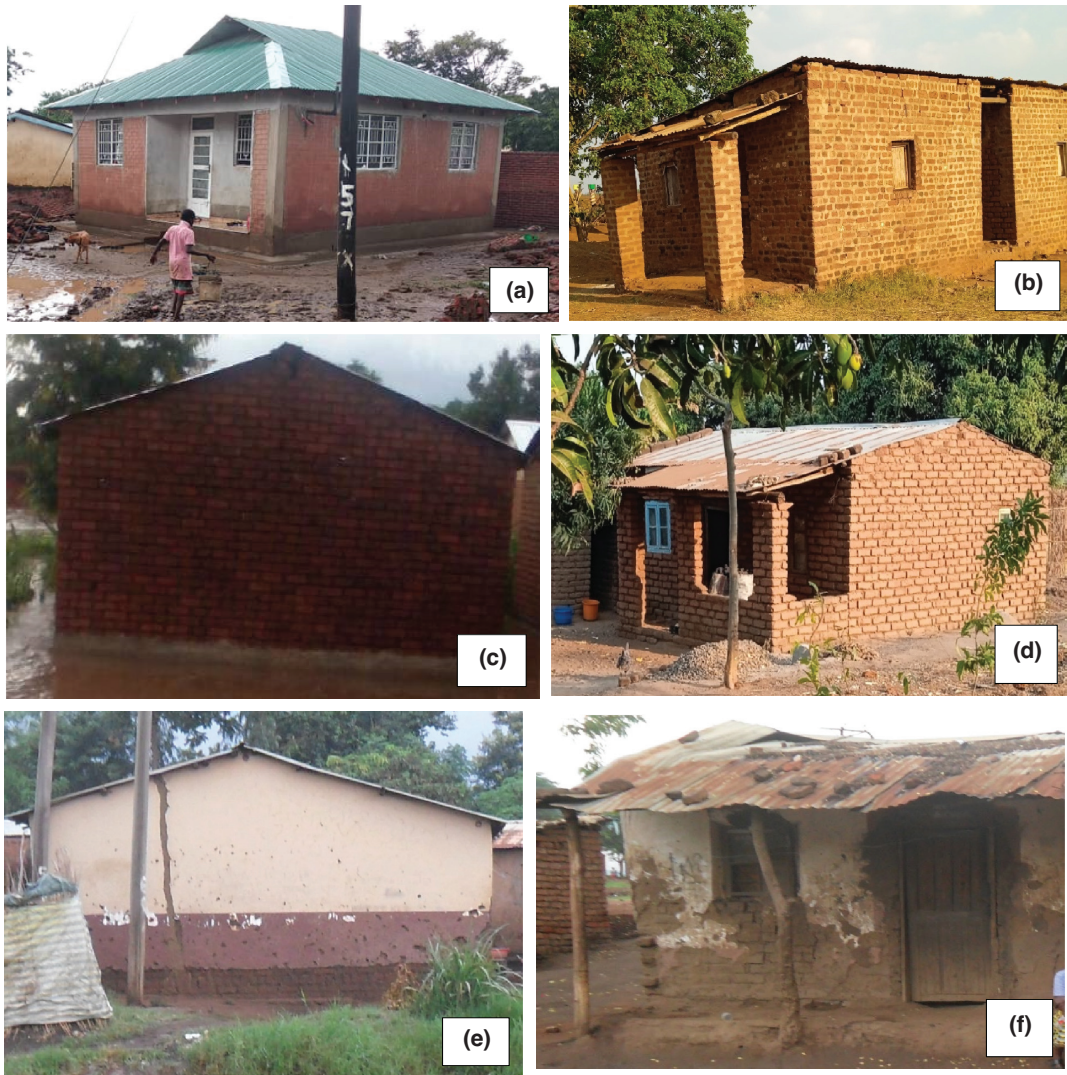
Figure 3 shows the building types found in the study area from building inventory data. Figure 3a is constructed with fired bricks with cement mortar walls and cements floors; Fig. 3b is built with fired bricks with cement mortar walls and mud/earth floors; Fig. 3c is constructed using fired bricks with

Building types. Source: Fieldwork, 2018.

mud mortar walls and cement floors; Fig. 3d is built of fired bricks with mud mortar walls and mud floors; Fig. 3e is made of sun-dried bricks with mud mortar and cement floors; and Fig. 3f is built of sun-dried bricks with mud mortar and mud floors.

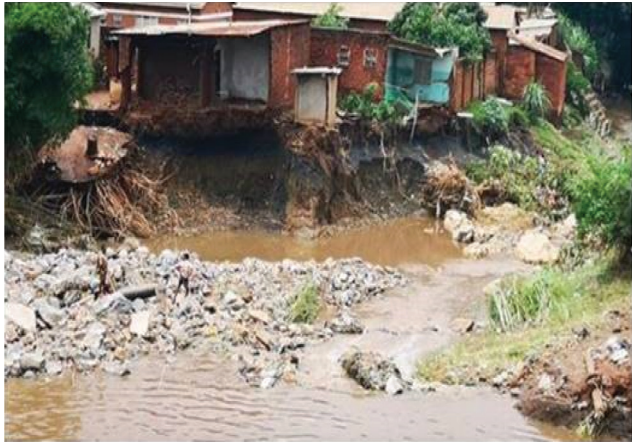
Building close to the river. Source: Fieldwork, 2018.

The results of exposure analysis (Table 9) based on the distance of buildings from the river and the elevation of the surroundings of the buildings show that over 90% of buildings were inundated by one or two flood events regardless of their proximity to the river and 100% of buildings that were on flat terrain were inundated by one or two flood events. Figure 4 shows a building close to the river.

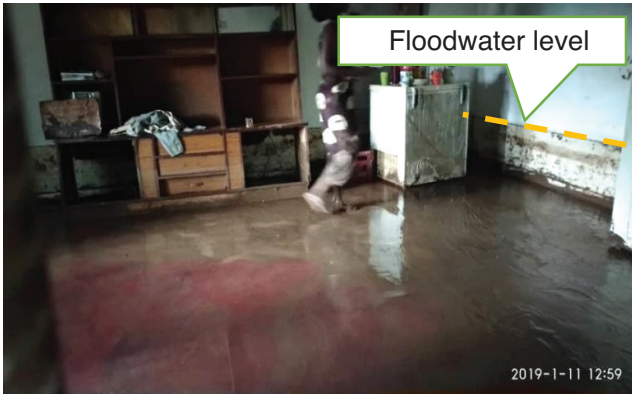
Floodwater level inside a building. Source: Fieldwork, 2018.

The results of exposure of buildings based on inundation depth inside the buildings also show that over half (54%) of the buildings were inundated by high floodwater of over 60 cm (Table 10). Figure 5 shows floodwater level marks inside of the building. Some of the buildings were partly

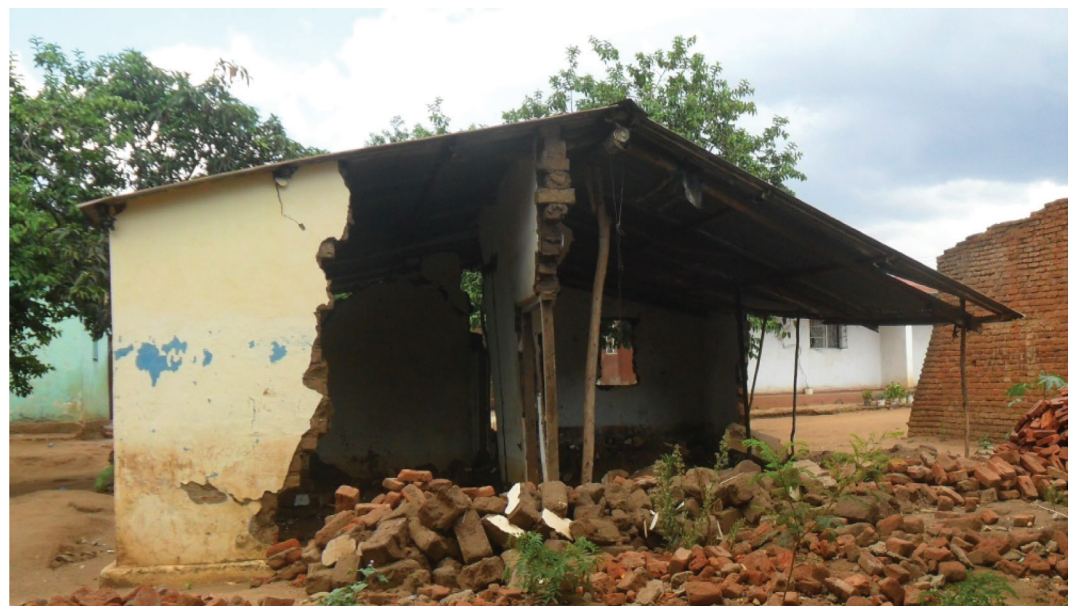
Figure 6Collapsed walls of building type 4.
Source: Fieldwork, 2018.

Figure 6 shows the collapsed walls of a type 4 building (sun-dried bricks with mud mortar walls and cement floor).

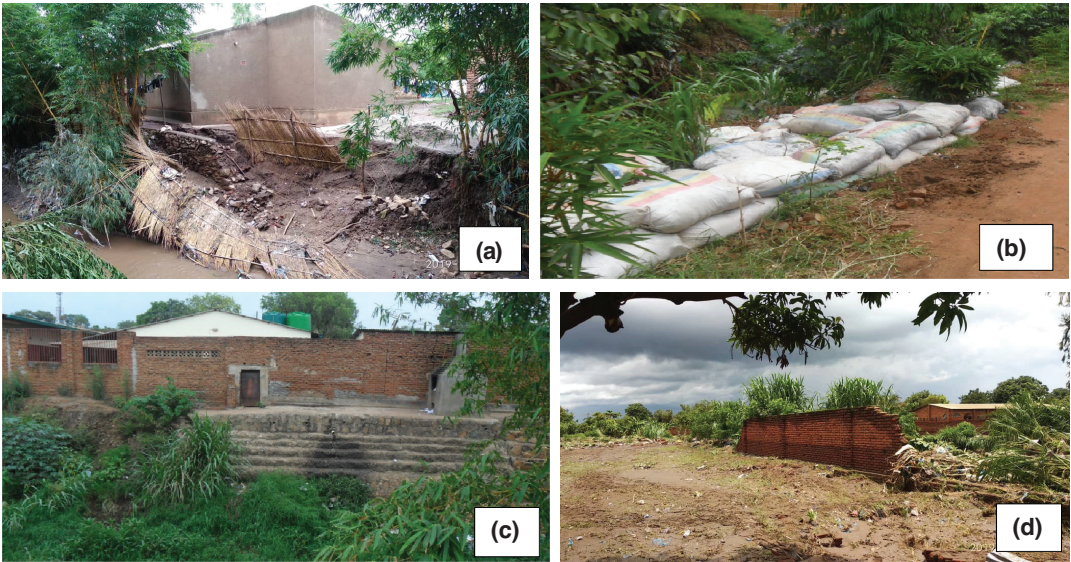
Some building protection measures.
Source: Fieldwork, 2018.

Figure 7 shows some of the building protection measures employed in the study area. Most buildings had multiple protection measures, Fig. 7a had structural (raised foundations, flood-resistant building materials), non-structural (storm drain) and vegetation along the river side, Fig. 7b had non-structural (sand bags and a storm drain) and vegetation as building protection measures, Fig. 7c had structural (flood-resistant construction materials, a brick fence and terraces along the river side) and vegetation and Fig. 7d had structural (flood-resistant building materials and a brick wall and vegetation) as building protection measures.
