Public Buildings in the  
South-West Quarter of  
Roman London

The archaeology of Roman London,  
Volume 3:

**Public Buildings in the  
South-West Quarter of  
Roman London**

**by**  
Tim Williams

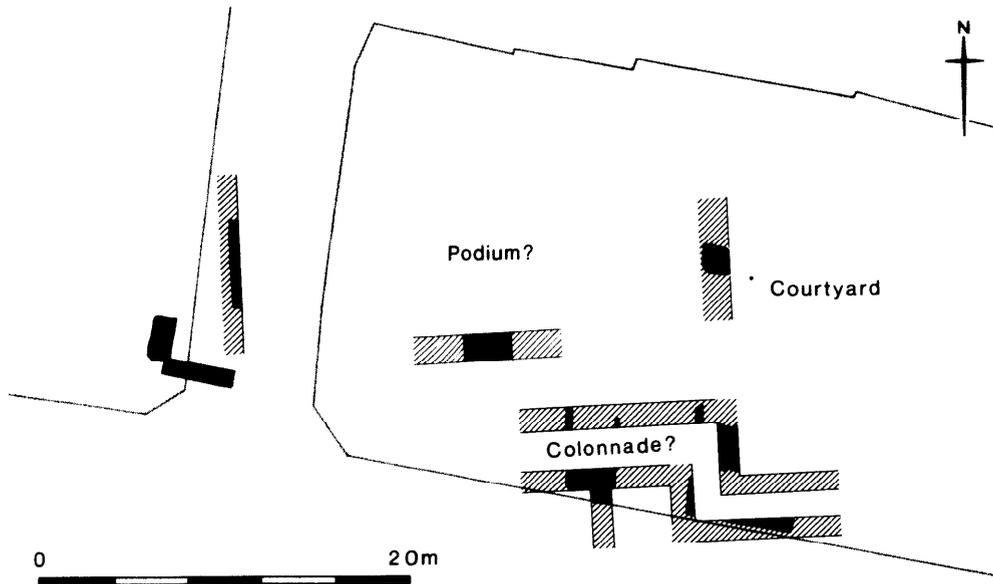
Fig 5 Period I complex; core area. The precise alignments of the foundations indicated in grey are not known. (1:400)

The features recorded beneath the Period II chalk platform at the Salvation Army Headquarters site fell into two groups, on the basis of their known alignments and structural techniques (p169). It is possible to suggest that the main group formed part of an integrated structure or structures (Fig 5). The structural evidence consisted of a number of ragstone foundations, bonded with white cement. Where the bases of the foundations were observed, circular timber piles had been used to support them. The only surface encountered on the site lay to the east of the observed foundations, and consisted of gravel with horizontally laid fragments of broken tiles (Fig 5). Its character suggests that the area was probably external.

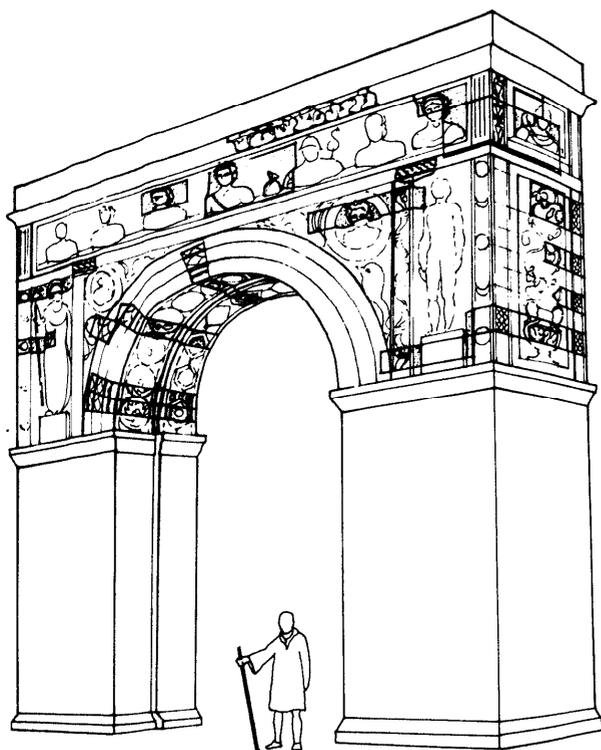
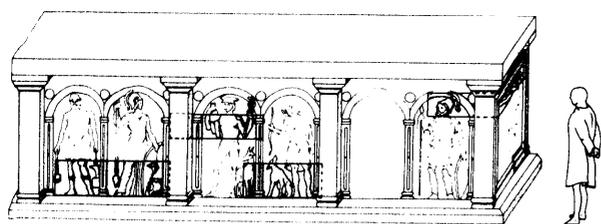
Fig 7 Reconstructions of the Monumental Arch (drawn by Tom Blagg), and the Screen of Gods (drawn by Sheila Gibson). The arch is shown as a free-standing monument, although none of the stones recovered came from the structure's base, and it is possible that the arch lay upon precinct walls, forming a monumental entranceway.

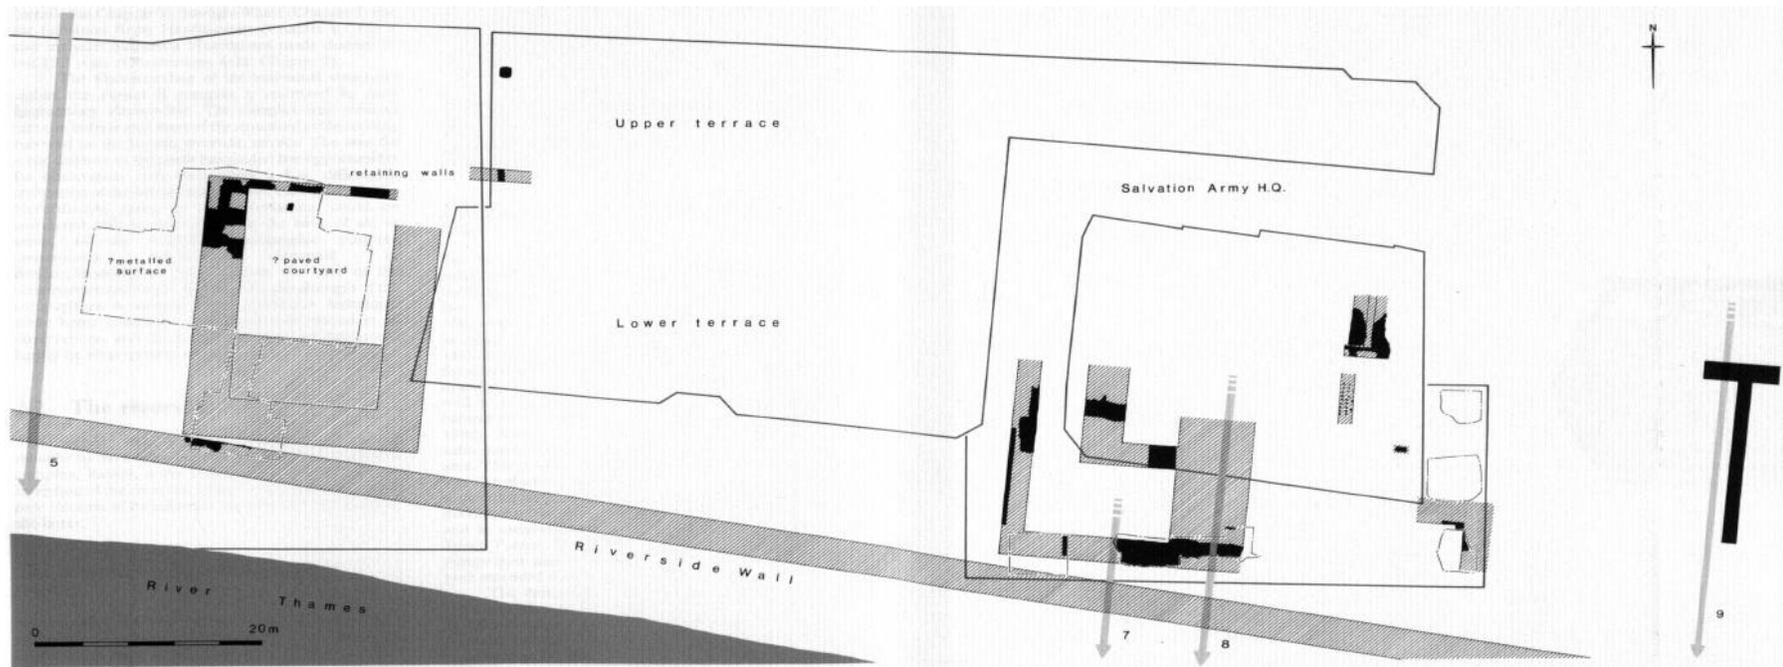
Fig 9 Period II complex; foundations in the core area. It is not clear what form the above-ground walls would have taken, but it is likely that the larger foundations supported more than one wall or colonnade. They appear to have formed individual structures, all on the same alignment, but without continuous elements extending the length of the complex. The structures were clearly not on the same alignment as the slightly earlier riverside wall. Blue arrows indicate the possible watercourses (cf Fig 4). (1:400)

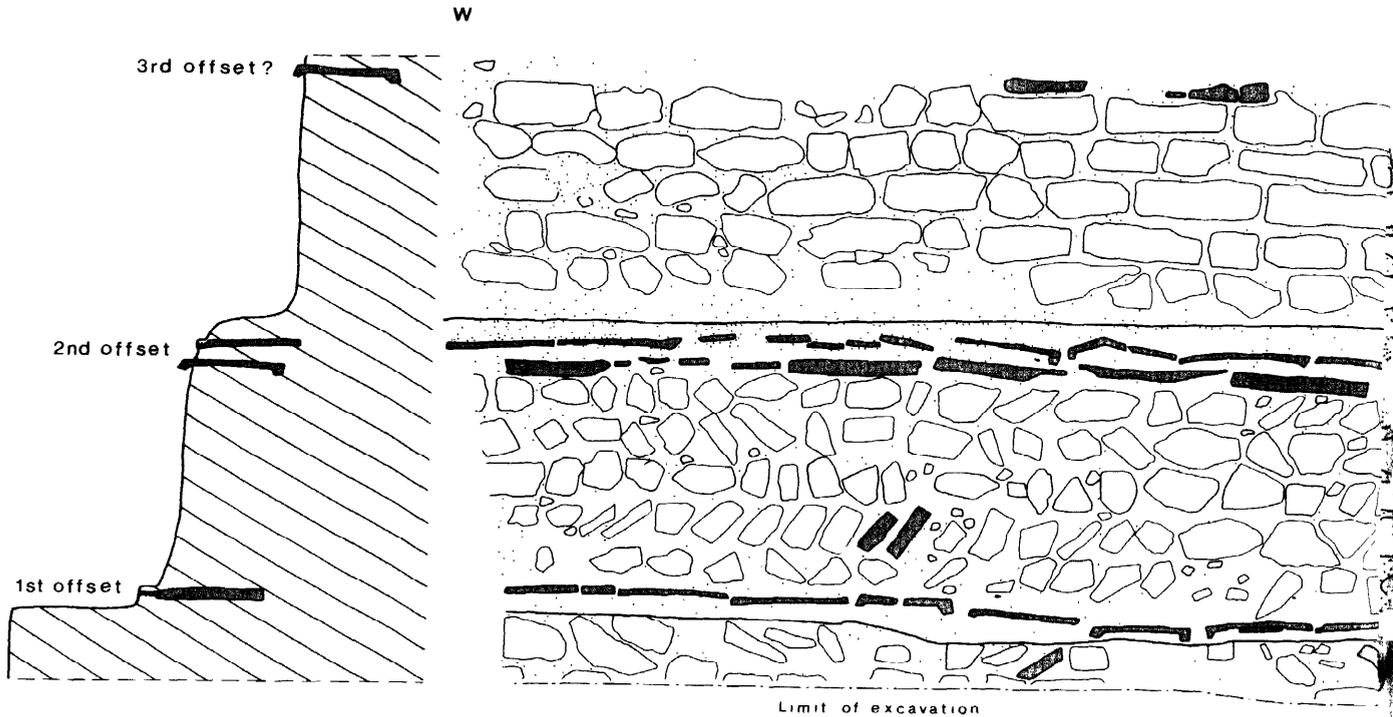
Fig 10 North face of the riverside wall at Peter's Hill. The ragstone facing was laid in a herringbone pattern below the 2nd off-set. Tile courses comprise inverted roofing tiles (*tegulae*), laid in alternate courses showing flange or profile. Heavy stippling indicates the layer of *opus signinum*. (1:20)

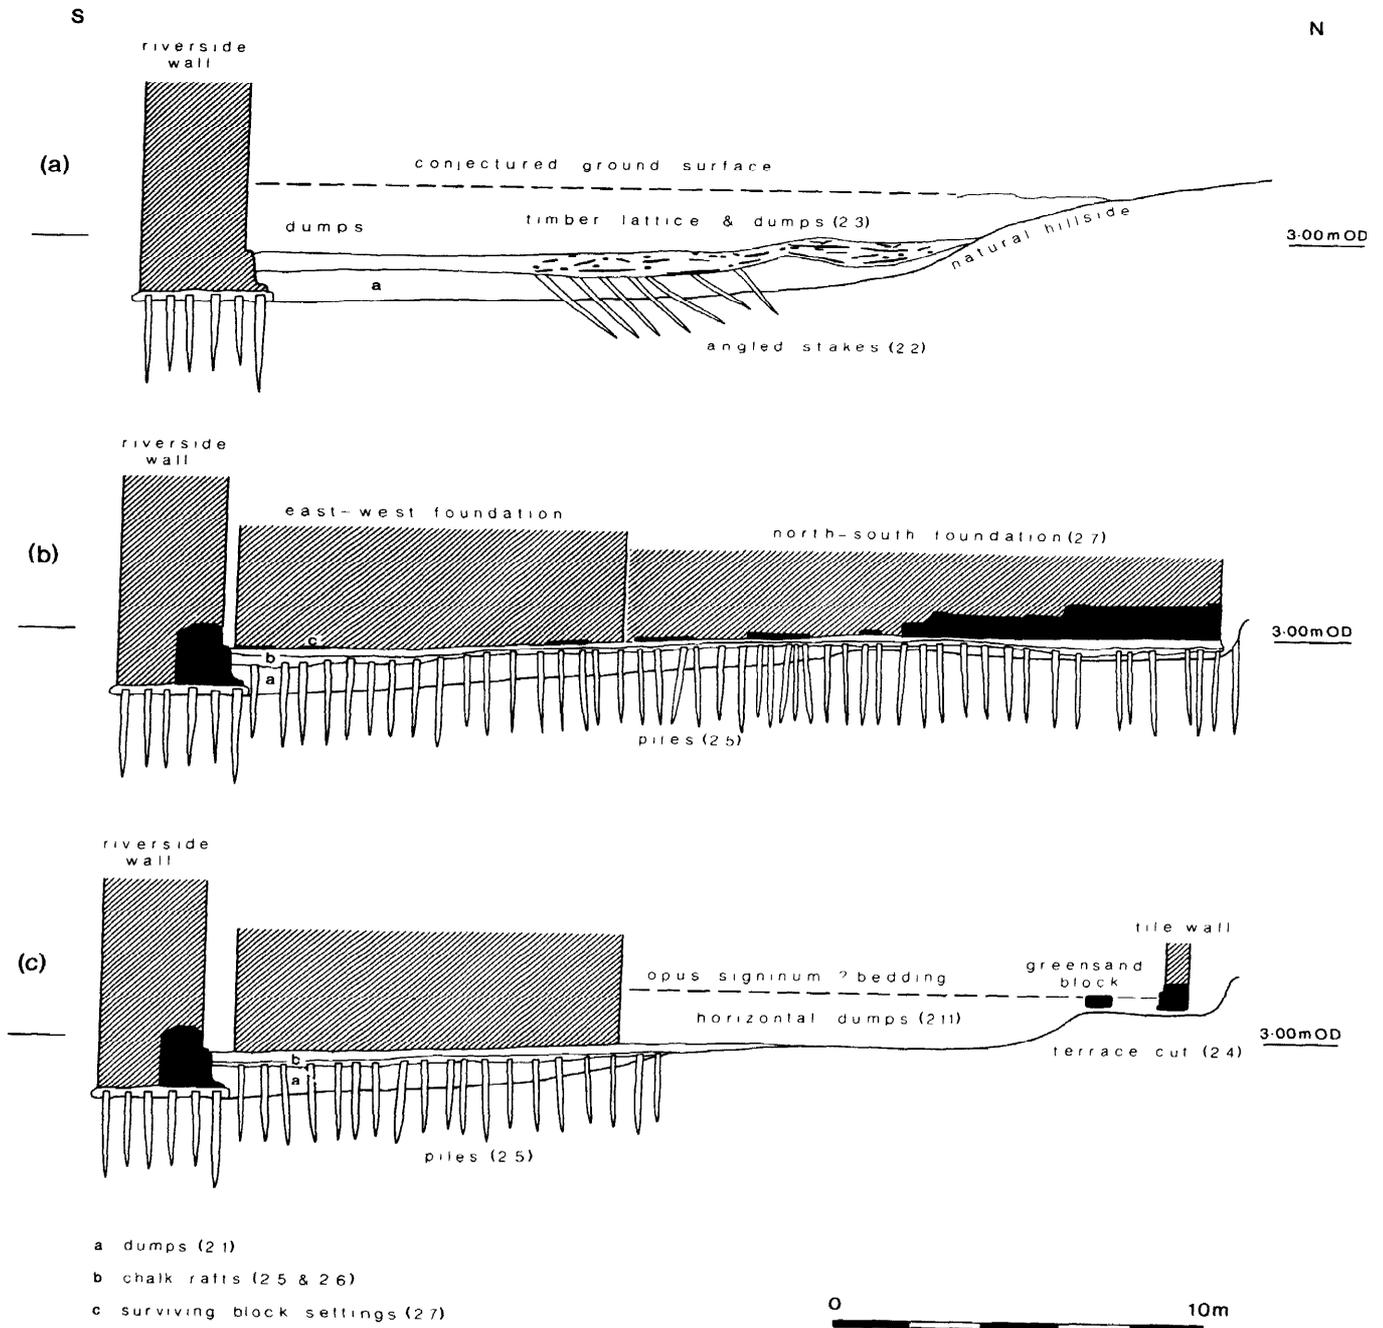
Fig 11 Reconstructed sections through the hillside at the time of the Period II complex. Profiles (a-c) are directly comparable, as they lie at corresponding points on the north-south slope. Numbering on profiles (a-c) refers to Peter's Hill phasing Groups (p39). Features annotated on profile (d) refer to Salvation Army Headquarters observations (p57). (Sections at 1:200)

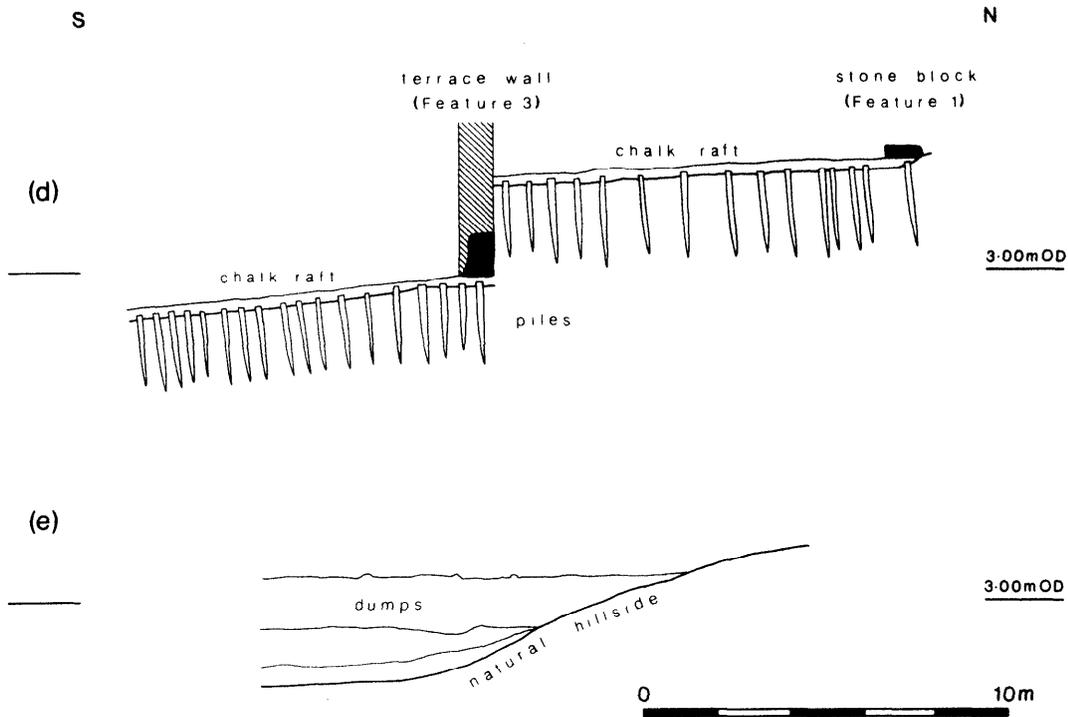
(d) Salvation Army Headquarters; section exposed at the western end of the site. In the centre a terrace wall divides the area to the south from a higher terrace to the north. Further north, a single stone block might indicate a more northerly terrace. (e) Lambeth Hill (Observation 10); a profile of the natural hillside with Roman levelling dumps. (Redrawn from Grimes 1968, fig 12.)

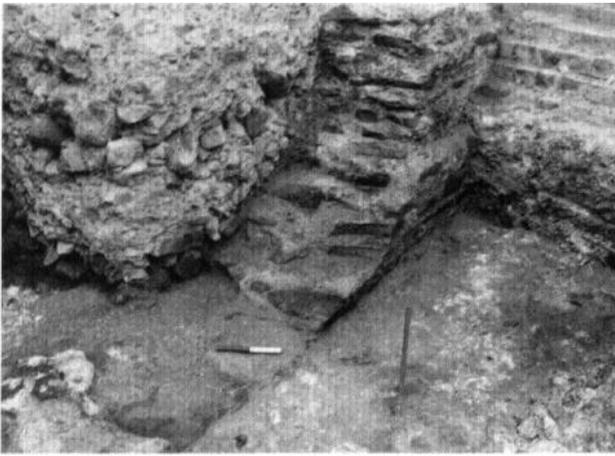
Fig 12 Peter's Hill; tile built terrace wall, looking east. Note the off-set course in the south and the discolouration of many of the tiles, which appear to have been re-used from a working hypocaust. The smoothed chalk platform, upon which the wall was constructed, can be seen in the right foreground. ( Scale 2 x 0.10m)

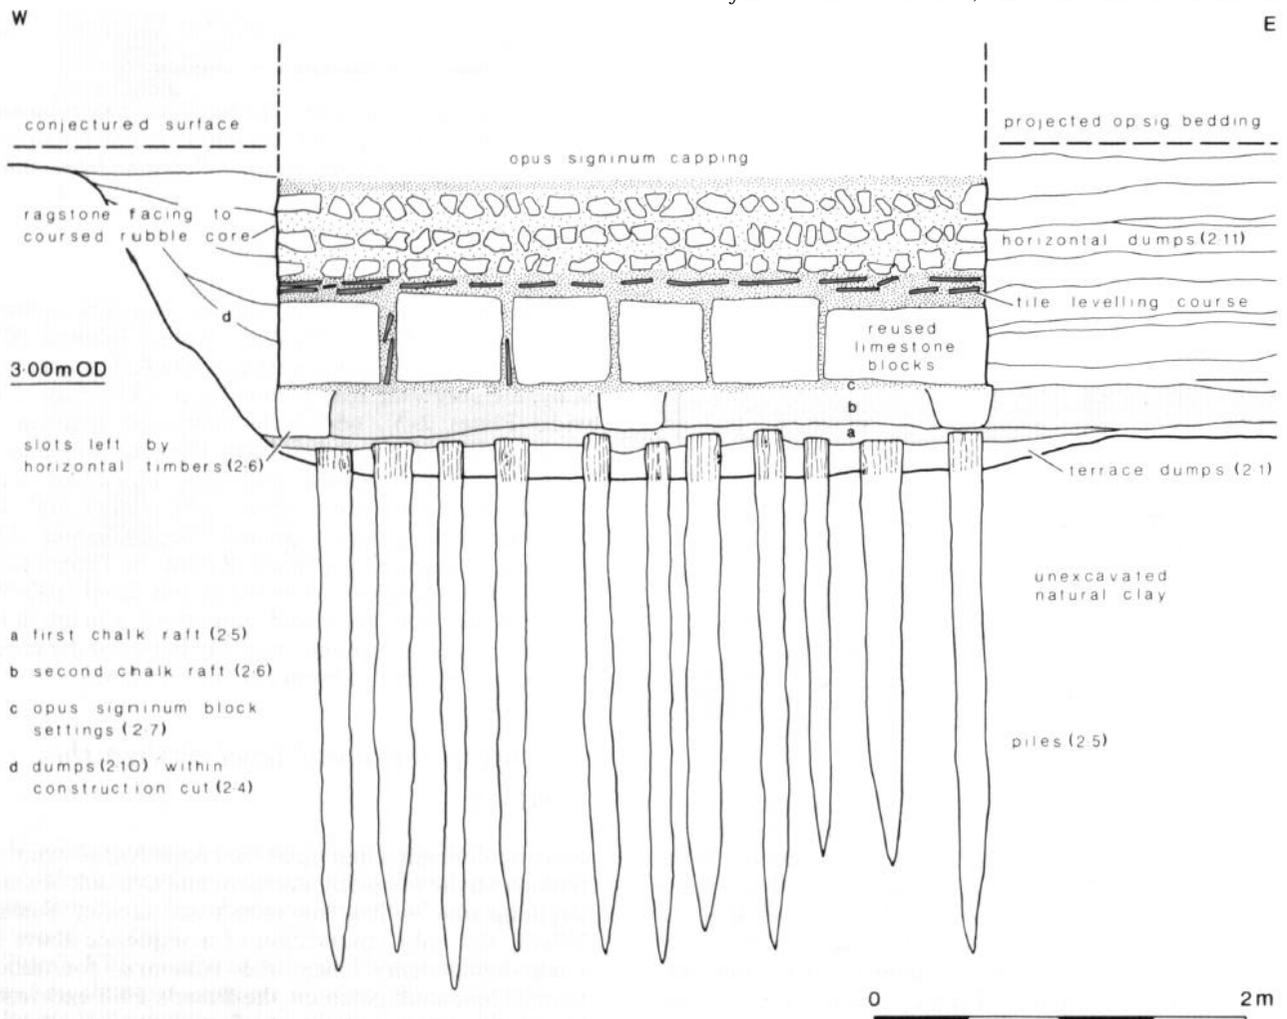
Fig 13 Reconstructed section through the masonry foundation on the Peter's Hill excavation. Eight stages can be identified in the construction of the foundation. Preparatory dumps and terracing (1) levelled the area for the pile preparation (2) (size conjectured from Sunlight Wharf evidence, p57), which supported the first chalk raft (3). A second chalk raft (4) was horizontally braced with a timber framework (5), above which a single course of massive limestone blocks was placed (6). This, in turn, supported a coursed rubble core, with tile coursing (7), retained by a coursed ragstone facing (8). (1:40)

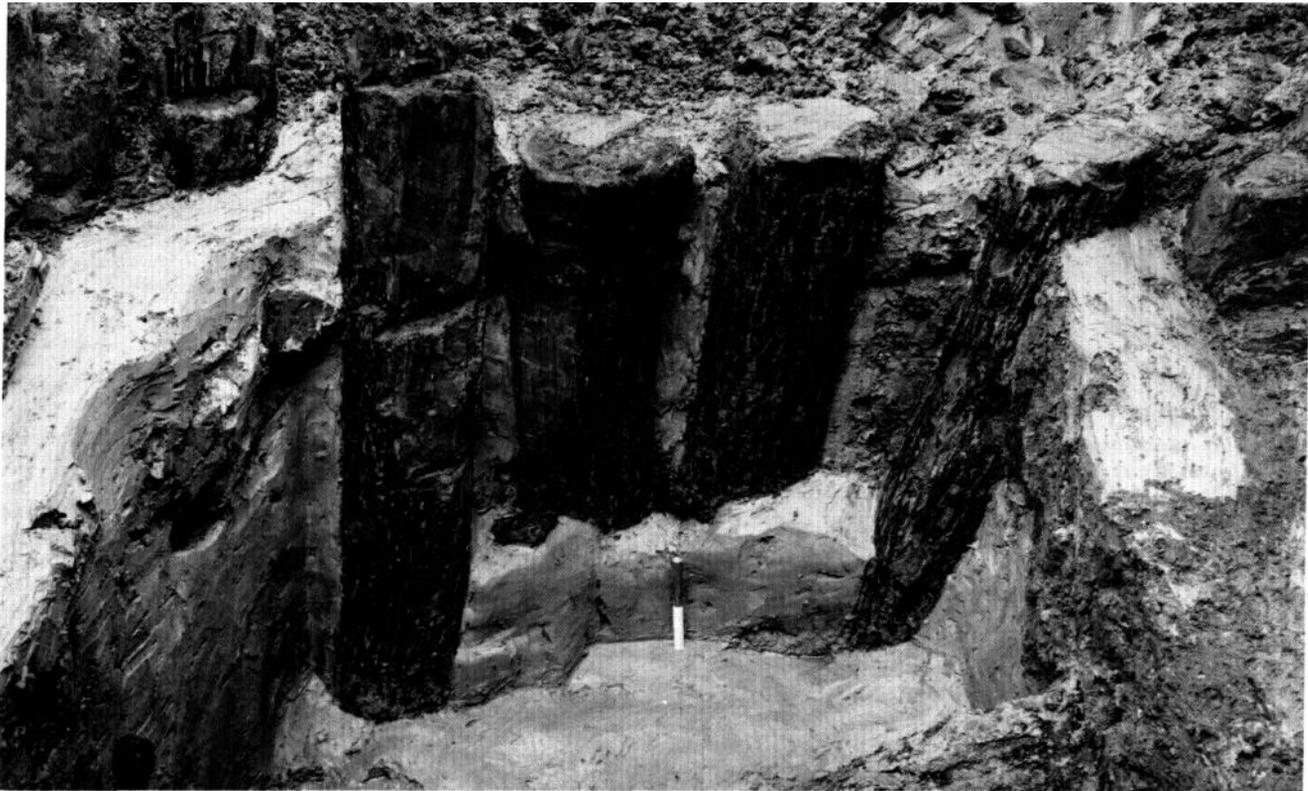
Fig 14 Peter's Hill; oak piles, driven into the compacted natural clay, in preparation for the masonry foundations (partially exposed during the watching brief). Note the intact bark still covering the timbers (only missing where damaged during the cutting of the sondage). Most of the piles were complete boles, between 3 and 4.5m in length. (Scale 2 x 0.10m)

A large area of the complex was prepared with oak piles. These usually comprised circular timbers, complete boles, with bark still adhering (Figs 14, 15 and 17); at Sunlight Wharf, and to a lesser extent at Peter's Hill, a few squared timbers, cut to approximately the same size, were also used (Appendix 3). The timbers were very straight, and varied between 2m and 3.5m in length; considerable effort would have been required to drive these into the relatively stiff clay dumps and the natural hillside beneath. The pile heads were left projecting some 0.15m above the level of the terrace (Fig 13). The densely packed piles did not appear to have been arranged in either rows or arcs, although the areas examined were relatively restricted (Fig 15).

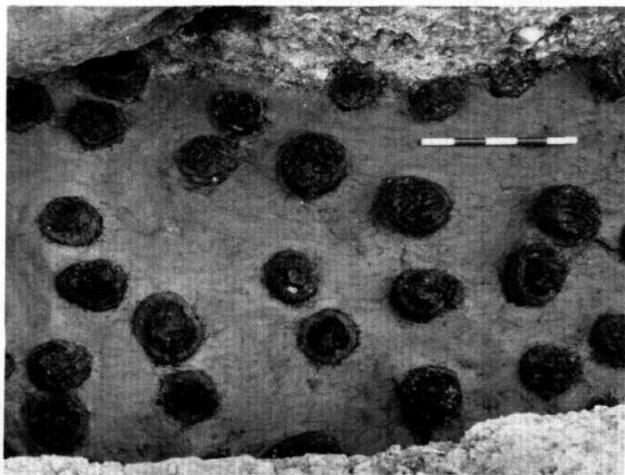
Fig 15 Peter's Hill; densely packed oak piles after the removal of the chalk raft. The lighter rings, at the edges of the piles, are sapwood surrounding darker heartwood. (Scale 5 x 0.10m)

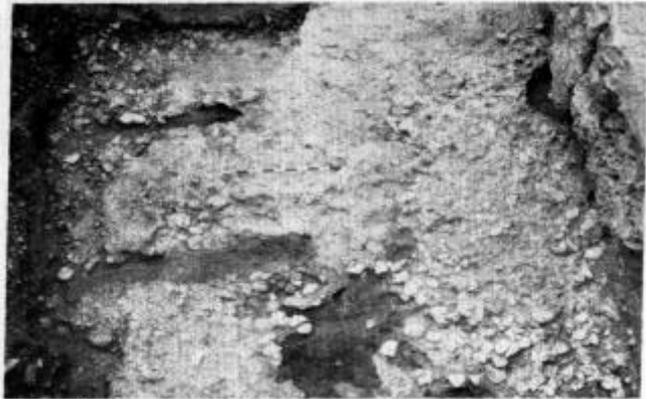
Fig 16 Peter's Hill; first chalk raft showing an uneven (nodular) and uncompacted finish outside the line of the later foundation. (Scale 10 x 0.10m)

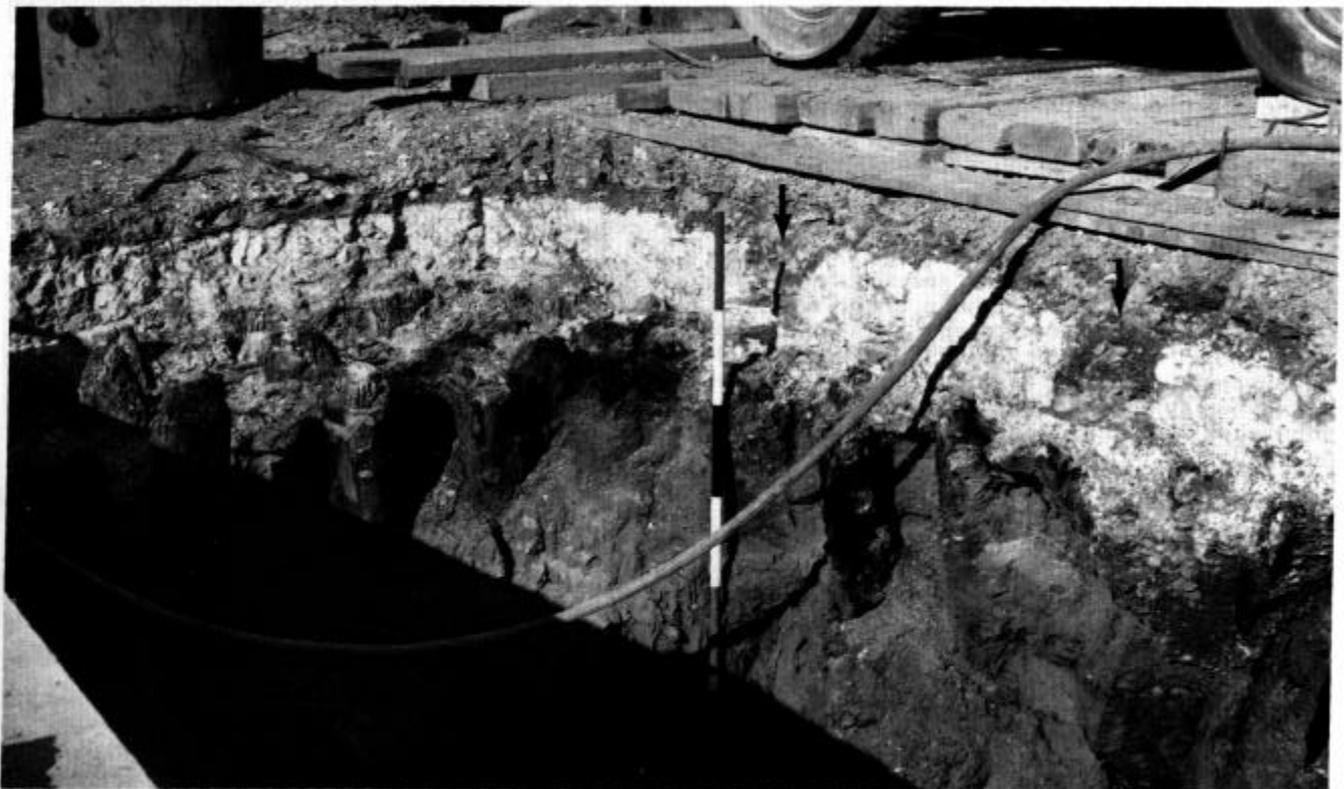
Fig 17 Salvation Army Headquarters; timber piles and chalk raft exposed during building works. Arrows indicate possible slots in the second chalk raft: evidence of a horizontal timber framework. (Scale 6 x 1')

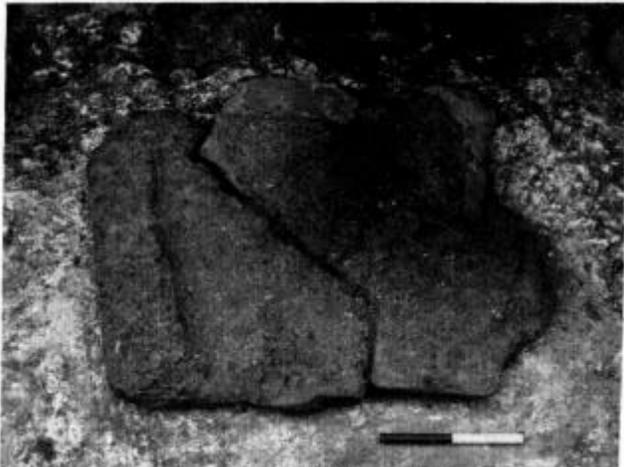
Fig 18 Peter's Hill; tiles and opus signinum were used to support a course of massive re-used limestone blocks in the monumental foundation. Blocks were positioned while the bedding was still wet, and their impressions can be seen in this bedding material - here ridges have been created as the material was forced up by the weight of the blocks. The blocks had been removed in antiquity. (Scale 2 x 0.10m)

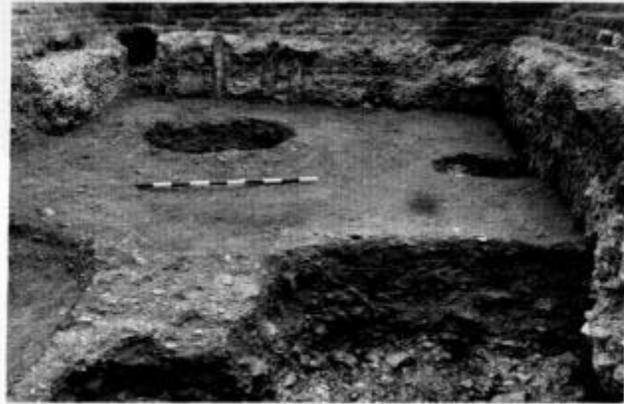
Fig 19 Peter's Hill; roughly level bands of heavily compacted building debris in the east of the site (Group 2.11). These deposits painstakingly consolidated the area prior to the laying of an opus signinum bedding layer (see Fig 20). (Scale 10 x 0.10m)

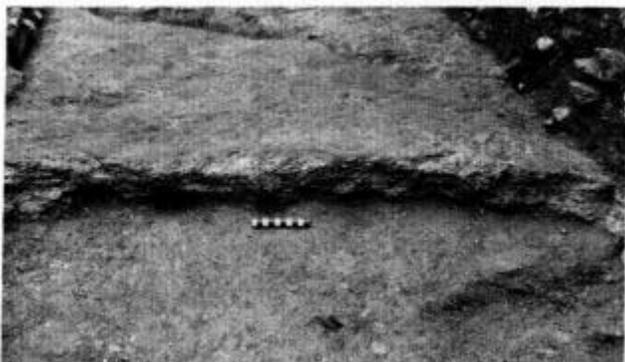
Fig 20 Peter's Hill; opus signinum bedding, poured in situ, partially excavated to expose the heavily compacted make-up dumps beneath (cf Fig 19). This deposit was not noticeably worn and may have provided the base for a surface, such as flagging. (Scale 10 x 10mm)

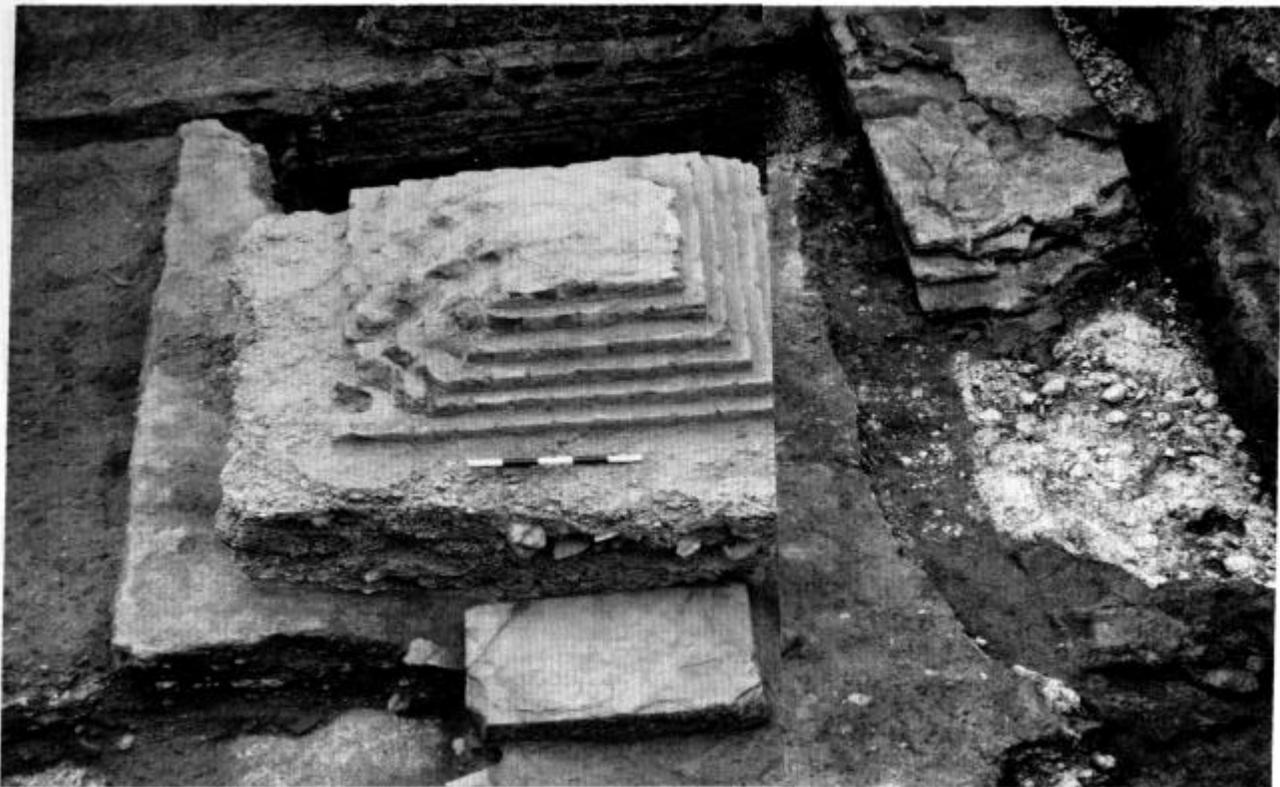
Fig 21 Peter's Hill; dressed block of greensand (foreground), set within compacted dumps of building debris (Group 2.11). (A 19th century foundation dominates the centre of the picture.) Trone probably served as a free-standing pier or statue base (cf Fig 42). The tile built terrace wall lies to the right, and the theth-south monumental foundation occupies the background. (Scale 5 x 0.10m)

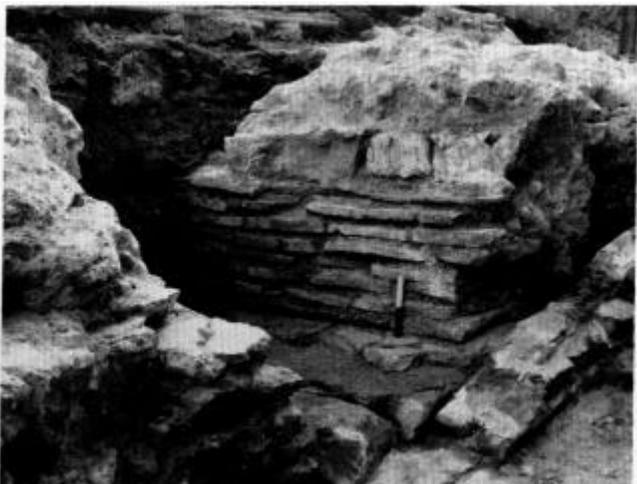
Fig 22 Sunlight Wharf; culvert within the monumental foundation (looking south-west). The base of the culvert utilised the re-used blocks of the monumental foundation. The sides were tile built for the first 0.3m, and then the core of the monumental foundation was faced with ragstone. (Scale 2 x 0.10m)

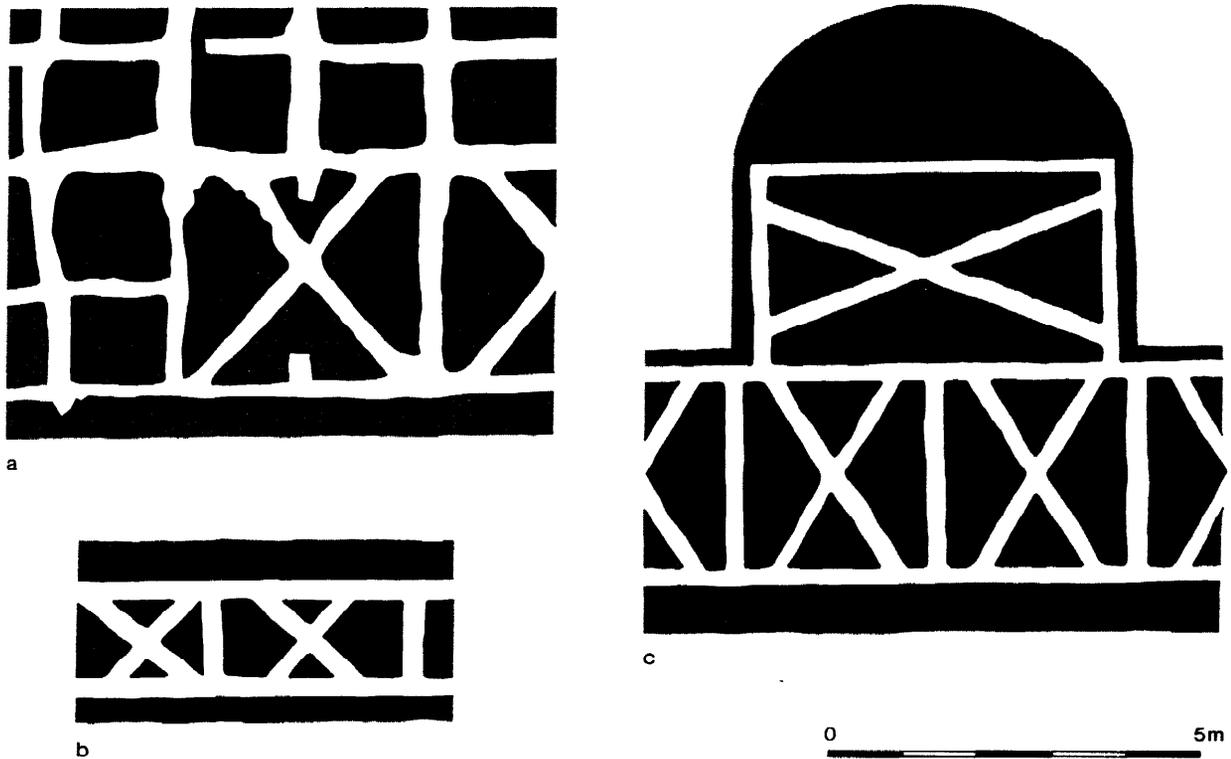
Fig 23 Packed chalk raft (grey), with negative impression of horizontal timber framework, used within monumental foundations: (a) the Period II complex at Peter's Hill; (b) the Saxon Shore Fort at Porchester (after Cunliffe 1975, fig 9); (c) the Saxon Shore Fort at Pevensey (after Cunliffe 1975, fig 10). (1 :100)

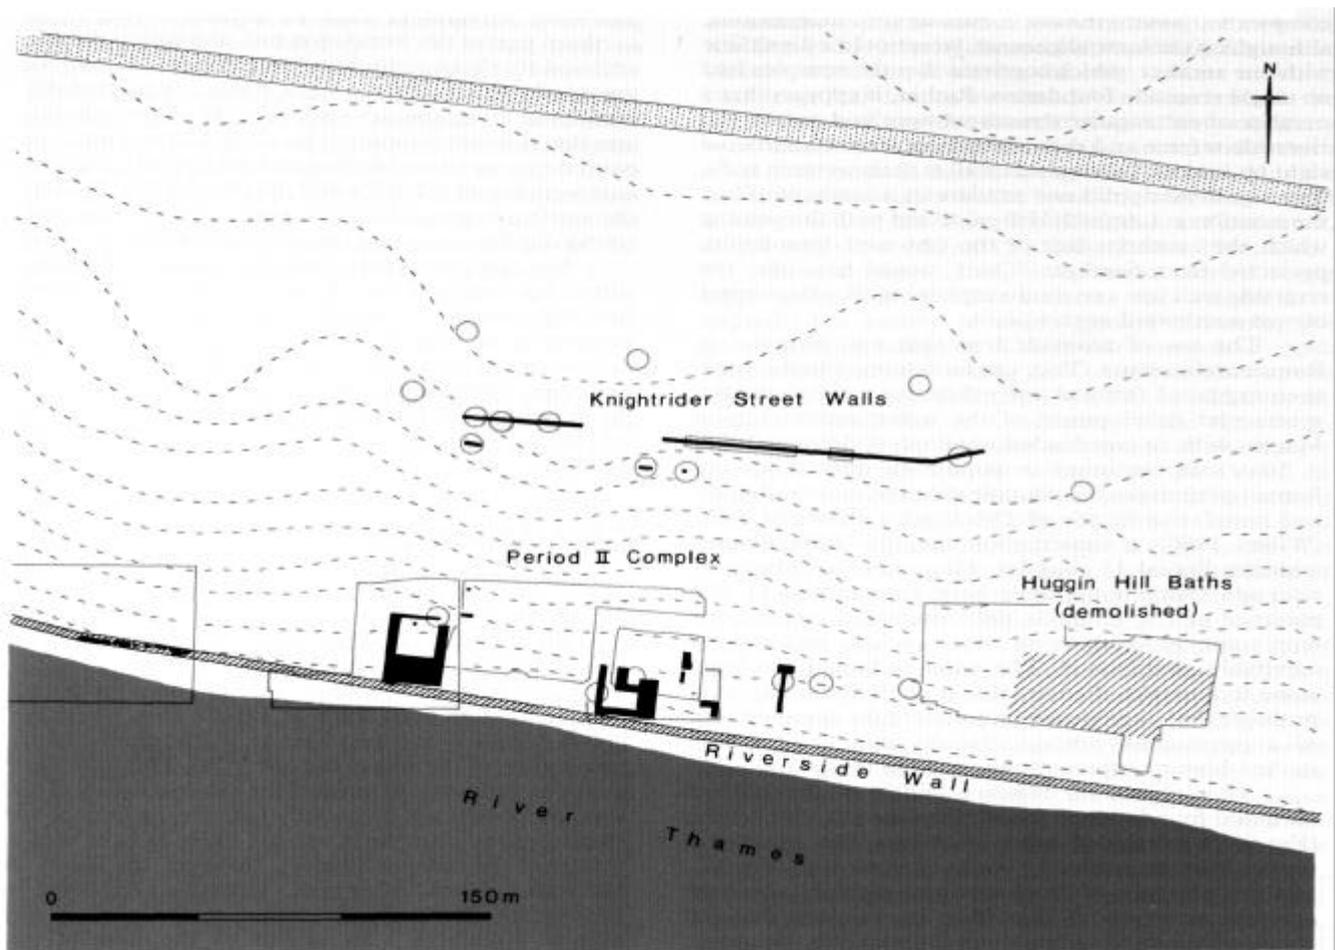
Fig 24 Period II complex and its environs. The long north wall at Knightrider Street probably formed the northern boundary for the complex. The angled western stretch of the riverside wall is a later addition, possibly constructed around the time of the Period II complex. Hatched area indicates approximate extent of Huggin Hill baths complex. (1:2500)

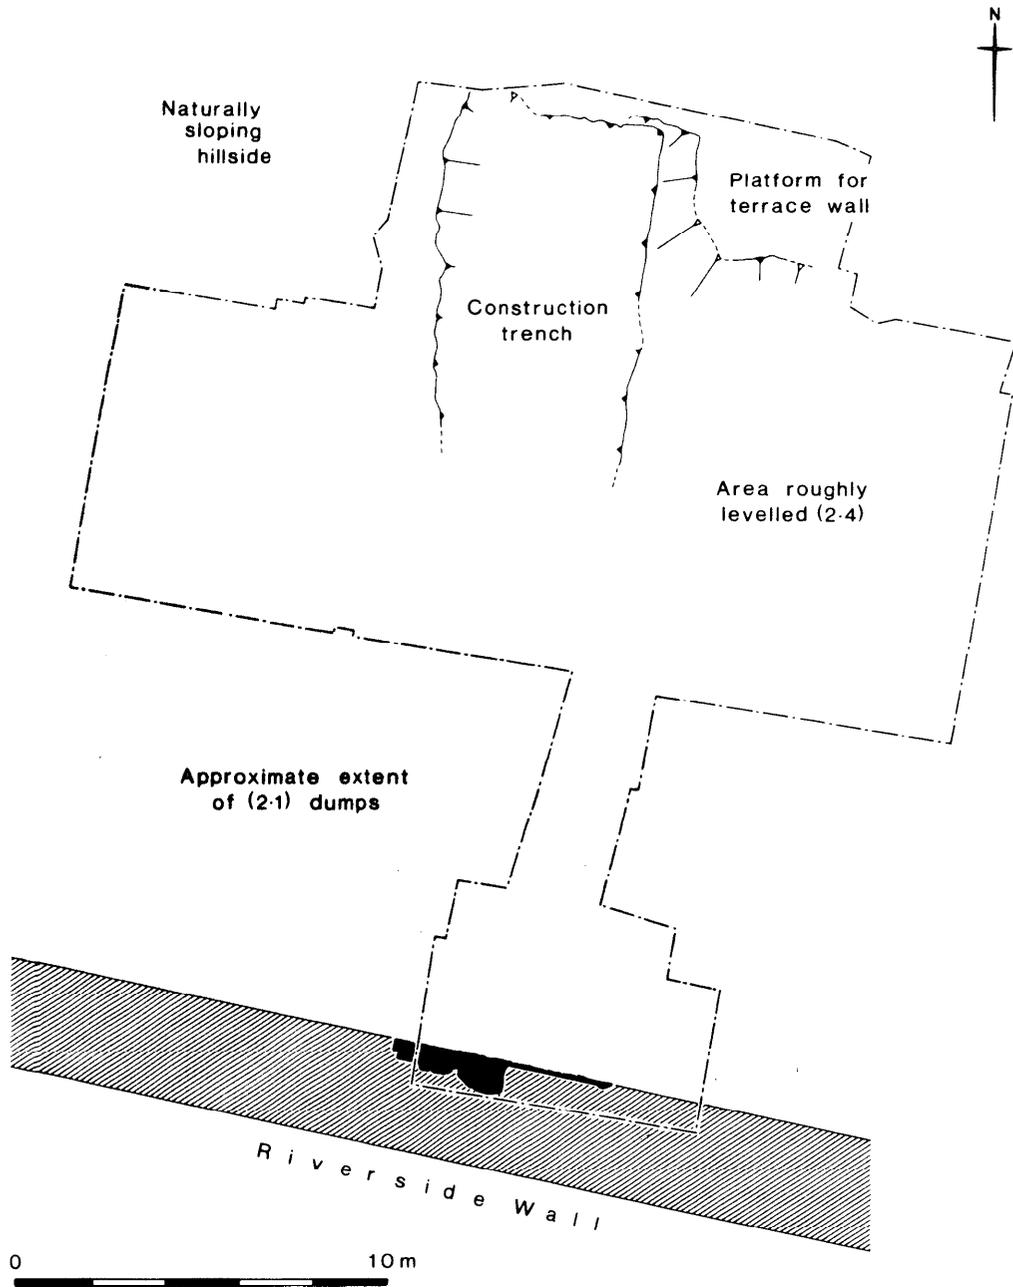
Fig 29 Peter's Hill; riverside wall to the south, with terrace formation to the north. The unaltered natural hillside sloped south-westwards. The terrace cutting was carefully planned to accommodate the Period II foundations; hence the construction trench for the massive north-south foundation, the undisturbed area left to support the tile built terrace wall, and the roughly levelled area for the compacted dumping sequence. (1:200)

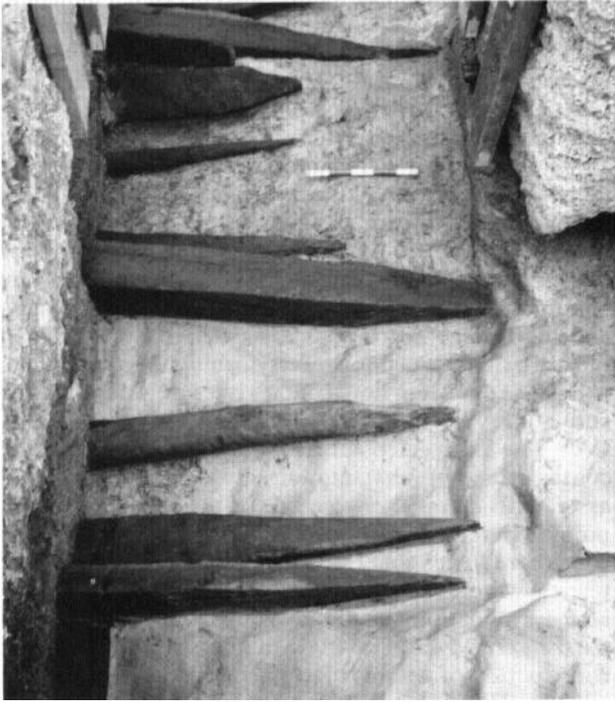
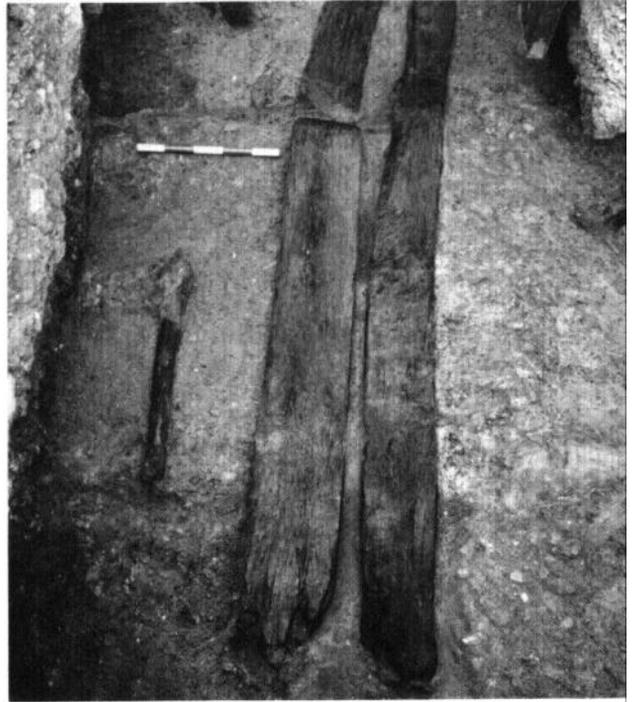
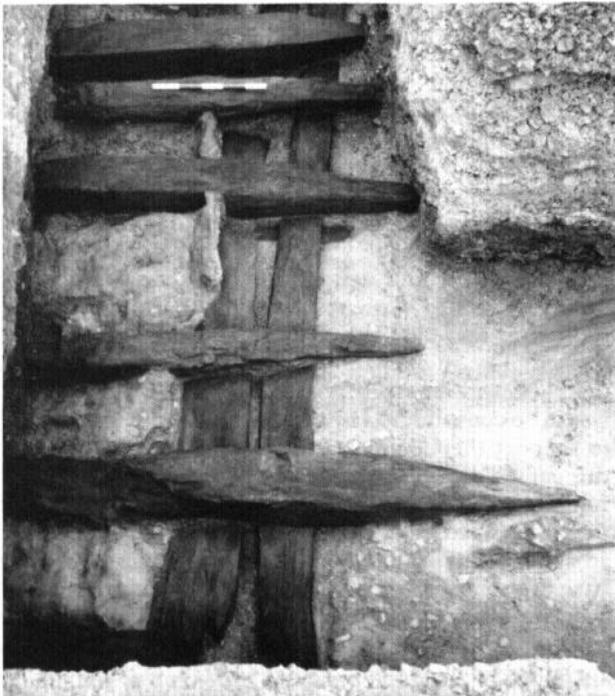
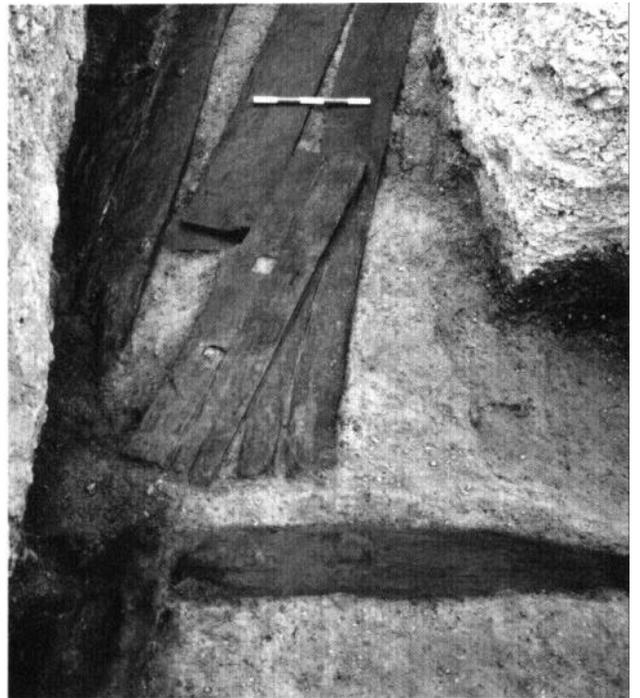
Fig 30 Peter's Hill; timber lattice (looking west) (Scale 5 x 0.10m)

(a) layer of sharpened timbers, laid on the natural clay.

(b) substantial planks laid horizontally on a bed of gravel and clay dumps, which sealed the sharpened timbers shown in (a).

(c) lattice of sharpened timbers, orientated north-south, overlying the east-west planks shown in (b). Intervening gravel and clay dumps can also be seen.

(d) layer of east-west planks. In the foreground, one of the north-south stakes shown in (c) is still visible. Many of the timbers showed signs of re-use.

The timbers of one layer, with a few exceptions, did not touch those of another layer, but were separated by the intervening dumps (Fig 30). The timber lattice was not therefore constructed as a self-contained structure, with the dumps used as infilling, but was constructed in layers, with the dumping forming an integral part of the process. The horizontal sharpened timbers in the northern part of the area were not driven into the slope of the natural hillside, but were simply placed upon the underlying deposits; the natural clay slope showed no signs of having been disturbed by their insertion.

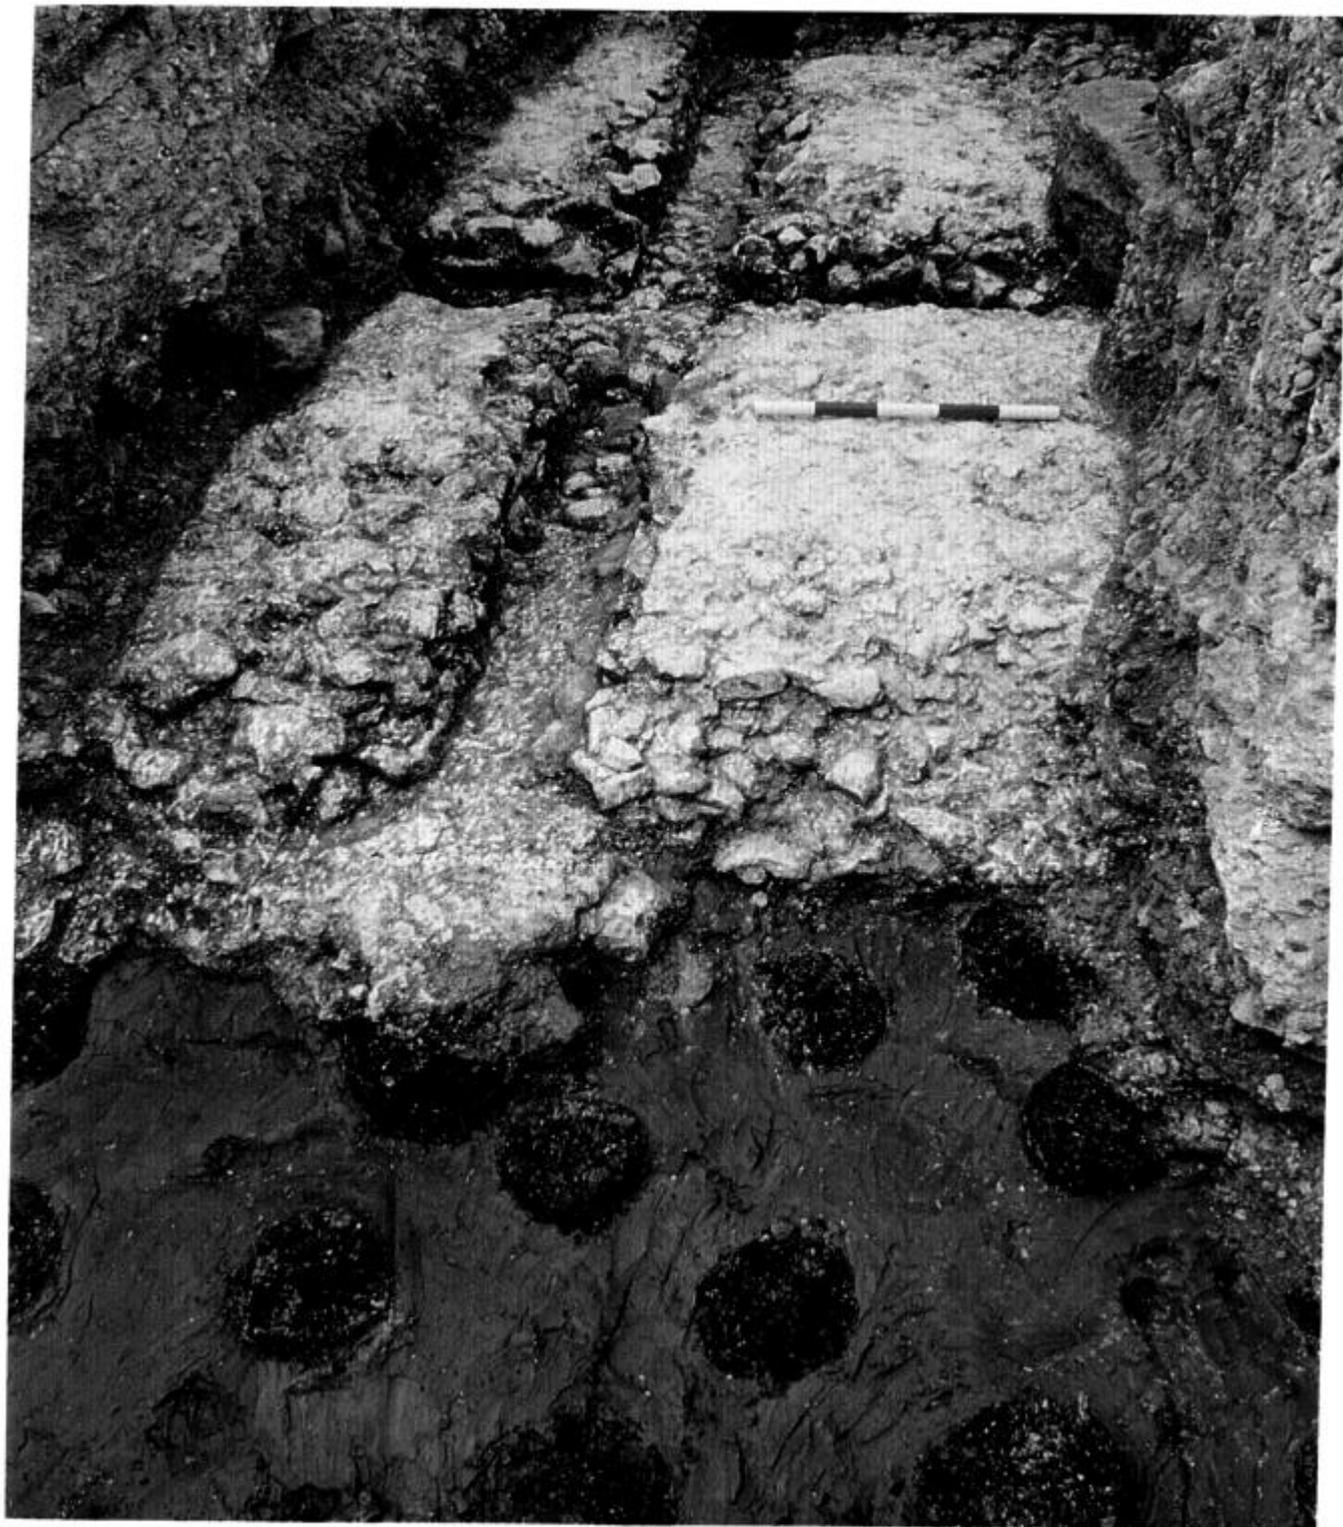
*Plate 1 Peter's Hill; timber slots and the second chalk raft (looking west). Note the sharp profiles of the 'slots' and the undisturbed first chalk raft, which formed their base. The timbers were placed directly upon the first raft, with the second raft packed around them. The oak pile support for the first raft is visible in the foreground. (Scale 5 x 0.10m)*
