Public Buildings in the  
South-West Quarter of  
Roman London

The archaeology of Roman London,  
Volume 3:

**Public Buildings in the  
South-West Quarter of  
Roman London**

**by**  
Tim Williams

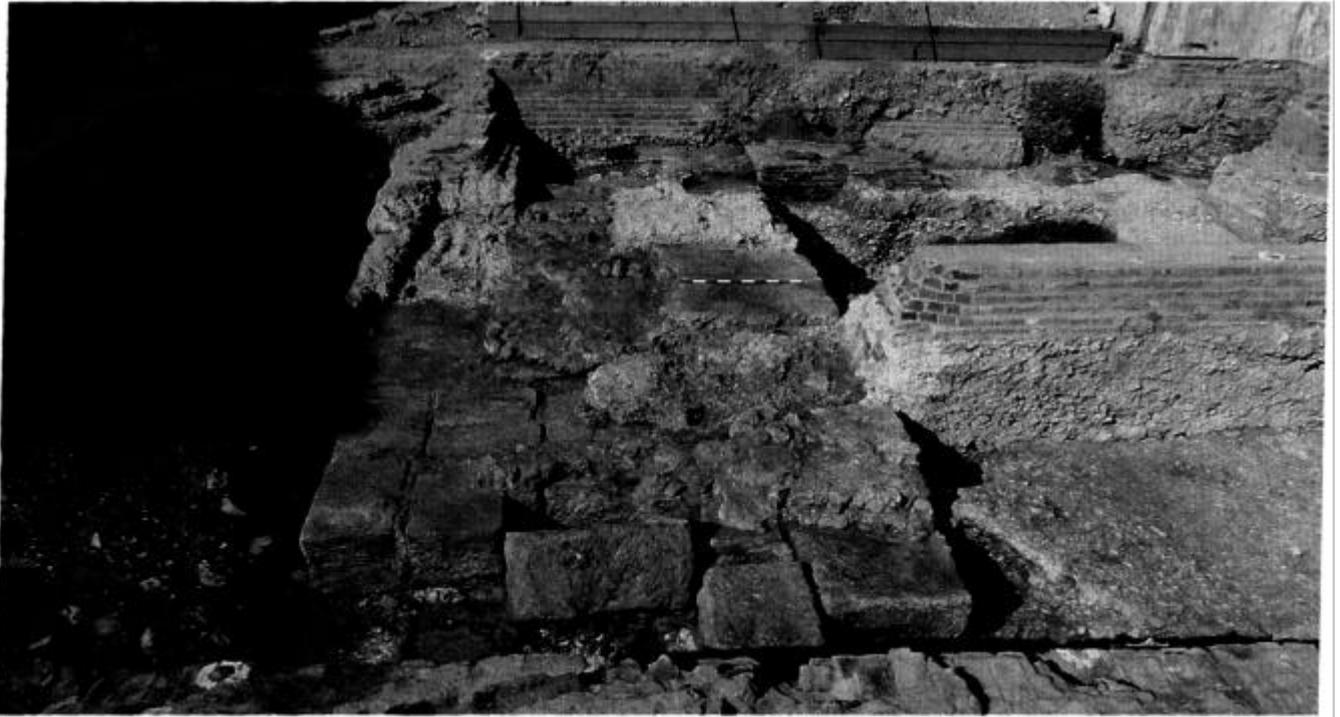
*Plate 2 Peter's Hill; monumental foundation seen from the south. The large gaps between the re-used blocks in the lowest course were infilled with a mixture of poured opus signinum and broken tiles. Above this was the coursed rubble core and ragstone facing of the main foundation. Photographed in strong sunlight. (Scale 10 x 0.10m)*

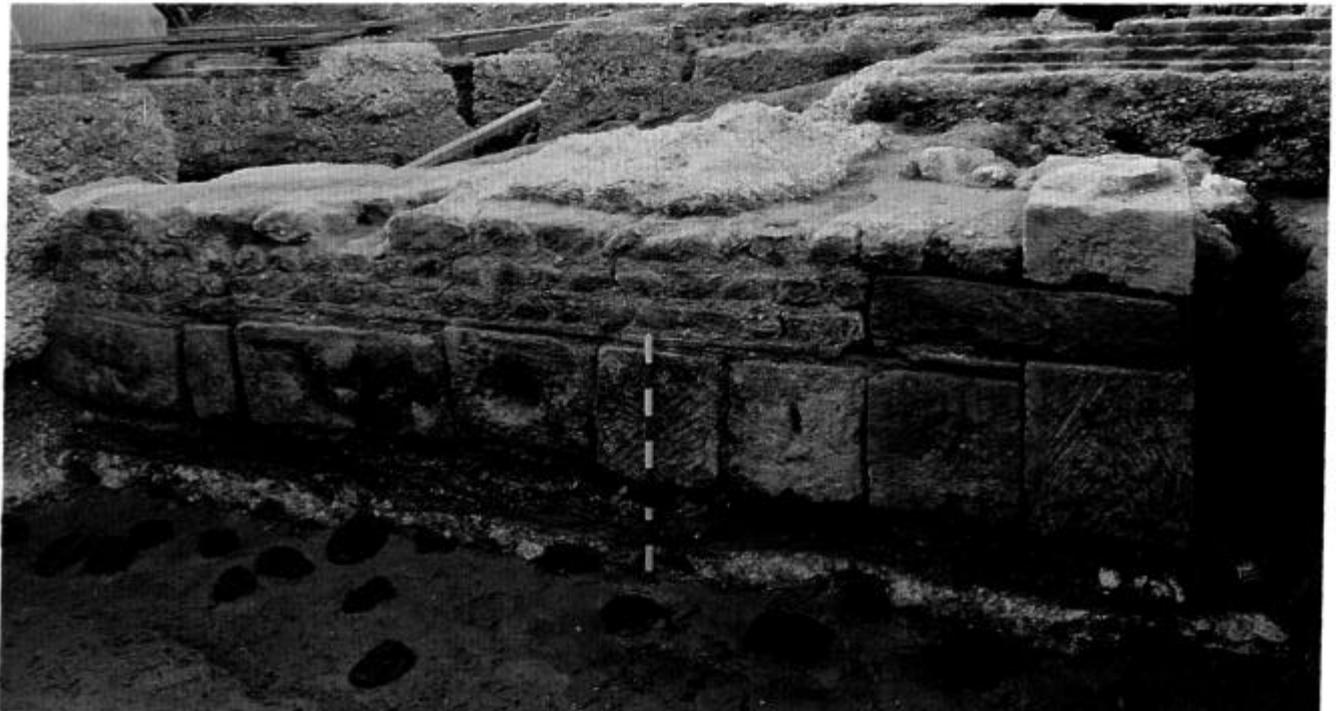
*Plate 3 Peter's Hill; north-south foundation, eastern elevation. (Scale 10 x 0.10m)*

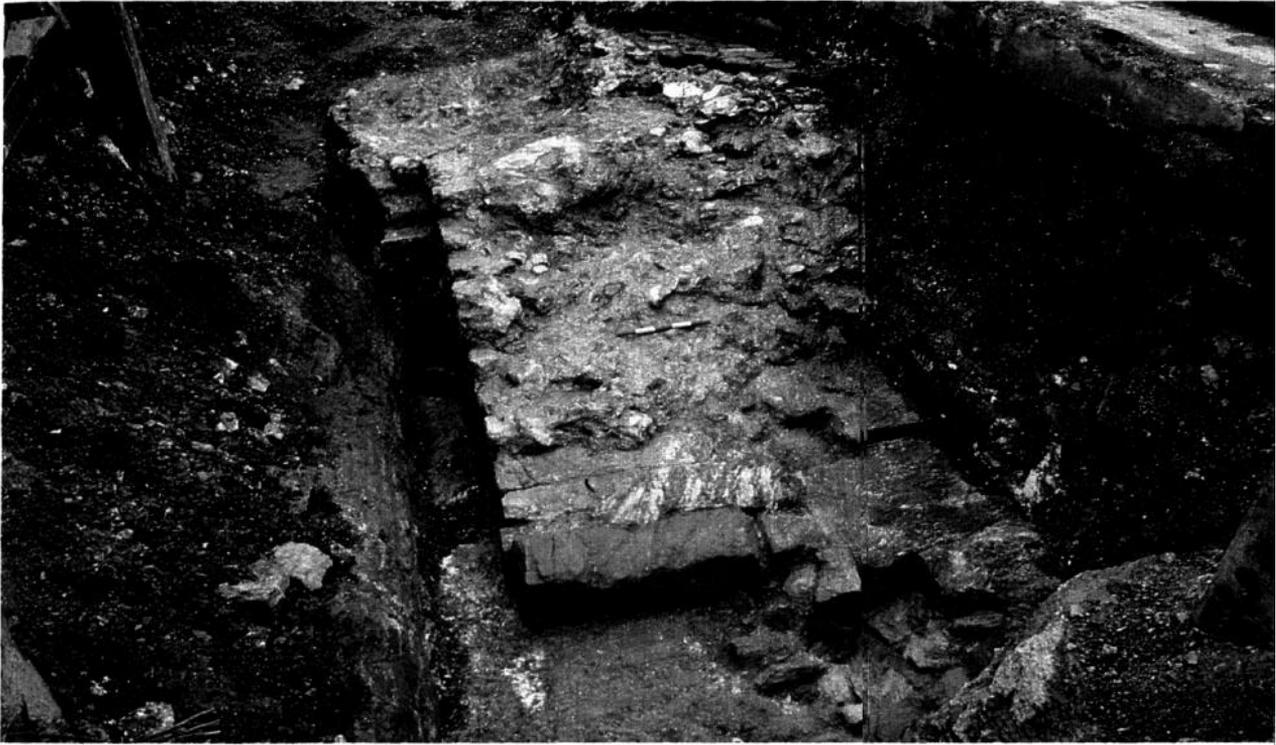
*Plate 4 Sunlight Wharf; east-west monumental foundation, returning northwan Trench BX (looking east).. Re-used sandstone and limestone blocks formed the basal course, above which the structure sisted of coursed ragstone and concrete rubble, faced with roughly squared ragstone. A Victorian sewer, to the left, cut thgh the north-south foundation, but lay slightly too far north for the east-west foundation to have been observed during construction. (Scale 5 x 0.10m)*

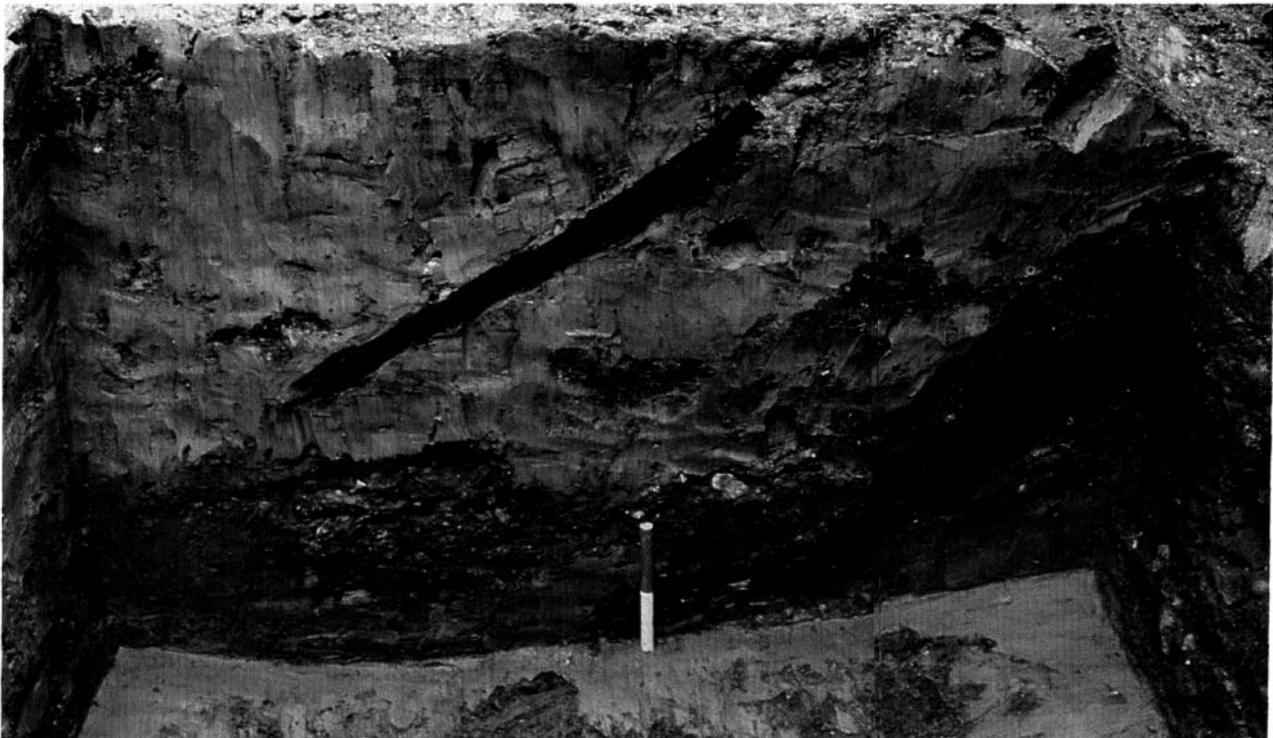
*Plate 5 Peter's Hill; angled stakes driven through the dumps at the base of the hie (looking east). (Scale 2 x 0.10m)*

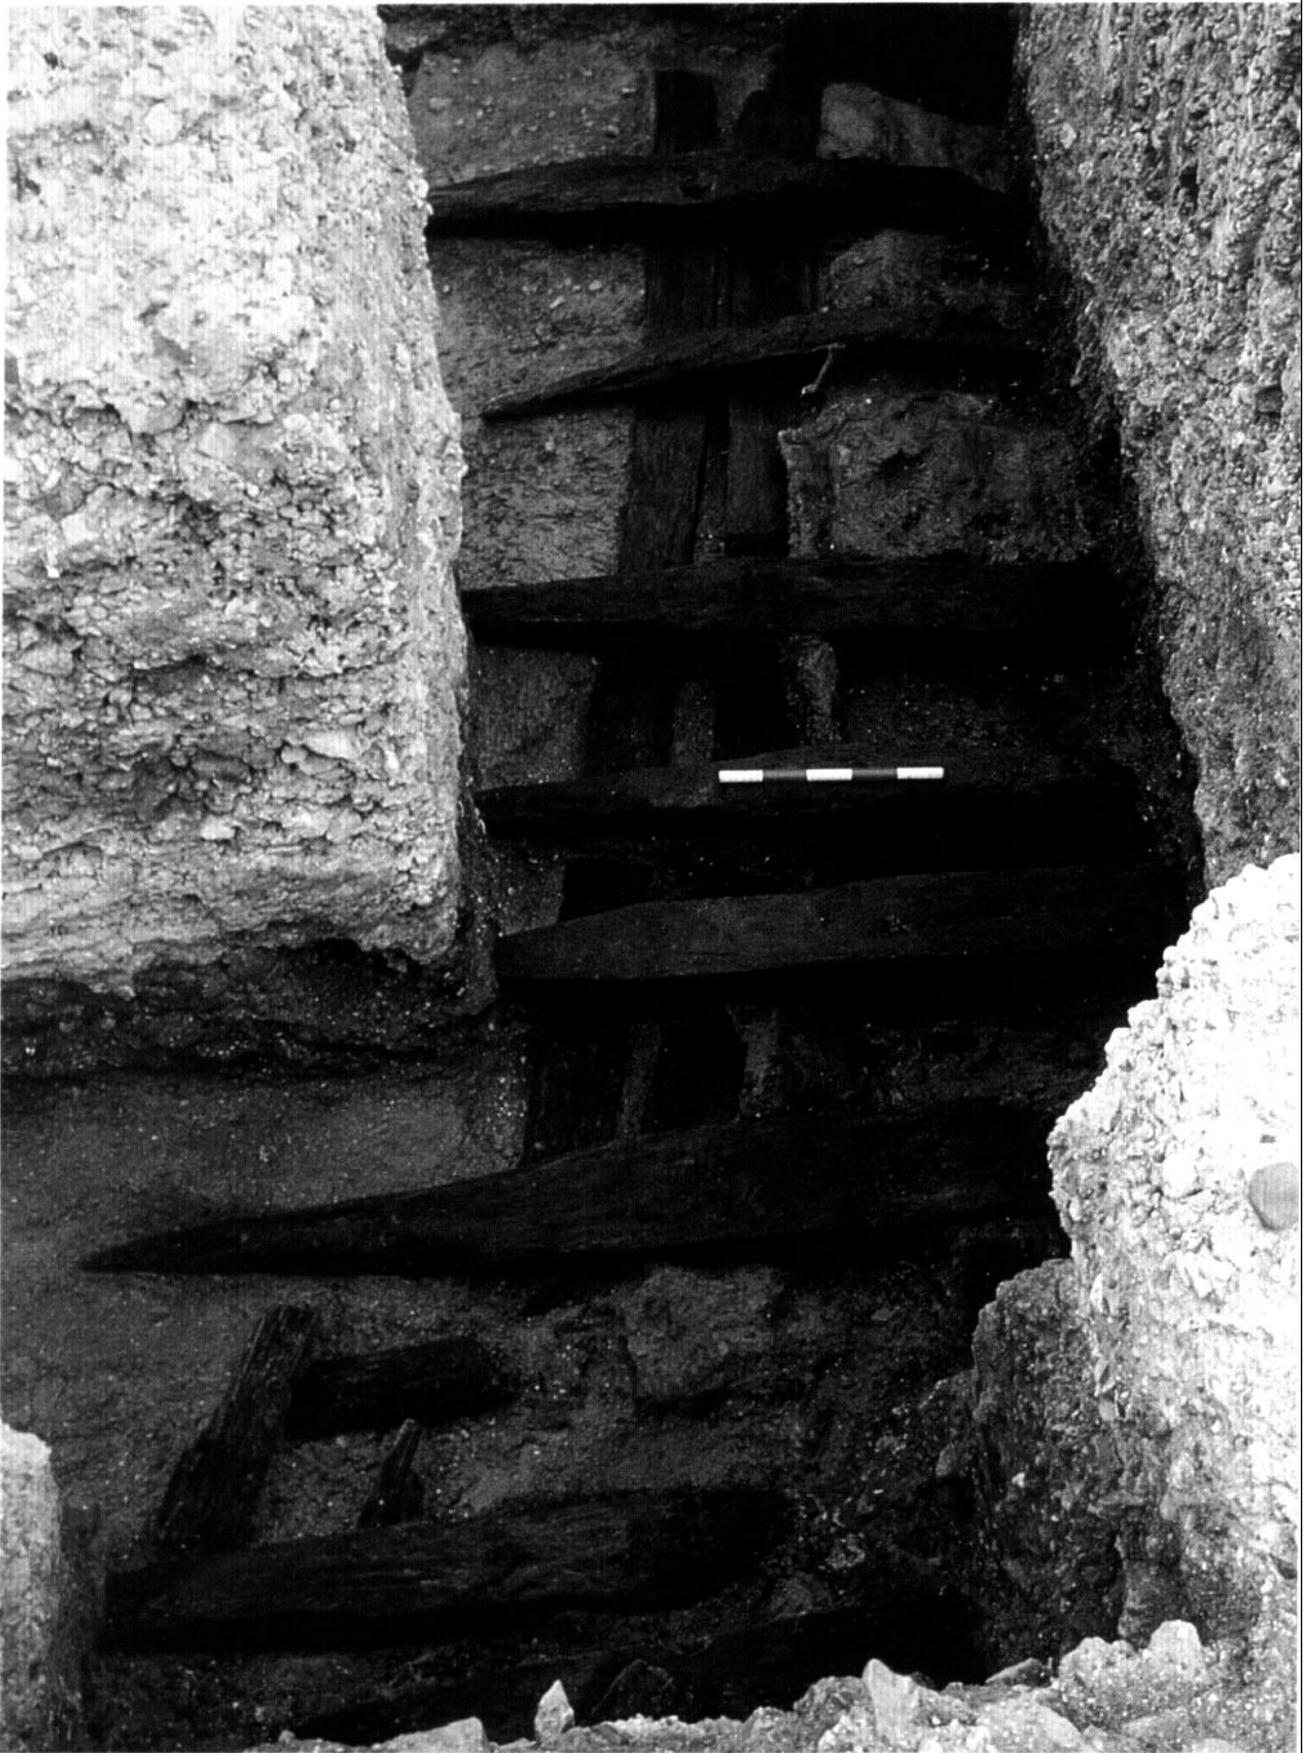
Plate 6 Peter's Hill; a lattice of sharpened timbers, orientated north-south, overlying planks laid east-west (looking east). Some of the intervening gravel and clay dumps can also be seen. (Scale 5 x 0.10m)

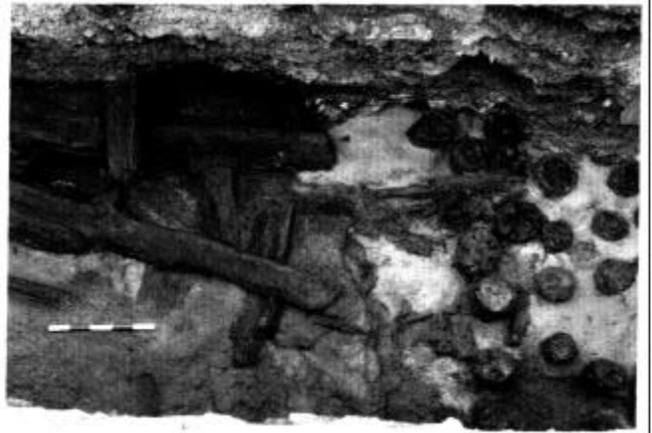
Fig 32 Peter's Hill; timber lattice (to the left), respecting the western limit of the Group 2.5 pile foundation, in the south of the site (looking north). Here the lattice was less structured than to the north (cf Fig 30). (Scale 5 x 0.10m)

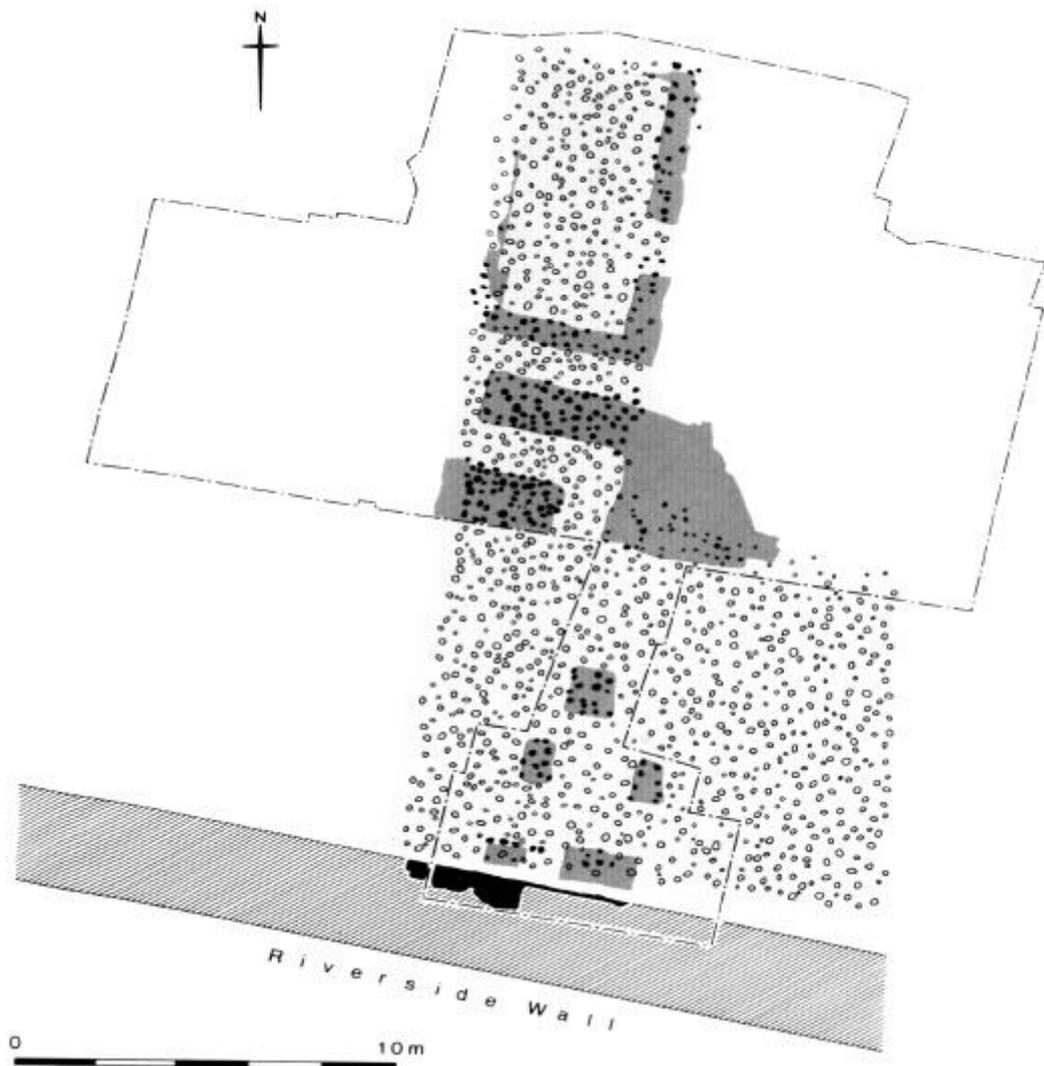
Fig 33 Peter's Hill; extent of timber piles and chalk raft foundation (Group 2.5). Piles were confined to the area of the terrace dumping (Group 2.1, Fig 29) and those areas directly beneath a subsequent masonry foundation. The conjectured nature of the evidence in the area of the masonry foundation indicated on Fig 38 is because the latter was not removed. (1 :200)

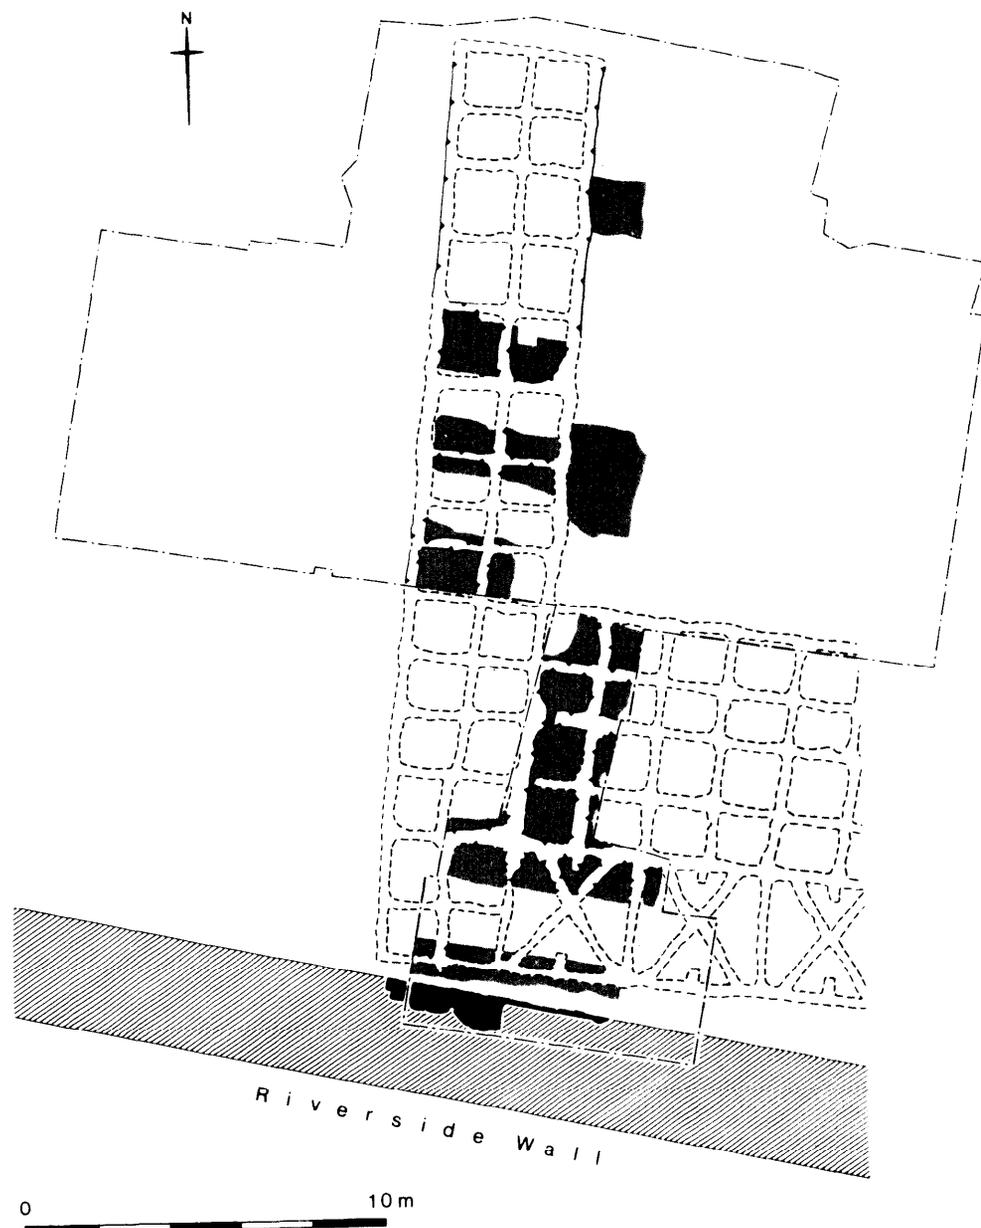
Fig 35 Peter's Hill; slots in the second chalk raft (all Group 2.6) indicate the position of horizontal timbers used to lace the foundation. The north-south/east-west pattern shifted through  $45^\circ$  in the south of the area. (1:200)

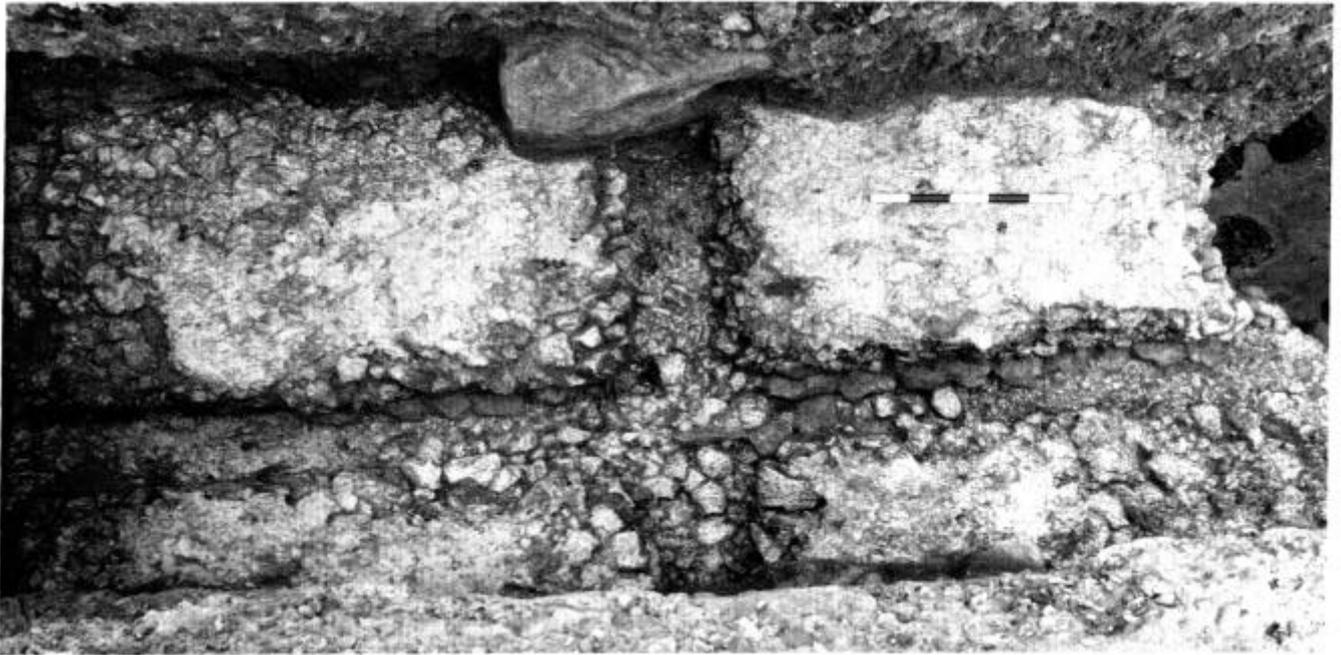
Fig 36 Peter's Hill; horizontal timbers, indicated by the slots, were supported by small fragments of tile, which were used to wedge or support the beams in place. The second chalk raft was packed around them. (Scale 5 x 0.10m)

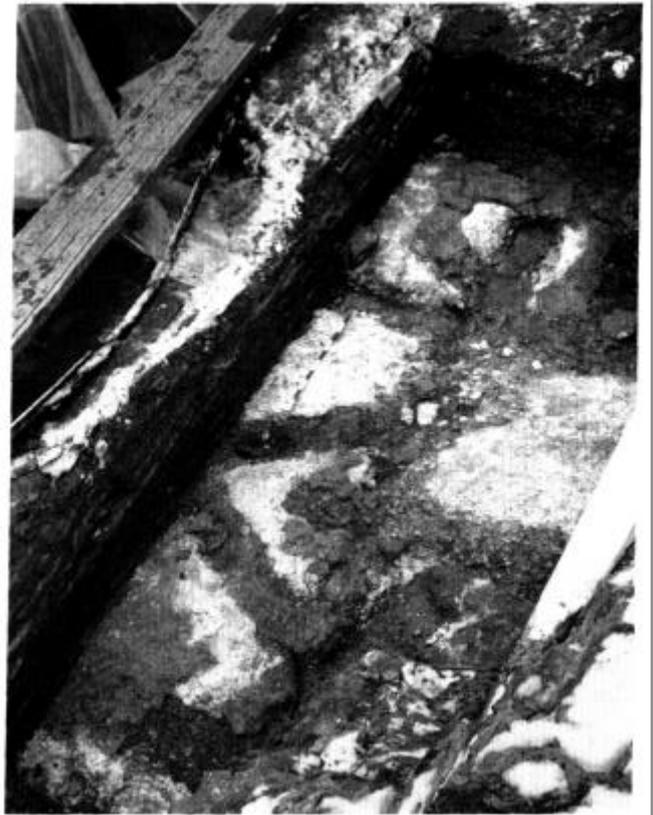
Fig 37 Peter's Hill; southern area of the foundation, observed during the last stages of the excavation, when weather conditions were less than favourable. The diagonal pattern of the unexcavated slots can be seen. (Scale 10 x 0.10m)

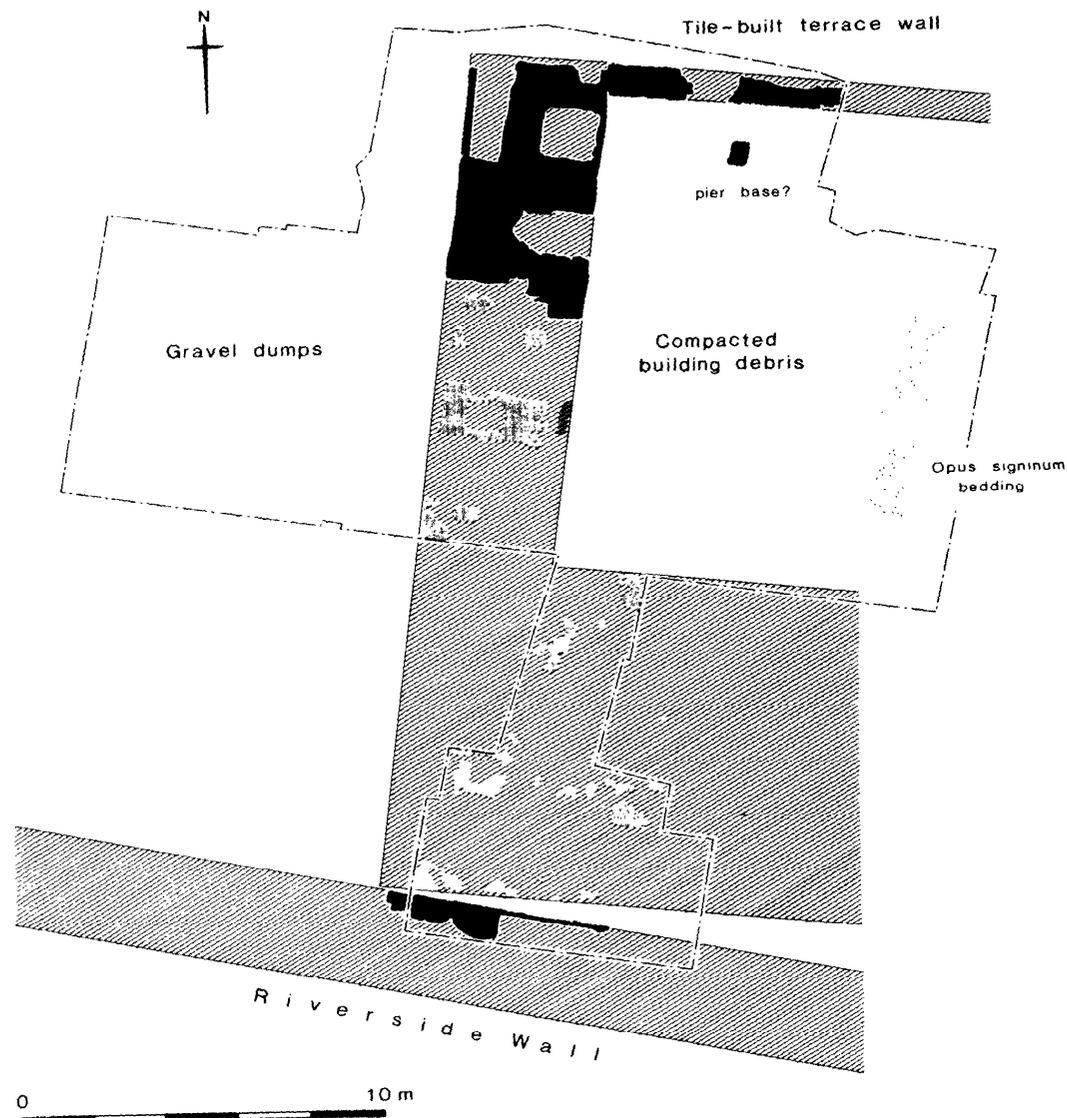
Fig 38 Peter's Hill; massive masonry foundations (Group 2.7). Conjecture has been aided by the surviving block settings (grey). ?External gravel dumps to the west (Group 2.10) and compacted dumps of building debris to the east (Group 2.11). The opus signinum bedding, preserved under an early medieval street, suggests that the entire eastern area was surfaced with this material. (1 :200)

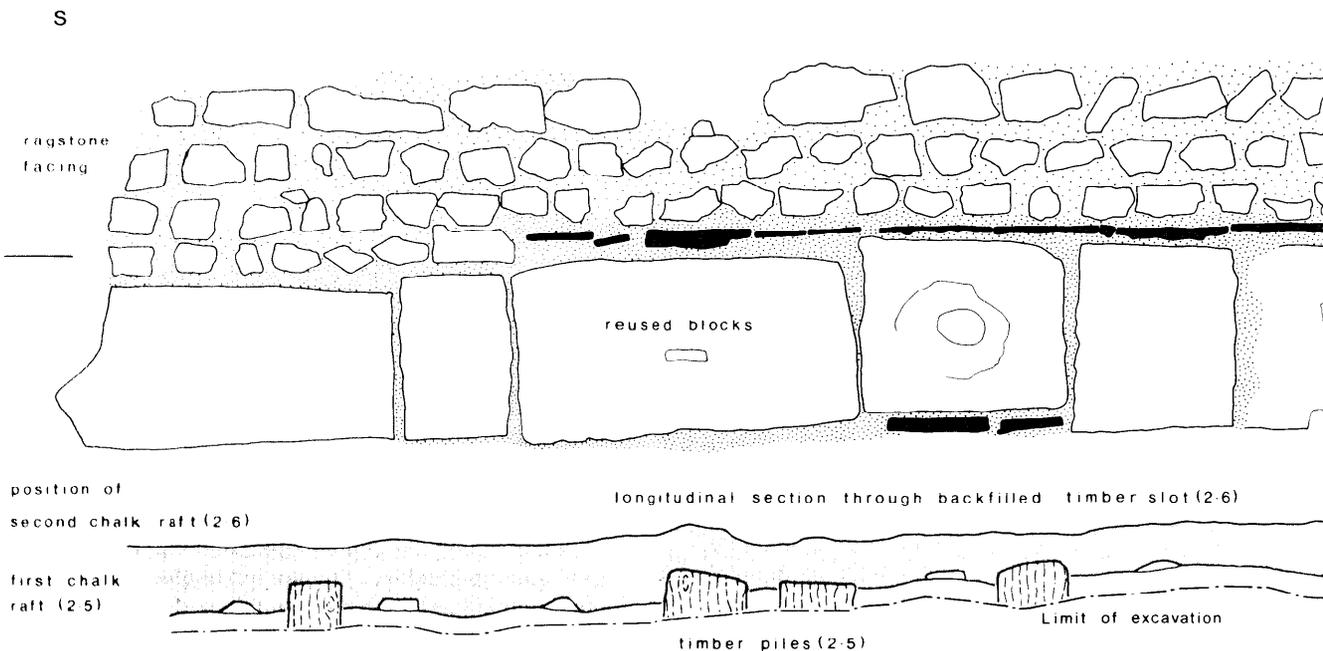
Fig 39 Peter's Hill; elevation of the eastern face of the monumental masonry foundation (Group 2.7). Note the 'stepping up' of the massive re-used blocks at the northern end of the foundation, and the tiles beneath one of the blocks, to level it roughly. The intermittent tile levelling course above the blocks was formed from inverted roofing tiles (*tegulae*). The second chalk raft is not visible here as the line of the elevation coincides with one of the backfilled north-south timber slots, which was framed within that raft. (1:20)

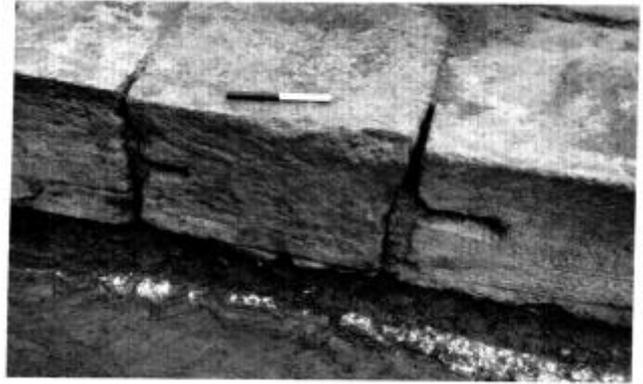
Fig 40 Peter's Hill; detail of limestone blocks in the massive foundation. Note Lewis holes. The dark material beneath the blocks was a backfield timber slot, beneath which the first chalk raft is visible. (Scale 2 x 0.10m)

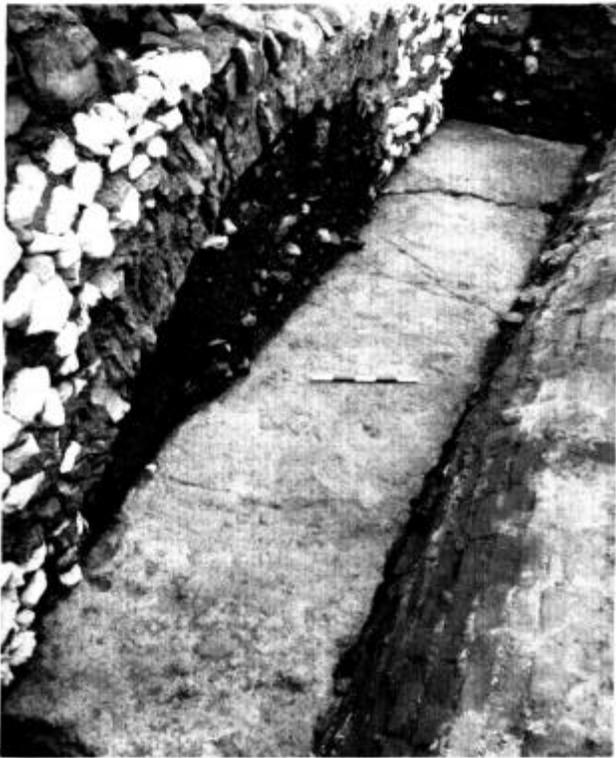
Fig 41 Peter's Hill; *opus signinum* bedding surviving beneath the early medieval street of Peter's Hill. Destroyed by medieval church foundations (left) and a Victorian sewer (right). (Scale 5 x 0.10m)

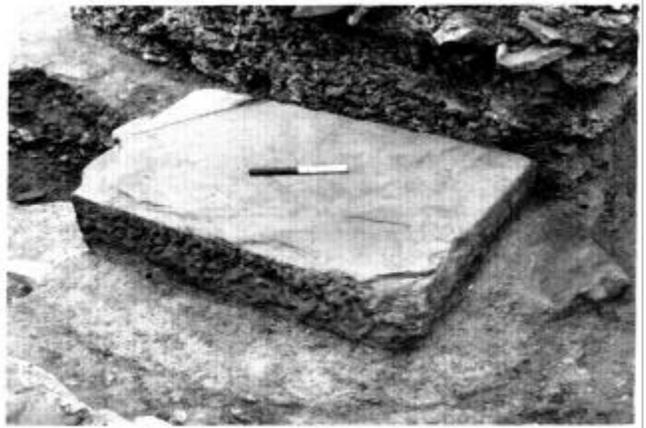
Fig 42 Peter's Hill; greensand block, forming possible pier/column base (cf Fig 21). A faint cross is visible scored into the smooth upper surface of the block; the latter contrasts with the roughly tooled sides. The backfilled construction pit for the block is also visible. (Scale 2 x 0.10m)

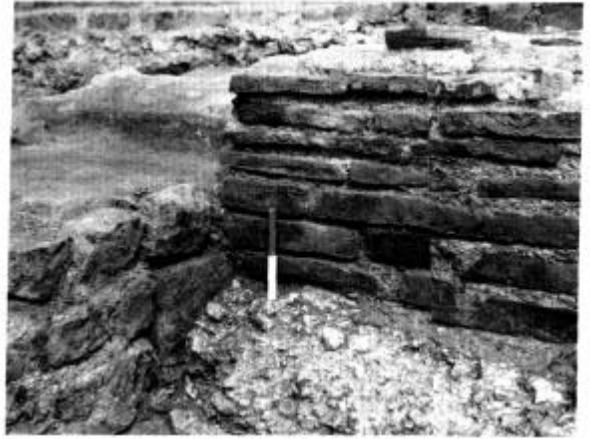
Fig 43 Peter's Hill; junction between the built terrace wall (right) and the monumental may foundation (left). The former was constructed upereries of chalk dumps which had been deposited against tastern face of the latter. (Scale 2 x 0.10m)

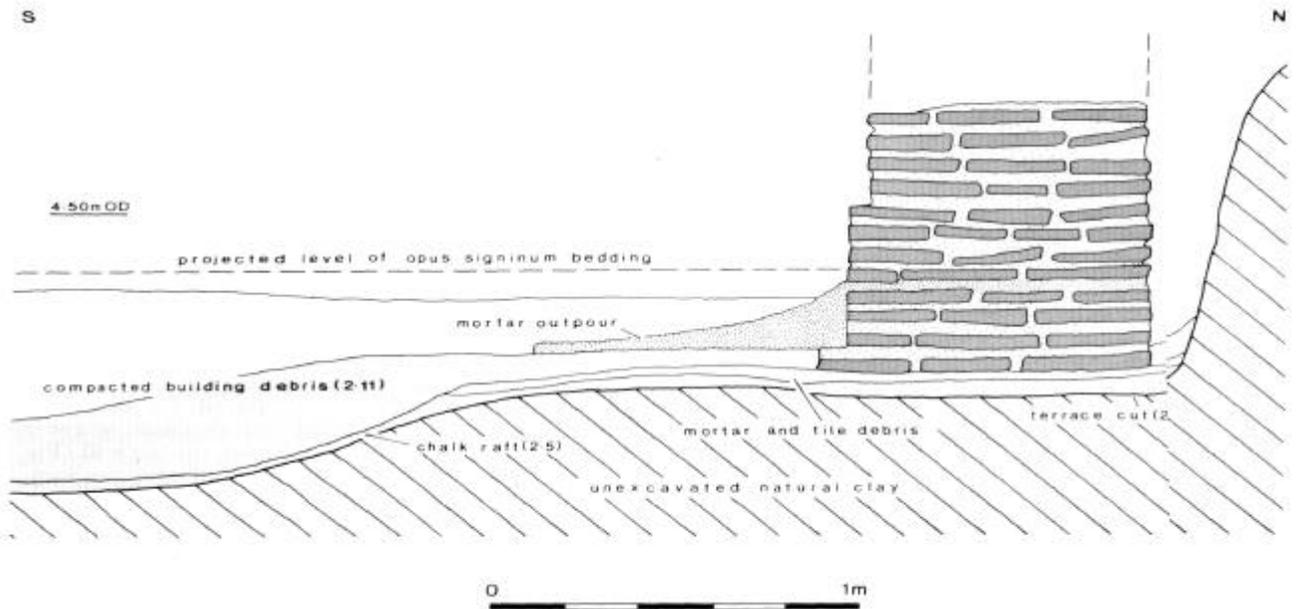
Fig 44 Peter's Hill; reconstructed section through the tile built terrace wall. The wall was constructed in twoges, above and below a mortar outpouring. The chalk raft was only rammed smooth in the area of the wall; to the south is left in a rough state. (1 :20)

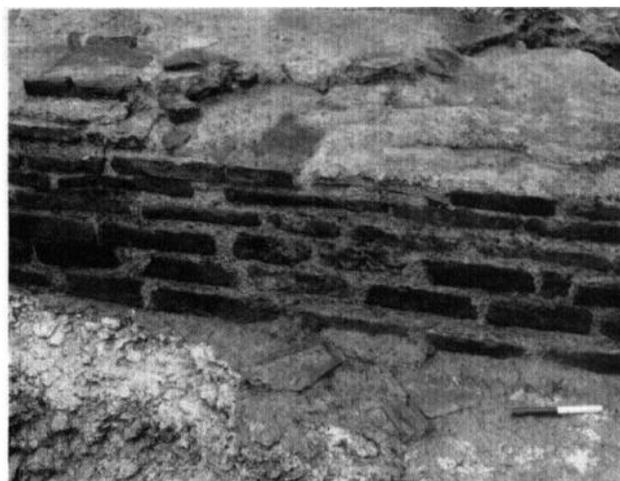
*Fig 45 Peter's Hill; detail of the tile built terrace wall, showing construction debris in the foreground. (Scale 2 x 0.10m)*

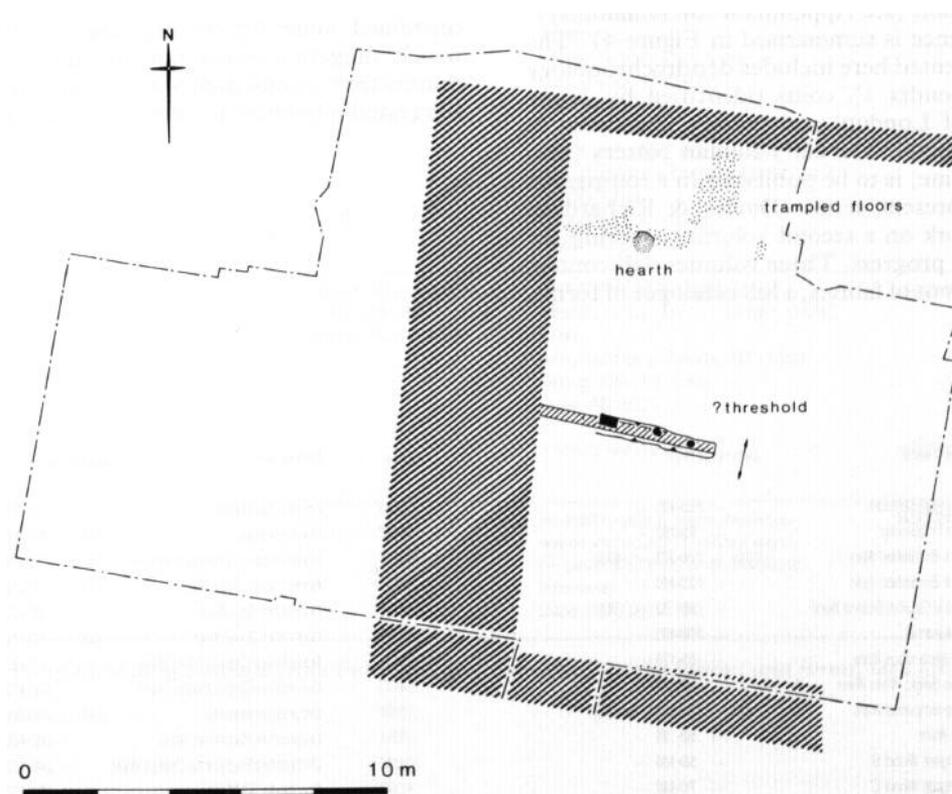
*Fig 46 Peter's Hill; late Roman building (Group 7), c AD 350 +, possibly re-using some of the Period II foundations. An east-west post-in-trench wall may have been associated with an area of trampled 'earth' floors and hearths which survived truncation in the north of the area. (1:200)*

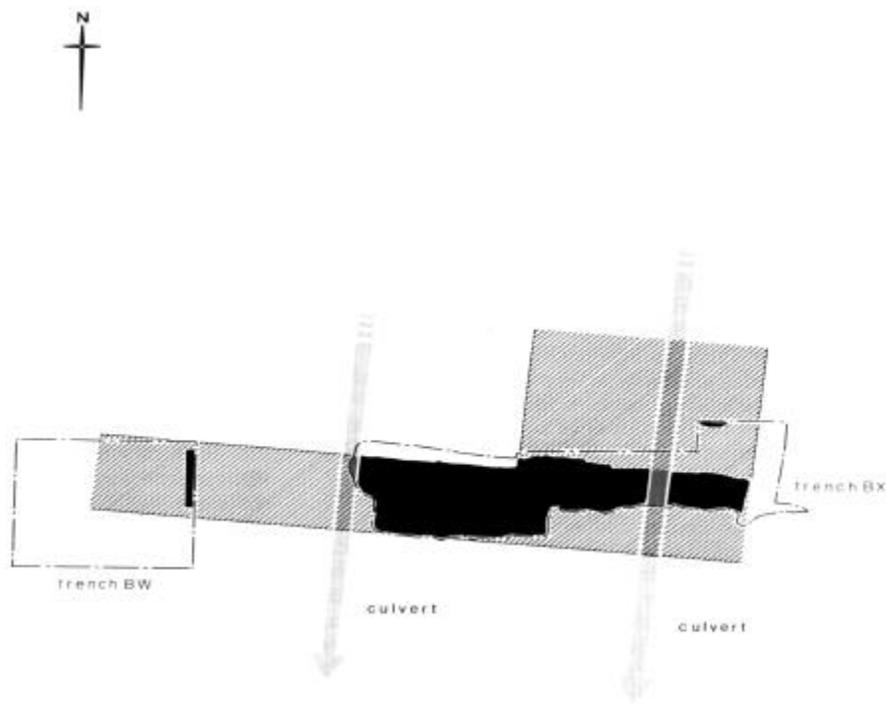
Fig 48 Sunlight Wharf; monumental foundations. Note that the eastern walls are of unknown width, having only been observed in small trenches. The north-south foundation did not appear in Trench BZ, and it is probable that it turned east (?and/or west) at this point. Blue arrows indicate the possible watercourses (cf Fig 4). (1 :200)

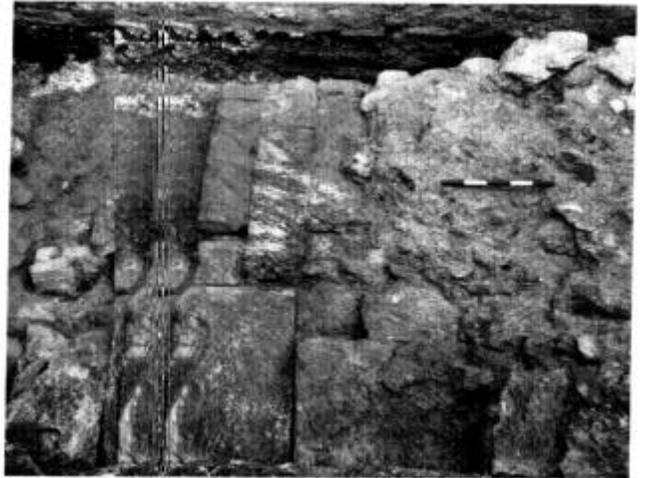
Fig 49 Wightlight Wharf; monumental foundation in Trench Boitheith the Victorian sewer in the background (looking n). Massive re-used blocks were arranged in the basal course to present their narrow sides to the face of the foundation. To the left, where the blocks have been removed, tile tile and *opus signinum* block settings are visible. To the right, the coursed ragstone rubble and concrete of the foundation survives. (Scale 5 x 0.10m)

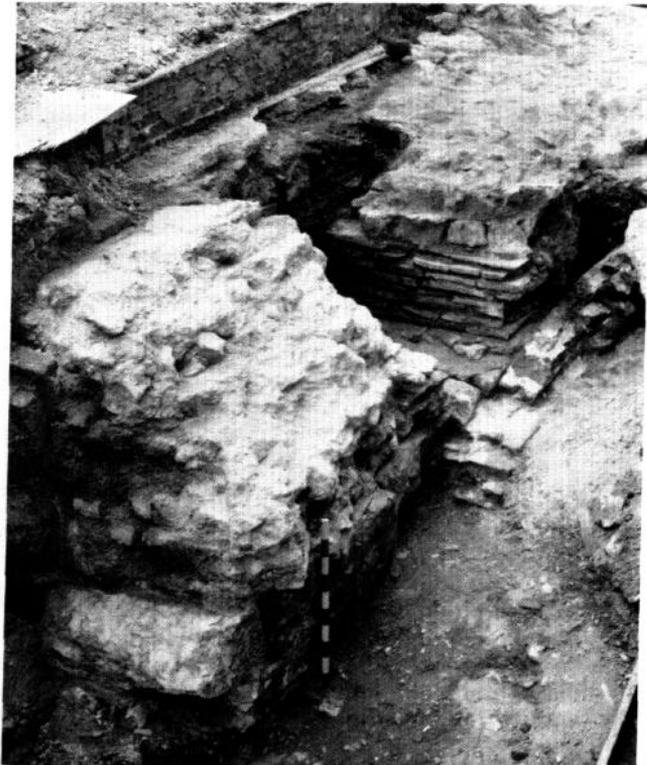
Fig 51 Sunlight Wharf; monumental foundation and culvert (looking south-west) - (Scale 10 x 0.10m)

A north-south culvert (Group 1.7) was constructed upon the stone blocks (Group 1.6), within the body of the foundation (Figs 22, 48, 51 and 52). The lower courses of the culvert walls were constructed from

bonding bricks, mortared with a very hard *opus signinum*, whilst at a higher level it was continued by the main core of the foundation (Group 1.9), faced with squared ragstone blocks (Fig 52). The base of the culvert was constructed of tile fragments set in *opus signinum*, and sloped gently down towards the south. It is evident that construction of the culvert commenced prior to the core of the main foundation (Group 1.9) and that it was then incorporated within the latter's ragstone facing. Thus, the culvert appears to have formed an integral part of the initial construction of the foundation, rather than been a later insertion.

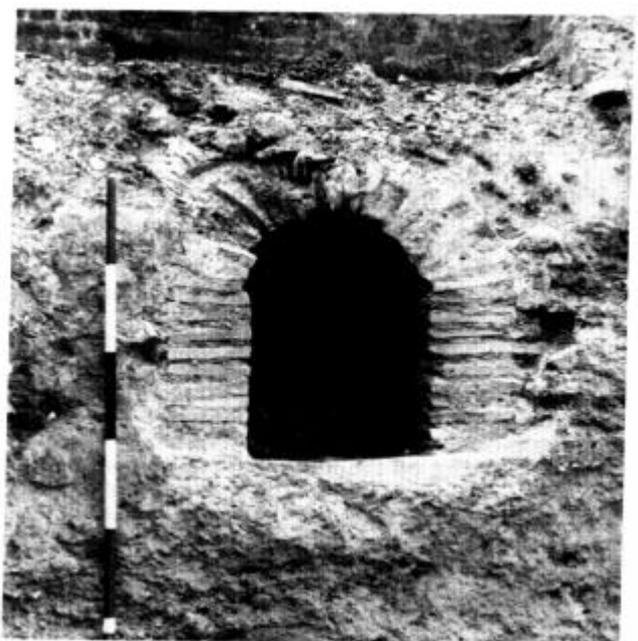
Fig 60 Culvert piercing the long wall at Knightrider Street (Observation 16). (Scale 6 x 1')
