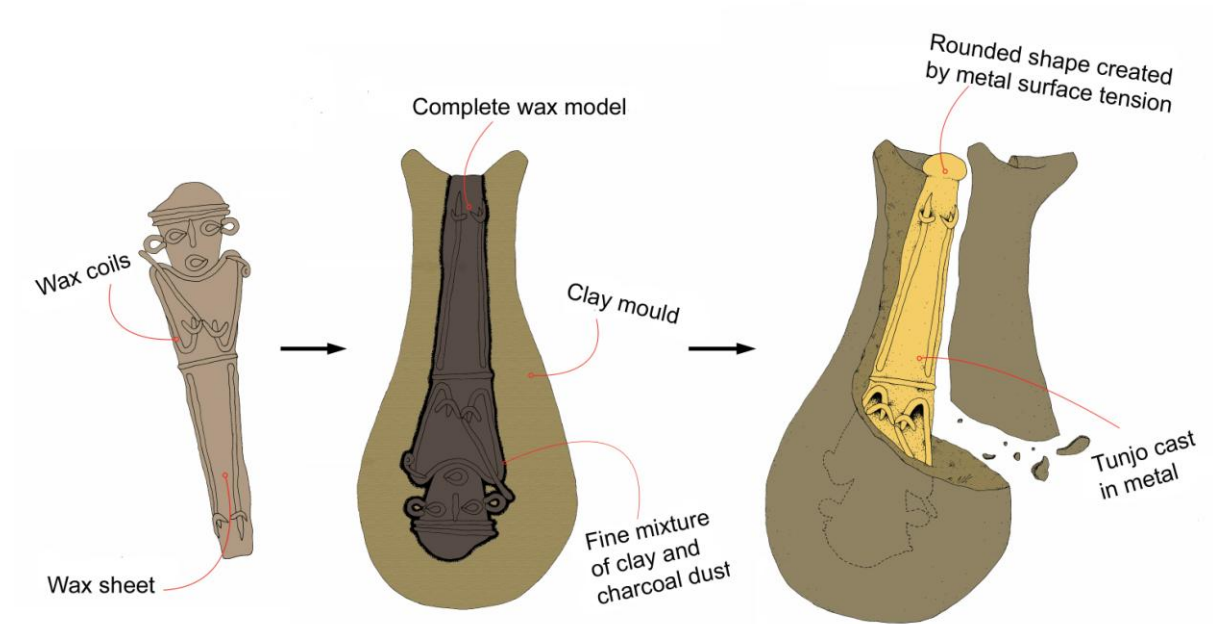
Figure 1. Schematic drawing of some of the main steps in the manufacture of a metallic *tunjo* by the lost-wax technique.

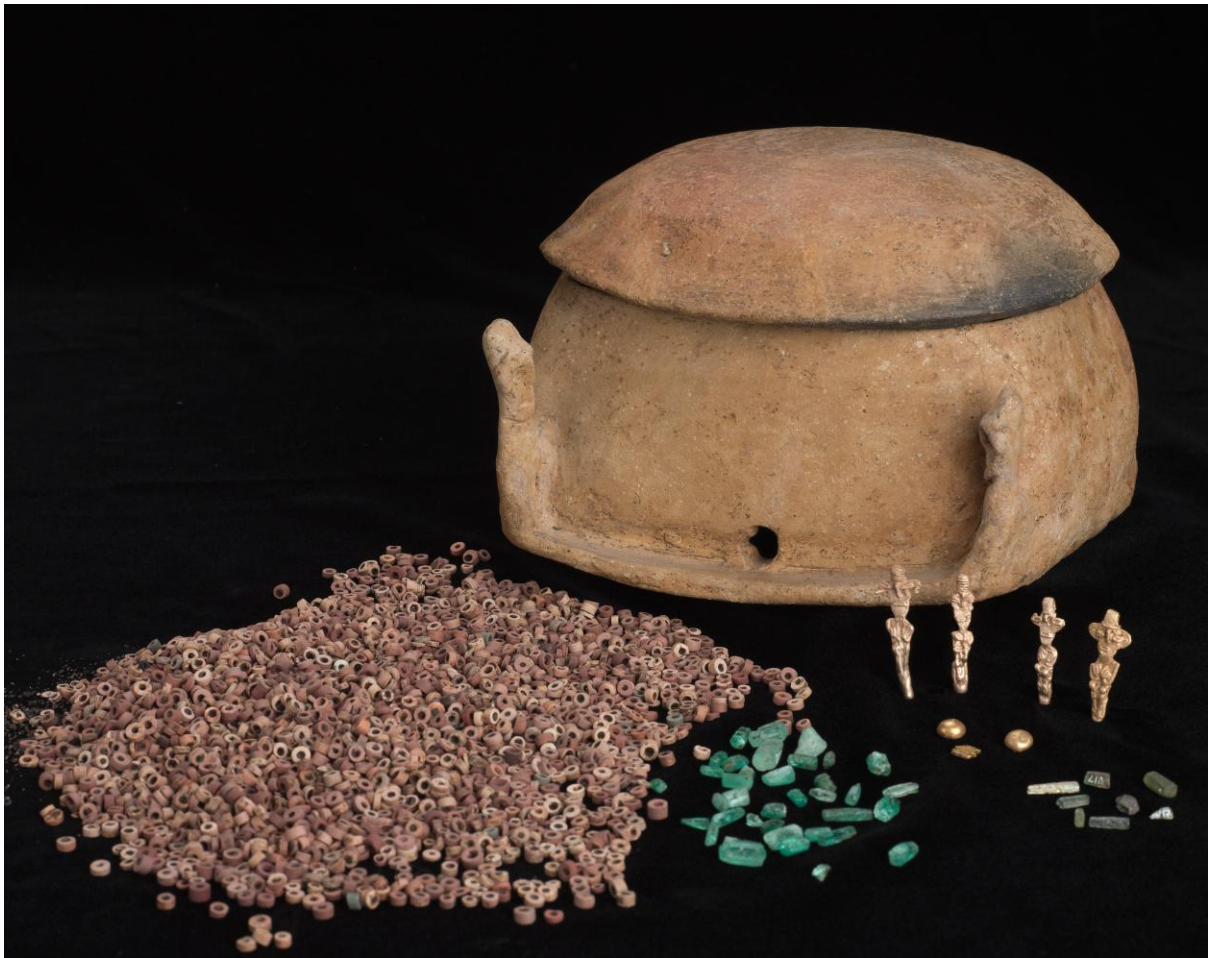
Figure 3. Complete offering from Tocancipá, including the ceramic offering vessel, numerous ceramic beads, fragments of emerald and glass, as well as four metallic tunjos, two small metal ingots or *tejuelos*, and a gold nugget.

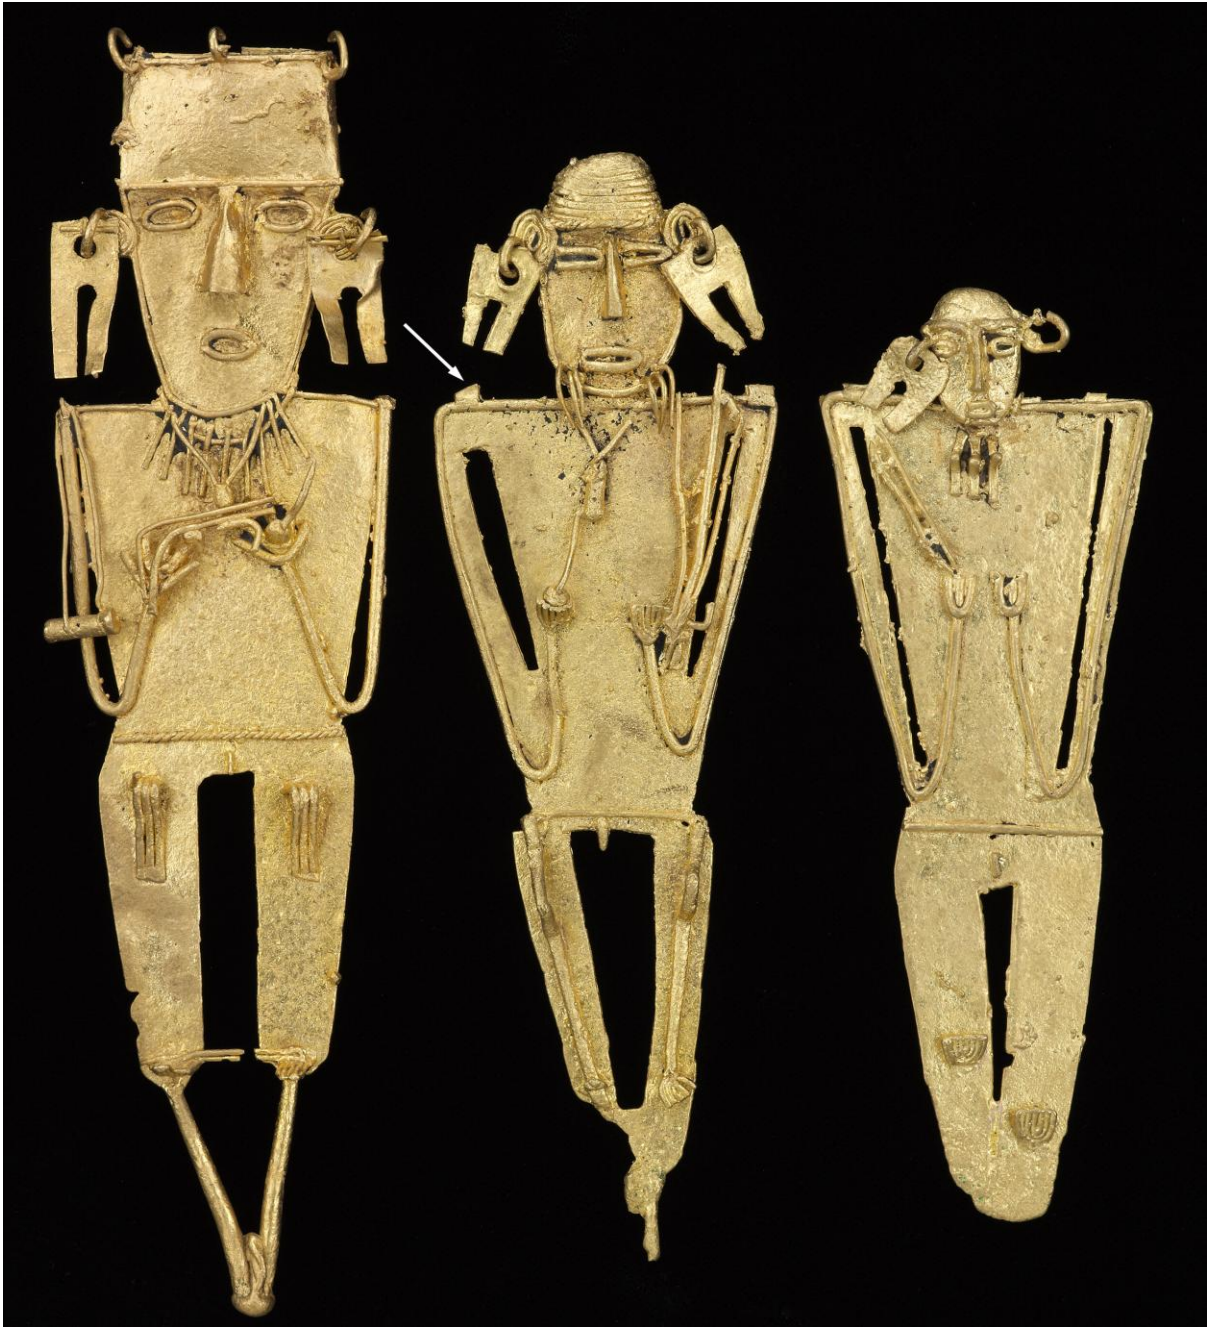
Figure 4. Three *tunjos* from the Gutiérrez offering. Each figure, including all their elements, was cast in a single pour. The earrings received the metal through feeders that connected them to the figure shoulders, and the 'stumps' left after cutting these feeders can still be noticed (one of them is pointed with an arrow). The two figures on the left still carry the casts of the main feeders attached to their feet, as these were never cut. Remains of charcoal and clay from the mould are still visible in some areas, such as the necklace of the left figure or the eyes of the middle one. The tallest figure is c. 17 cm in height.

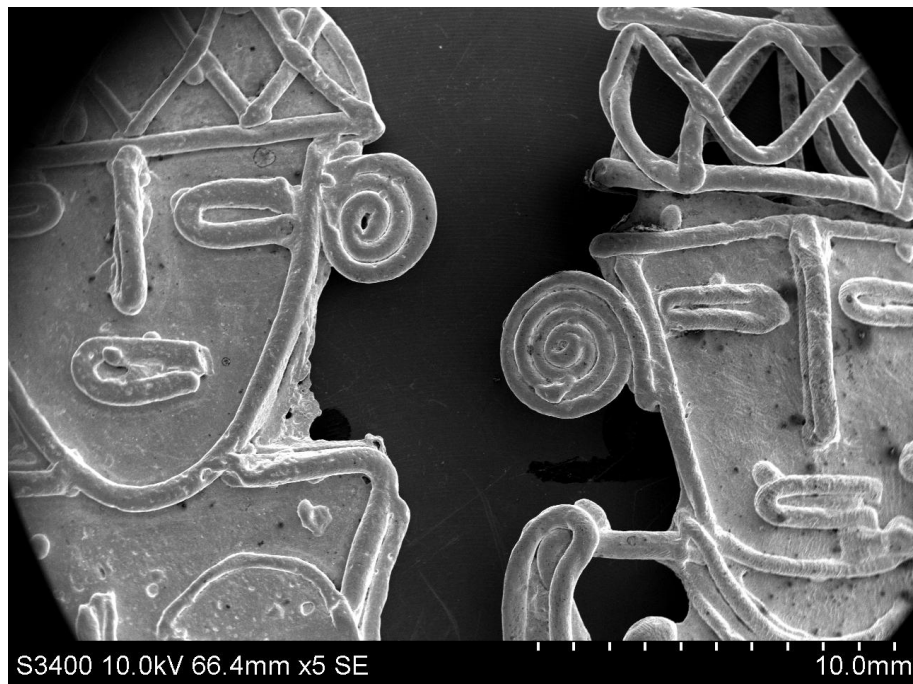
Figure 5. Scanning electron microscope image of two tunjos from Suba, showing detail of the waxwork on their faces and headdresses, including small balls of wax (now gold) used to stick together various wax parts before casting each figure in a single pour. A casting flash is visible at the neck of the figure on the left, while a casting void appears in the shoulder of the figure on the right.

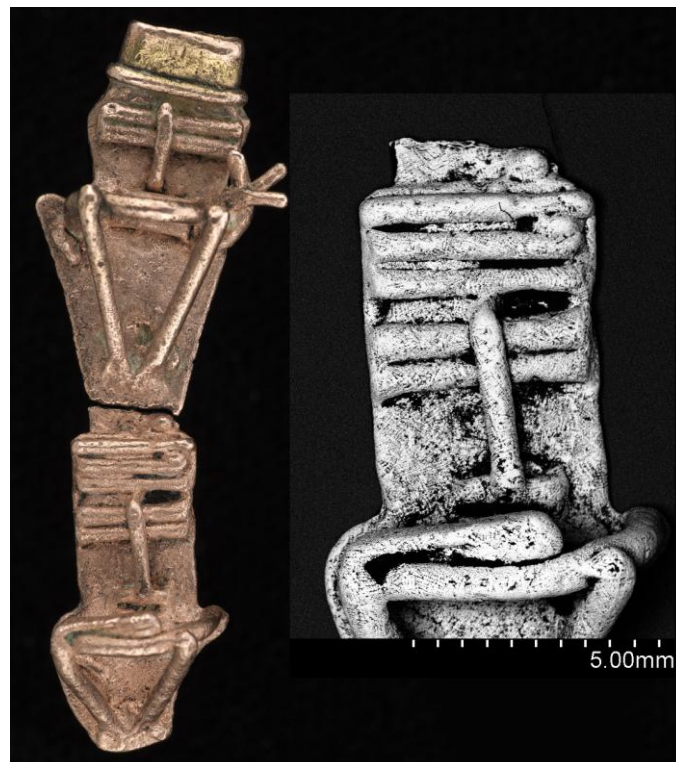
Figure 6. Two of the three very small figurines from the Carupa offering. Their arrangement shows that both figures were modelled as a single wax piece and cast together, before snapping the object quite crudely. The image on the right shows a high-contrast detailed view of one of them under the scanning electron microscope. Here one can appreciate the rough fracture at the top, the remains of charcoal and clay from the mould left in several crevices, and the dendritic texture resulting from a very slow cooling.

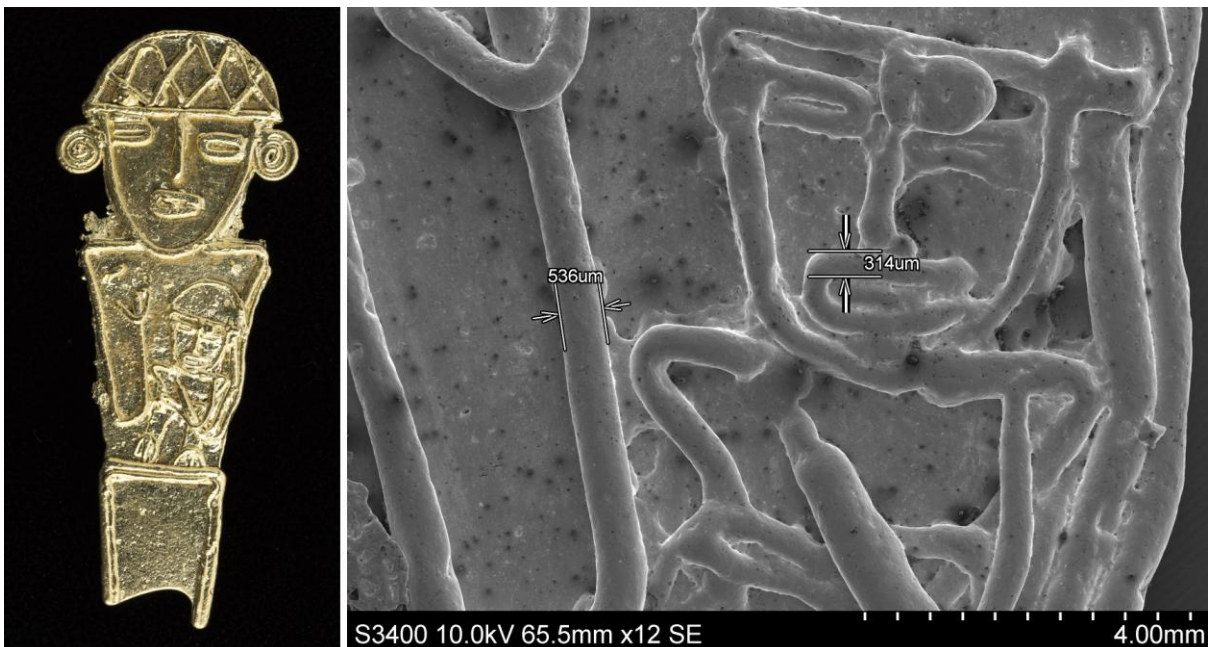
Figure 8. *Tunjo* from the Suba offering representing an adult carrying a baby. The image on the left shows casting flashes left on the figure, especially around the neck, as well as imperfections in the casting of feet where the metal was insufficient. In contrast, the scanning electron microscope image on the right shows a detail of the baby, demonstrating the fineness of the wax coils employed to manufacture the original model.
