# SEISMIC FRAGILITY OF PLASTERBOARD PARTITIONS VIA IN-PLANE QUASI-STATIC TESTS

Petrone C.<sup>1</sup>, Magliulo G.<sup>1,\*</sup>, Lopez P.<sup>2</sup>, Manfredi G.<sup>1</sup>

<sup>1</sup>*Department of Structures for Engineering and Architecture, University of Naples Federico II, Naples, Italy*

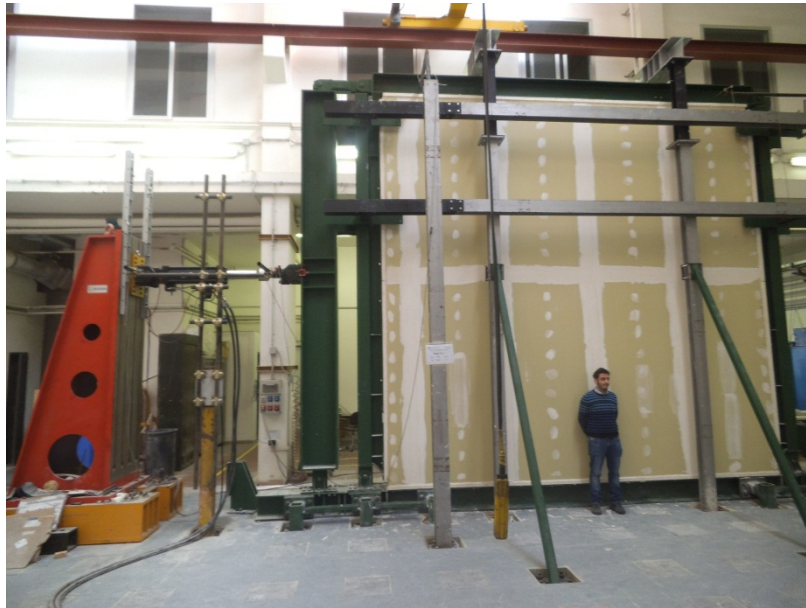
the test setup, which had a steel frame (see §2.1), the specimen, i.e., a plasterboard partition, a hydraulic actuator and a reaction wall. The tested plasterboard partitions were 5.0 m high and 5.1 m wide. They were composed of perimeter steel tracks, vertical steel studs, and plasterboards, which were screwed to the studs and the tracks.

**Figure 1. Test setup global view**

An out-of-plane reaction system is defined (Figure 1) to avoid undesired out-of-plane displacements. It consists of two I-shaped “HE 140A” columns and two I-shaped “HE 160A” horizontal beams for each side of the test setup. Four steel rollers (Figure 4) allow the specimen to slide and avoid undesired out-of-plane displacements. In addition, two diagonal stiffening inclined steel beams are provided in the out-of-plane direction (Figure 1). The weight of the entire steel test frame is approximately 80 kN.

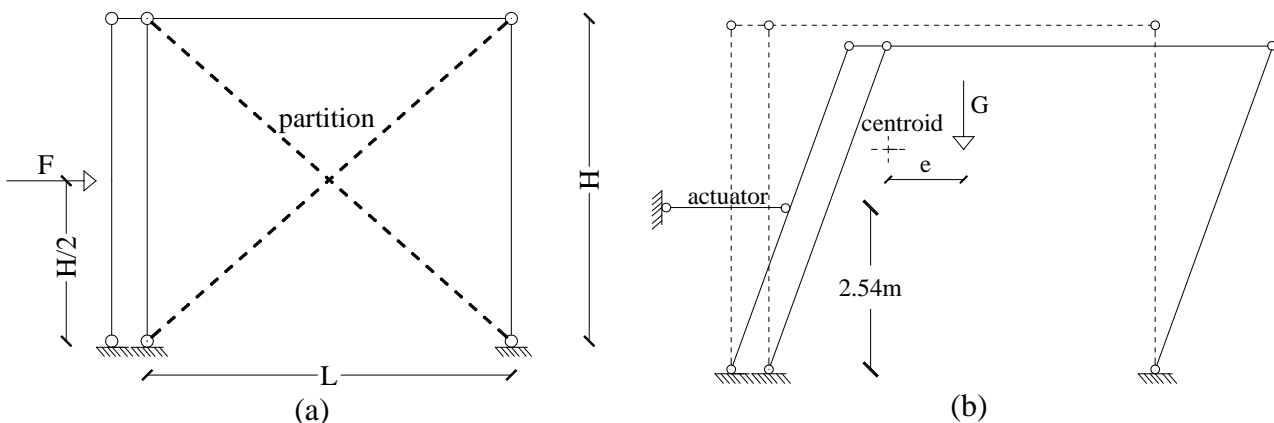
The steel test frame was conceived to transfer the load from the hydraulic jack to the partition without absorbing lateral forces; hence, a statically indeterminate scheme was developed (Figure 2a). Moreover, because the reaction wall cannot reach the height of the system, the actuator was placed at the middle height of the test setup. Hence, a given displacement produced by the actuator was doubled at the top of the setup, and a rigid loading column was assumed.

**Figure 2. (a) Conception scheme of the test setup; (b) kinematic mechanism of the test frame without the partition.**

The actuator is connected to a loading column at its mid span, and the loading column is connected to the frame surrounding the partition through a horizontal pendulum. Consequently, the loading column acts as a simply supported beam, which is loaded by a force in the centerline. The presence of the partitions introduce a lateral restraint in the unstable setup. Both translational and rotational equilibrium should be satisfied in the static scheme in Figure 2a. In particular, the equilibrium of the loading column ensures that a half of the actuator force is transmitted at the top of the setup, and the other half is transmitted at the base restraint.

The negative stiffness in the force-displacement relationship can be justified using the static scheme in Figure 2b. Indeed, when the test frame was loaded, the actuator exhibited a lateral restraint for the column to which it was connected; in particular, it acted as a horizontal pendulum. The imposed displacement produced an eccentricity, i.e.,  $e$  in Figure 2b. The moment of gravitational loads is balanced by the moment of the actuator horizontal reaction because the actuator represents a restraint for the test frame. Hence, the steel frame makes the actuator in tension during the pushing phase and in compression when the test frame is pulled.

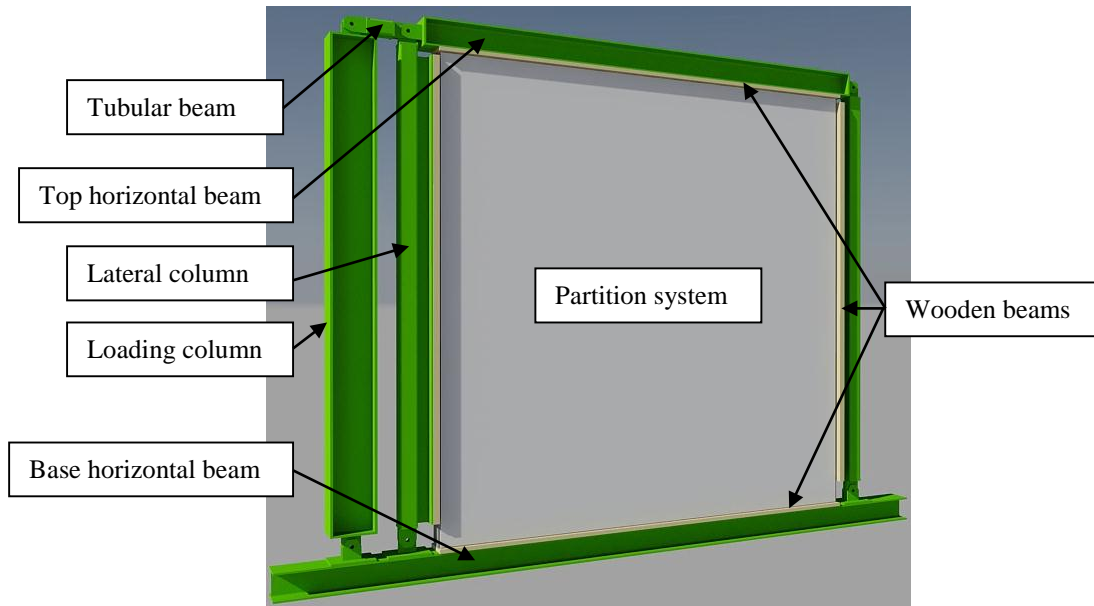
The setup design is defined according to Eurocode 3 [18, 19]. As shown in Figure 3, it is composed of:

- an I-shaped “HE 450B” vertical loading steel column, which is 4.785 m long;
- two tubular 180x180x10 mm lateral steel columns, which are 4.785 m long;
- an I-shaped “HE 280B” top horizontal steel beam, which is 5.370 m long;
- a horizontal steel tubular profile 150x150x12.5 mm S355, which is placed between the loading column and the nearby lateral column;
- an I-shaped “HE 280B” base horizontal steel beam, which is 7.800 m long.

Different steel elements are connected to one another using pin connections; the base restraint is provided with bolted connections between the columns and the base steel beam.

Figure 3. Test frame 3D view.

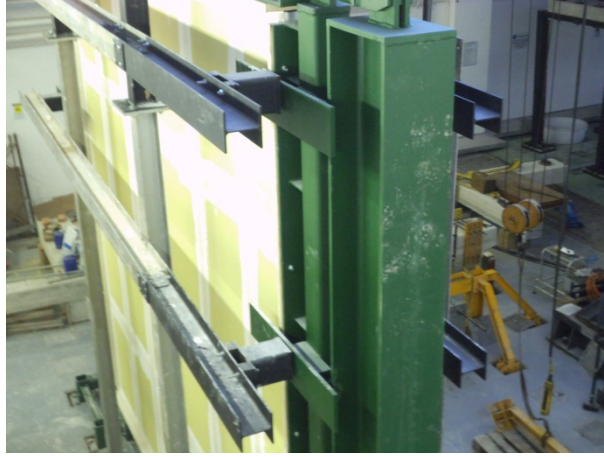
**Figure 4. Lateral view on the rollers of the out-of-plane reaction system.**

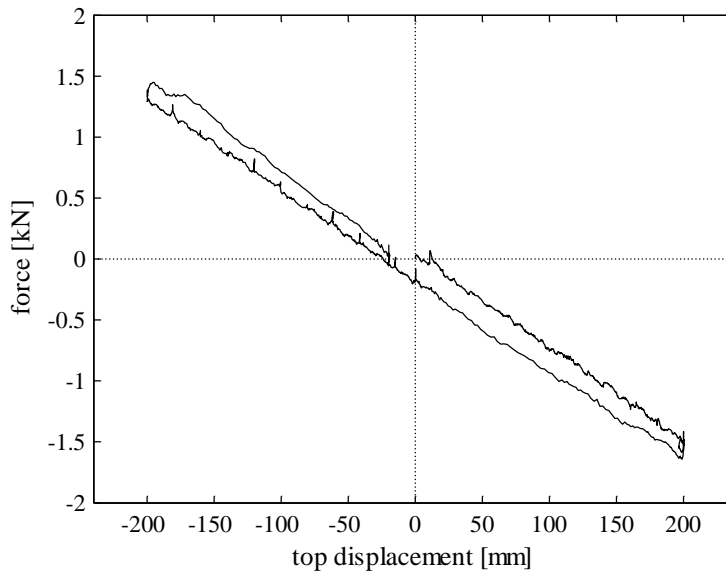
A preliminary test on the test frame without plasterboard partition was performed to verify the kinematic mechanism of the test frame and the absence of friction mechanisms in the test setup. The test consisted of pushing and pulling the test frame up to 10 cm at the actuator height. In addition, the inclination of the vertical elements was recorded using an inclinometer to verify that all vertical elements exhibited the identical rotation throughout the test. The recorded force-displacement relationship is plotted in Figure 5.

**Figure 5. Test on the bare test setup: force-displacement relationship.**

The centroid of the bare test frame is at 3.24 m from the base hinges, and the weight of the portion of the test setup in the mechanism is 29.72 kN. The force in the actuator for a displacement in the actuator of 100 mm, i.e., 200 mm top displacement, is evaluated as follows:

$$G \cdot e = R_{actuator} \cdot H / 2 \Rightarrow R_{actuator} = G \cdot \frac{e}{H / 2} = \frac{29.72 \text{ kN} \cdot \left( 0.10 \text{ m} \cdot \frac{3.24 \text{ m}}{2.54 \text{ m}} \right)}{2.54 \text{ m}} = 1.48 \text{ kN} \quad (0)$$

This result indicates that the recorded force in the actuator is related to the mechanism of the bare test frame, which can be neglected with respect to the force that the partition usually withstands because this value is notably small for the expected level of displacement during the test campaign. Finally, the force-displacement relationship clearly denotes that friction is negligible.

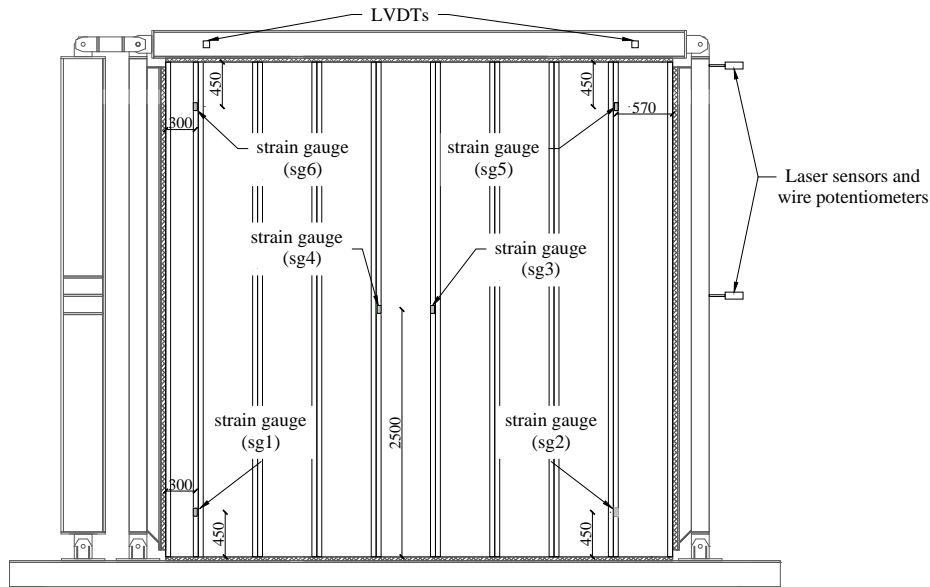
Different instruments were used to monitor the behavior of the specimens during the cyclic tests. The monitoring system consists of the following instrumentation typologies (Figure 6):

- two displacement laser sensors, which were placed at half the height of the column and the top of the same column to verify the rigid movement of the vertical column and monitor the top in-plane displacement;
- two wire potentiometers, which were placed in parallel to the laser sensors;
- two displacement transducers (LVDTs) at the two edges of the top horizontal beam, which measure the out-of-plane displacements to verify the planarity of the motion;
- twelve strain gauges (Figure 6), which were equally divided among the steel studs (sg1 – sg6) and outer plasterboard layer (sg7 – sg12); in particular, sg7 corresponds to the same position of sg1, sg8 corresponds to sg2, etc.

Figure 6. Specimen no. 1: instrumentation position.

The strain gauge (Figure 6) recordings on steel studs and plasterboards (Figure 16) lead to the following observations:

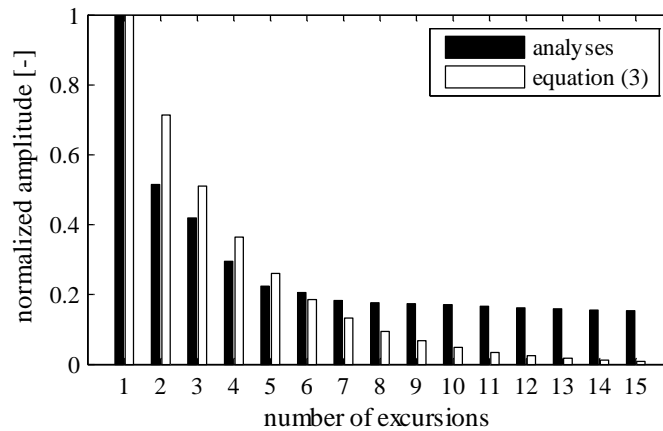
The parameter  $c$  was calibrated to minimize the scatter between the amplitudes in Equation (0) and the mean normalized pre-peak displacement that resulted from the analyses. In total, 15 steps were considered. The minimum scatter is given by the following relationship:

$$a_{i+1} = 1.39 \cdot a_i \quad (0)$$

In Figure 7, the discrepancy between the analytical results and the protocol provided by equation (0) is shown.

**Figure 7. Comparison between the ordered normalized amplitudes that resulted from the analyses and the amplitudes provided by equation (0)**

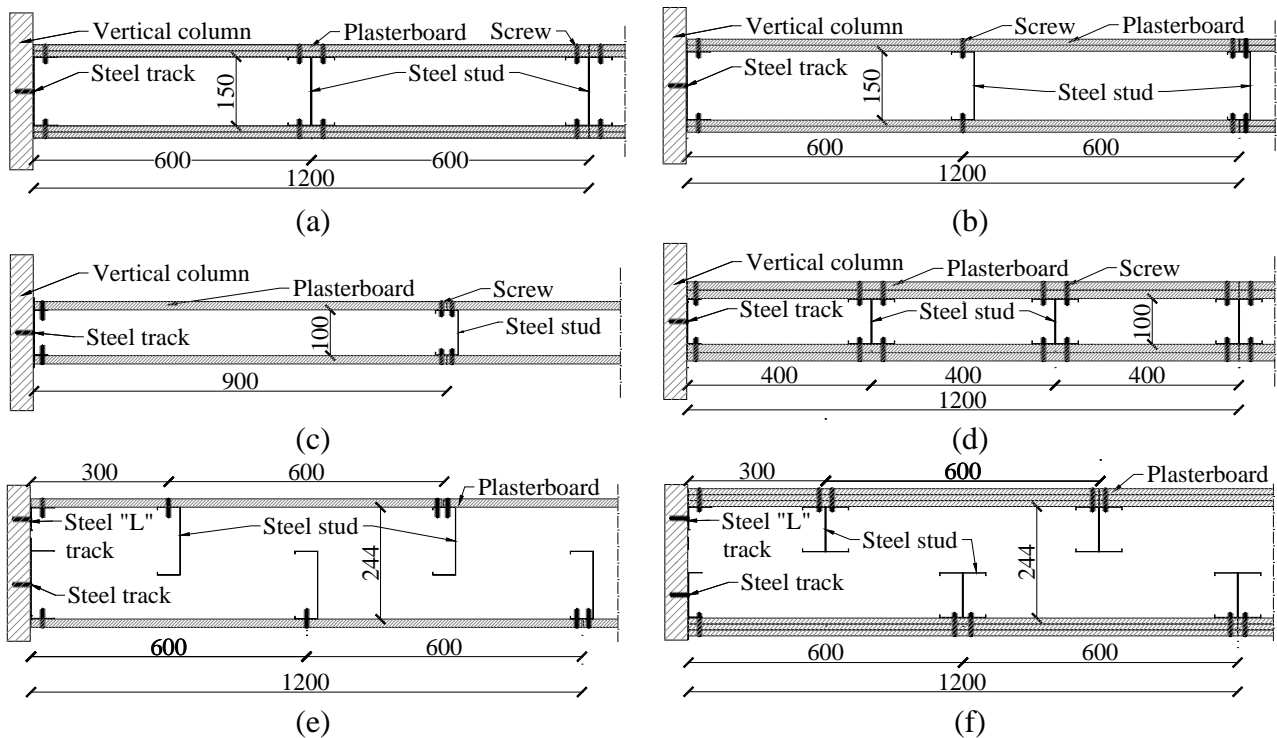
The specimens represent the plasterboard partitions that are typically commercialized in Europe for industrial buildings. They can be classified into two groups based on the horizontal cross section of the partitions in Figure 8:

- symmetric partitions, i.e., specimens nos. 1-4 (Figure 8a-d);
- staggered partitions, i.e., specimens nos. 5-6 (Figure 8e-f).

**Figure 8. Horizontal cross-section of different test specimens: (a) specimen no. 1, (b) specimen no. 2, (c) specimen no. 3, (d) specimen no. 4, (e) specimen no. 5 and (f) specimen no. 6 (dimensions are in mm).**

The two groups incorporate different types of horizontal and vertical tracks, where single or back-to-back studs are placed. Symmetric partitions are characterized by C-shaped tracks, whereas staggered ones have both C-shaped and L-shaped vertical tracks. Both types of partitions provide either single or double layers of boards; three layers of boards are adopted in only one case. Three different board typologies were used for different specimens (Table 3). A standard 12.5 mm thick plasterboards was used for specimens no. 1, no. 2 and no. 6; specimens no. 4 and no. 5 were characterized by standard 18 mm thick plasterboards, whereas innovative boards were adopted for specimen no. 3. Innovative boards have a larger hardness and better fire performance than the standard boards. The plasterboards were assembled to define one or two horizontal joints (Figure 9) because of the limited height of the panels. They were screwed to either the studs or the tracks. We avoided connecting the plasterboard with a single screw to both a stud and a horizontal guide. Both the screw and the stud spacings of each partition are listed in Table 3. The studs are 5 m long; they are only placed in the horizontal tracks without any direct mechanical connection. Both vertical and horizontal tracks are connected to the perimeter wooden beams through 250 mm spaced screws. Vertical and horizontal plasterboard joints are filled with paper and compound.

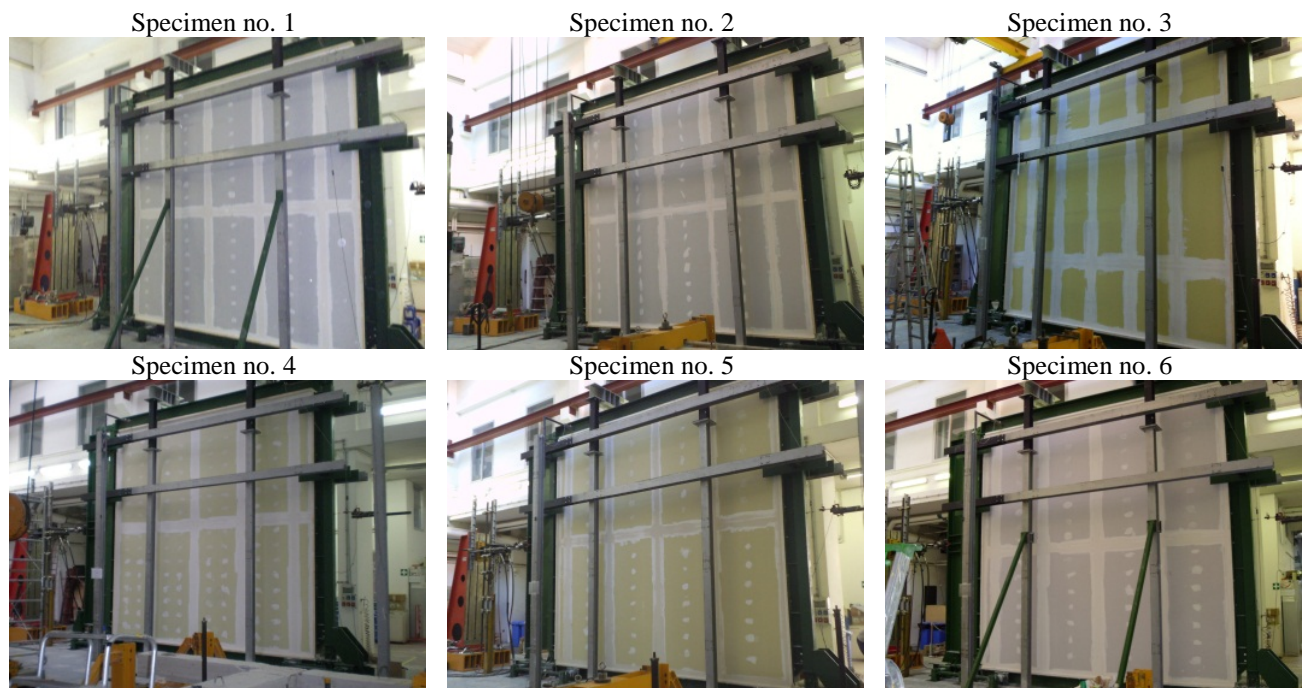
1.43 MPa tensile strength. The elastic modulus range is 2.41-5.24 GPa. The self-drilling screws are characterized by a 3.5 mm diameter and a length of 35-45 mm; their hardness is 600-760 HV. In Table 3, the components for each specimen are described. A global view of different specimens in the test setup is shown in Figure 9.

**Figure 9. Global view of the specimens nos. 1-6 (from top left to bottom right).**

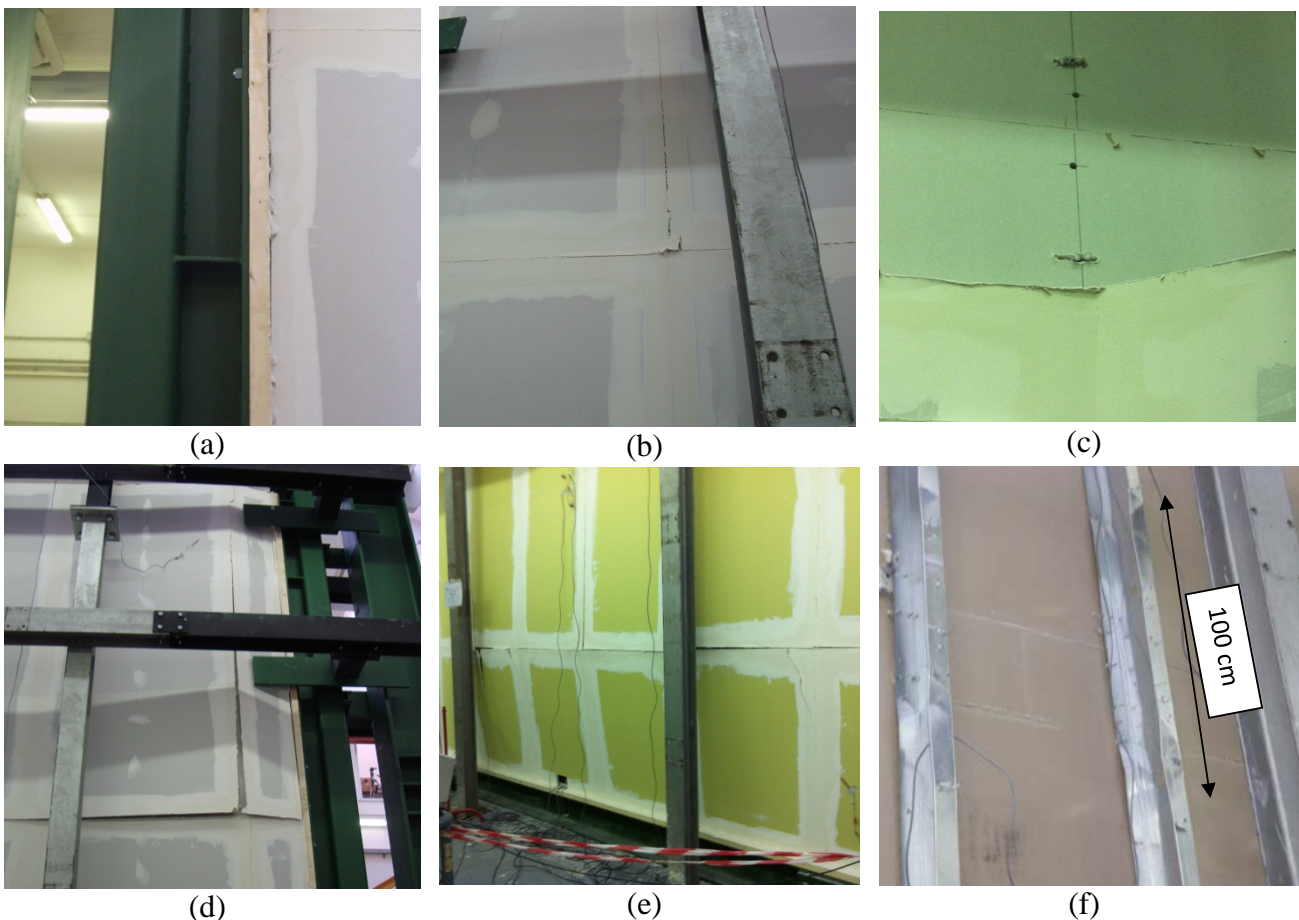
- The first damage occurs along the perimeter: the paper starts cracking (Figure 10a) and detaches the partition along the edges.
- Further cracks occur in the vertical and horizontal joints among the panels, which allows the adjacent panels to exhibit relative displacements for slightly larger drift levels (Figure 10b). The damage is localized at these joints. After corner cracks form, a significant creaking sound is heard: this sound is related to the bearing failure of the board-to-steel screwed connections; this failure mode is clearly shown in the inner layers of the plasterboard during the dismantling phase (Figure 10c).

- The specimens collapse in the out-of-plane direction because of the buckling of one or more steel studs. Indeed, the buckling failure mechanism typically involves a single stud of the partition (Figure 10d). A global buckling of the partition is only observed in test no. 3 (Figure 10e), where all steel studs show a buckling failure in the out-of-plane direction.

During the dismantling phase, the local buckling in the studs is clearly observed. The stud buckling failure mainly concentrates across the plasterboard horizontal joints (Figure 10f).

**Figure 10. Damage progression in the specimen: (a) paper cracking along the perimeter (test no. 1); (b) paper cracking in the vertical and horizontal joints (test no. 6); (c) bearing failure of the boards-to-steel screwed connections (test no. 2); (d) local buckling of the partition (test no. 2); (e) global buckling of the partition (test no. 3); (f) buckling of the stud across a plasterboard horizontal joint (test no. 2).**

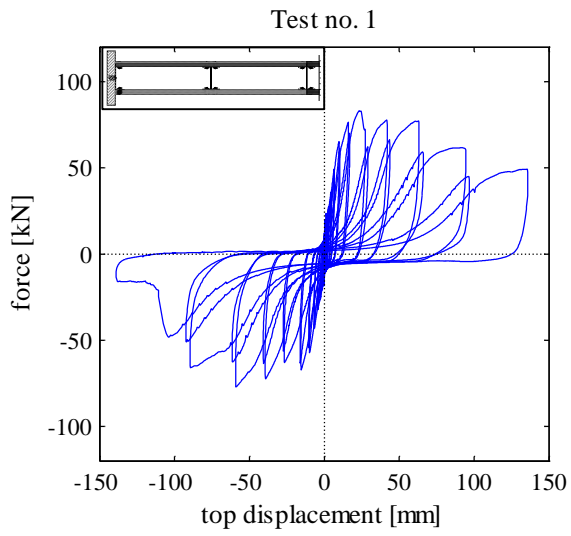
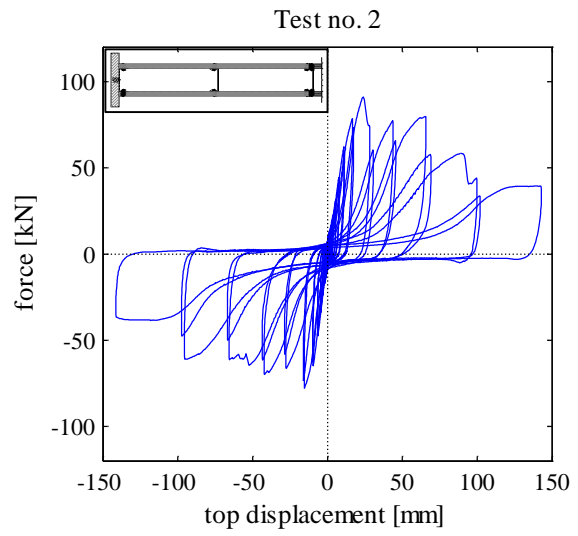
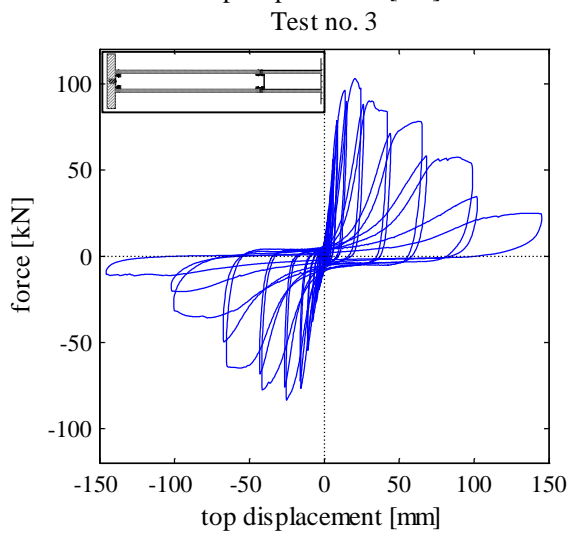
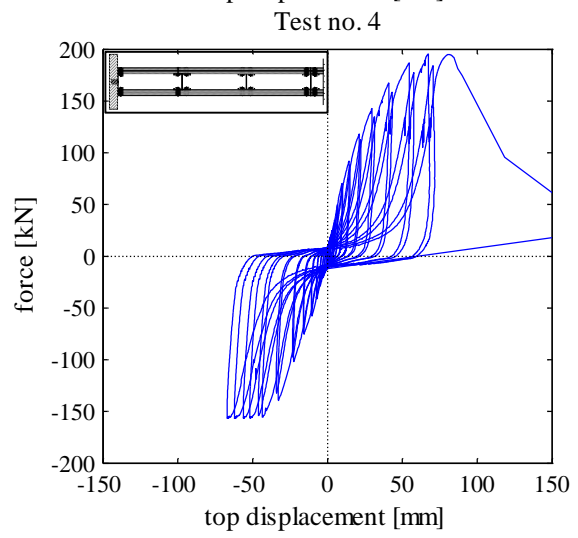
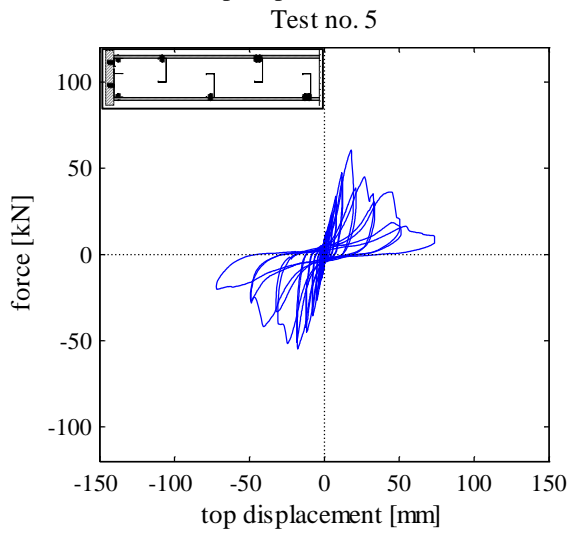
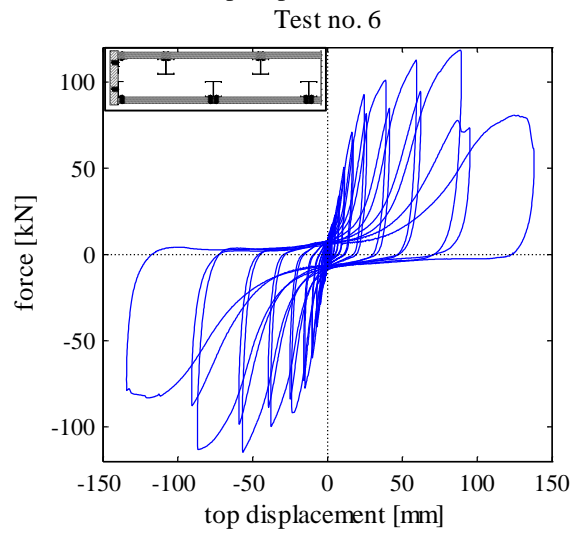
Quasi-static tests were performed on the six specimens using the defined testing protocol. Hysteretic curves are obtained by plotting half of the force provided by the actuator (§2.1) versus the top displacement (Figure 11).

- the high initial secant stiffness of different specimens decreases when the relative displacement increases;
- the degrading behavior, which is exhibited after the maximum force is reached, i.e., the post-capping negative stiffness;
- a significant degrading behavior between two cycles at identical displacements;
- the buckling-dominated failure modes of different specimens are clearly visible when the recorded force suddenly decreases after the specimen buckles; it should be noted that the buckling of the partition is also visually detected;
- the frictional behavior in the first cycles (e.g., Figure 12a) and significantly pinched behavior (e.g., Figure 12b), which are exhibited when the screwed connections begin damaging.

**Figure 11. Hysteretic loops from test no. 1 to test no. 6.**

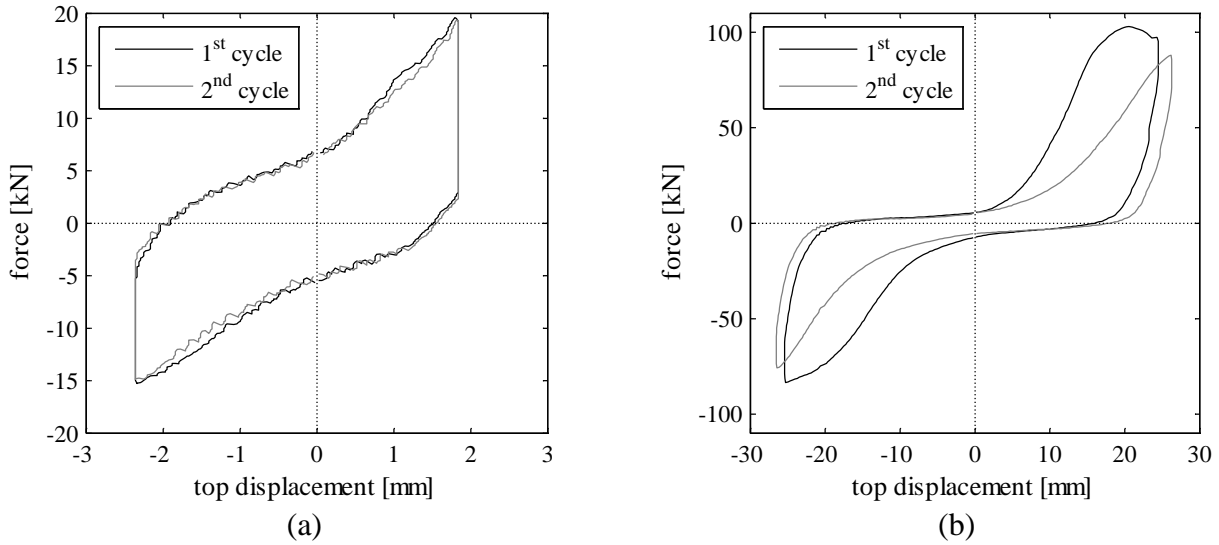
**Figure 12. Hysteretic loops recorded during (a) step no. 5 and (b) step no. 11 in specimen no. 3.**

where  $E_D$  is the dissipated energy, and  $E_S$  is the maximum strain energy at a given cycle. The  $\xi_{eq}$  values are evaluated for the 1<sup>st</sup> cycle at each step and plotted versus the corresponding interstory drift ratio amplitudes in Figure 15. The tested partitions exhibit similar equivalent viscous damping trends. The equivalent viscous damping is notably large for the first cycles, i.e., 20-45%, which confirms the friction-based behavior for low interstory drift demand (Figure 12a); the pinching-

based behavior (Figure 12b) induces a reduction of the equivalent viscous damping for different tested specimens at large interstory drift ratio. However, the equivalent viscous damping is larger than 10%, except in test no. 4 at the last step.

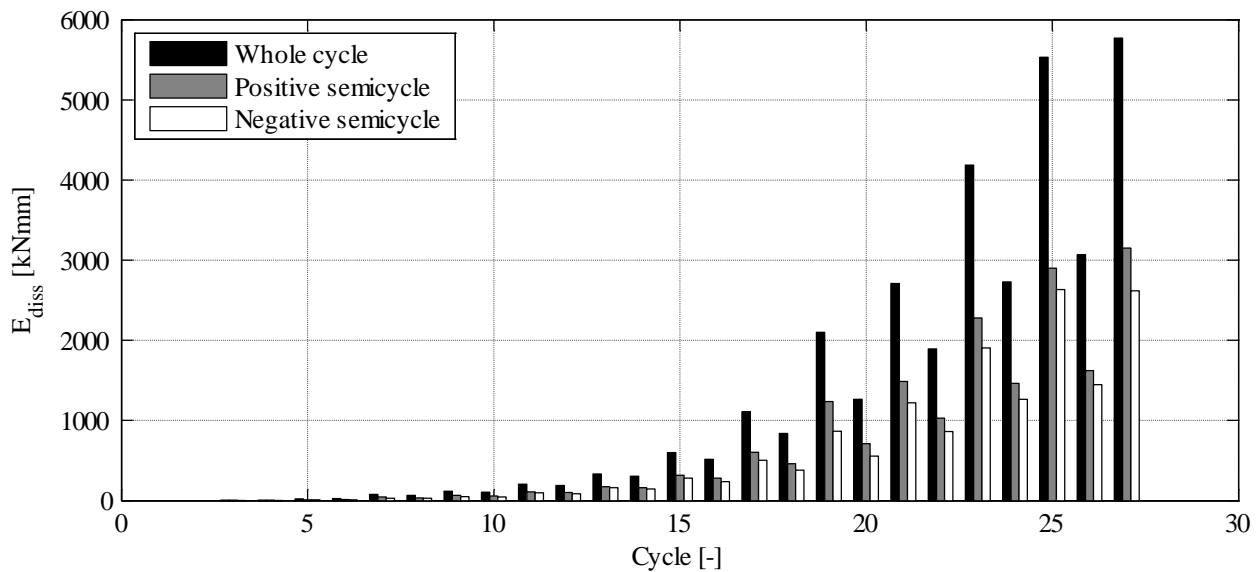
Figure 14 shows the dissipated energy in test no. 1 for each cycle of the protocol and each negative and positive semi-cycle. The strongly degrading behavior of the specimen is clearly shown:

- the testing protocol provides two consecutive cycles at the identical displacement (see Section 2.3); the energy dissipated in the second cycle of the step is significantly smaller than the energy dissipated in the first cycle of the same step;
- the energy dissipated in the negative semi-cycle is smaller than the energy dissipated in the preceding positive semi-cycle.

**Figure 14.** Energy dissipated in test no. 1 for each cycle of the protocol and each negative and positive semi-cycle.

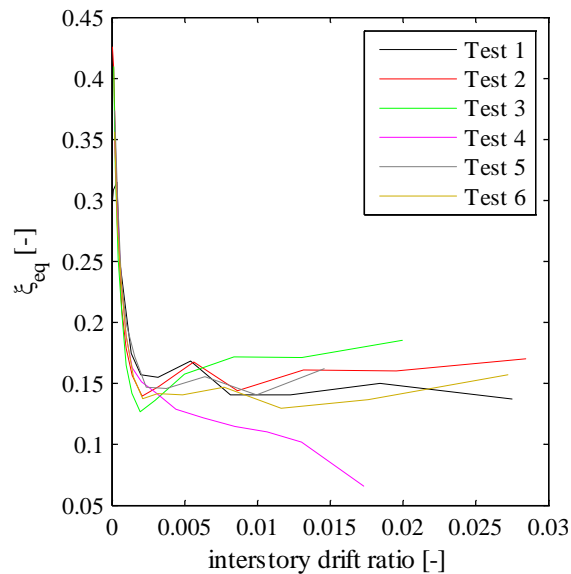
**Figure 15. Equivalent viscous damping trend for different tests.**

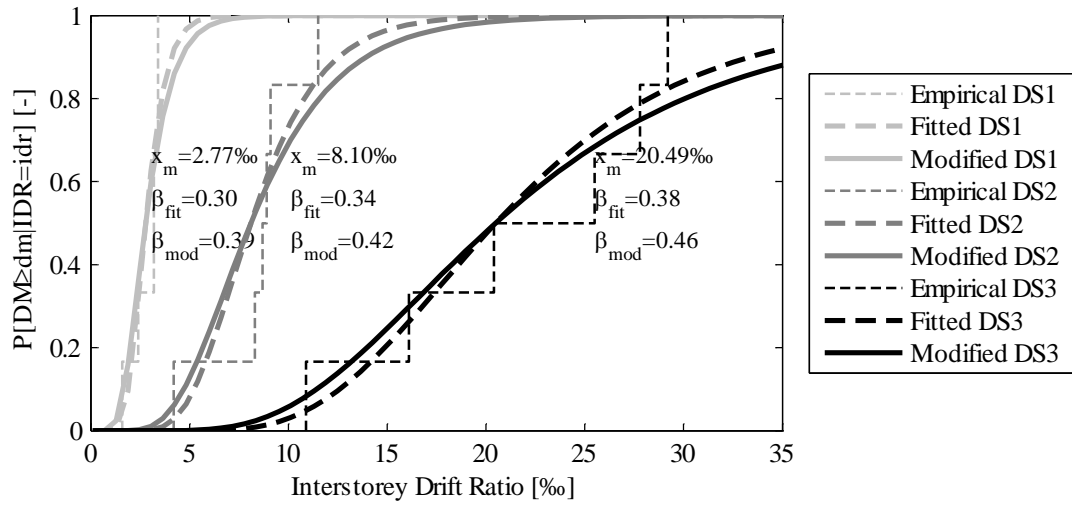
where  $M$  is the number of tested specimen,  $r_i$  is the interstorey drift ratio (IDR) where a given damage state occurs in the  $i$ -th specimen, and  $\beta_u$  is 0.25 because all specimens are subjected to the same loading history [29]. The fragility curves for the three considered damage states are plotted in Figure 17. The fragility curves that fit the experimental data (dashed thick lines in Figure 17) are

clearly highlighted; a solid line denotes the fragility curves that are characterized by an increased dispersion  $\beta_{mod}$  (solid thick lines in Figure 17), which also considers the logarithmic standard deviation  $\beta_u$ . The fragility curves satisfy the Lilliefors goodness-of-fit test [30] with a 5% confidence level.

**Figure 17. Fragility curves for the considered damage states for the tested specimens. The dashed thick lines are the fragility curves that fit the experimental data (dashed lines); the solid thick lines are the fragility curves that include a larger standard deviation because of the use of the same loading protocol for the different specimens [29].**

The median IDR values that cause DS2 and DS3 are slightly larger than the ones evaluated by Retamales et al. [16], i.e., 6.7‰ and 10.5‰ for DS2 and DS3, respectively; however, the logarithmic standard deviations are in the same order of magnitude. The difference in the DS2 and DS3 median IDR values may be justified by the larger flexibility because of the larger number of horizontal plasterboards joints and the non-connection of the studs to the tracks in the tested 5 m high partitions. Moreover, the specimens tested by Retamales et al. [16] are representative of typical US partitions. Their different construction details, e.g., mechanical properties of boards and screws, may have caused a different seismic performance compared to the European specimens.
