Effect of orientation on the hygrothermal behaviour of a capillary active internal wall insulation system

KEYWORDS: *internal insulation, capillary active, relative humidity, orientation, solar radiation*

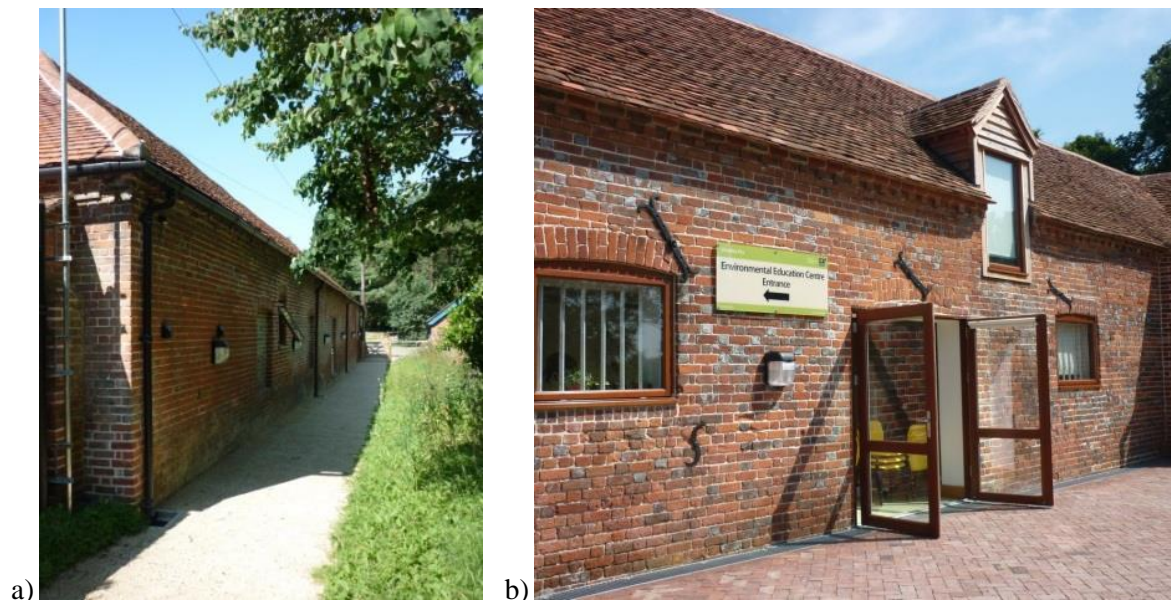
FIG 1. Building and external walls insulated a) north facing wall; b) south facing wall (access to teaching area)

The external walls (solid brick) were insulated internally with 100 mm of Pavadentro, a composite board formed by woodfibre and a mineral layer that creates a light vapour diffusion resistance; the total equivalent air layer thickness of the dry composite board is $s_d = 1.6$ m.

The existing wall was levelled with a lime-based coat before the insulation was applied and then a bonding coat was used to provide full contact between the insulation and the existing wall. External façades were left exposed, without any impregnation treatment or installation of damp proof courses; therefore not limiting moisture penetration into the building. The building durability could be maintained if potential moisture accumulation were counterbalanced by subsequent moisture drying (a process formed by evaporation and vapour transfer).

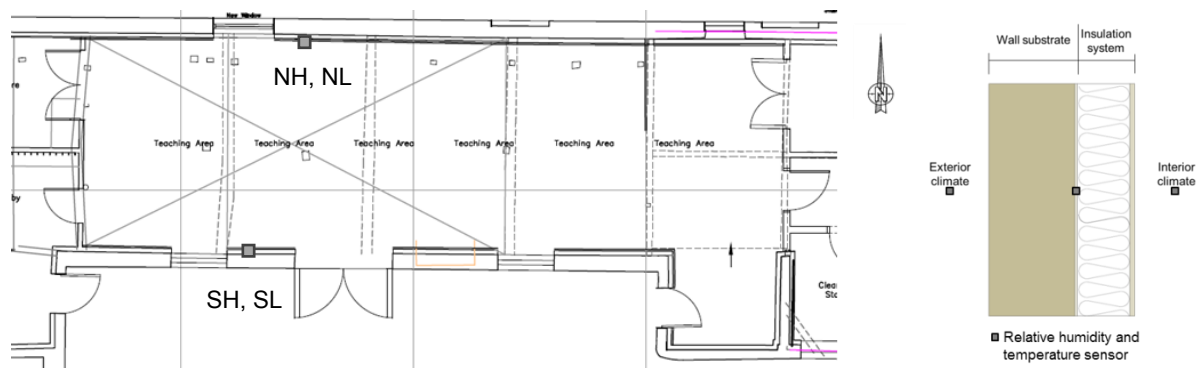
FIG 2. Building plan with focus on the teaching area and locations of sensors

The aim of the study was to estimate the effect of orientation on the hygrothermal behaviour of internally insulated walls. Four thermocouples and resistive probes (sensors) to measure temperature (T) and relative humidity (ϕ) respectively were installed at the interface between the existing wall and the insulation; sensors (NH, NL) were installed at 30 cm (low – L) and at 200 cm from the ground (high – H) on the north-facing wall and on the south façade (SH, SL) respectively, as shown in figure 1. Sensors were set with a sampling interval of $\Delta t = 30$ min and an accuracy of $T = \pm 0.7$ °C and $\phi = \pm 5$ % at 21 °C. Data were collected for 22 months starting on 01/11/2011 and ending on 11/09/2013.

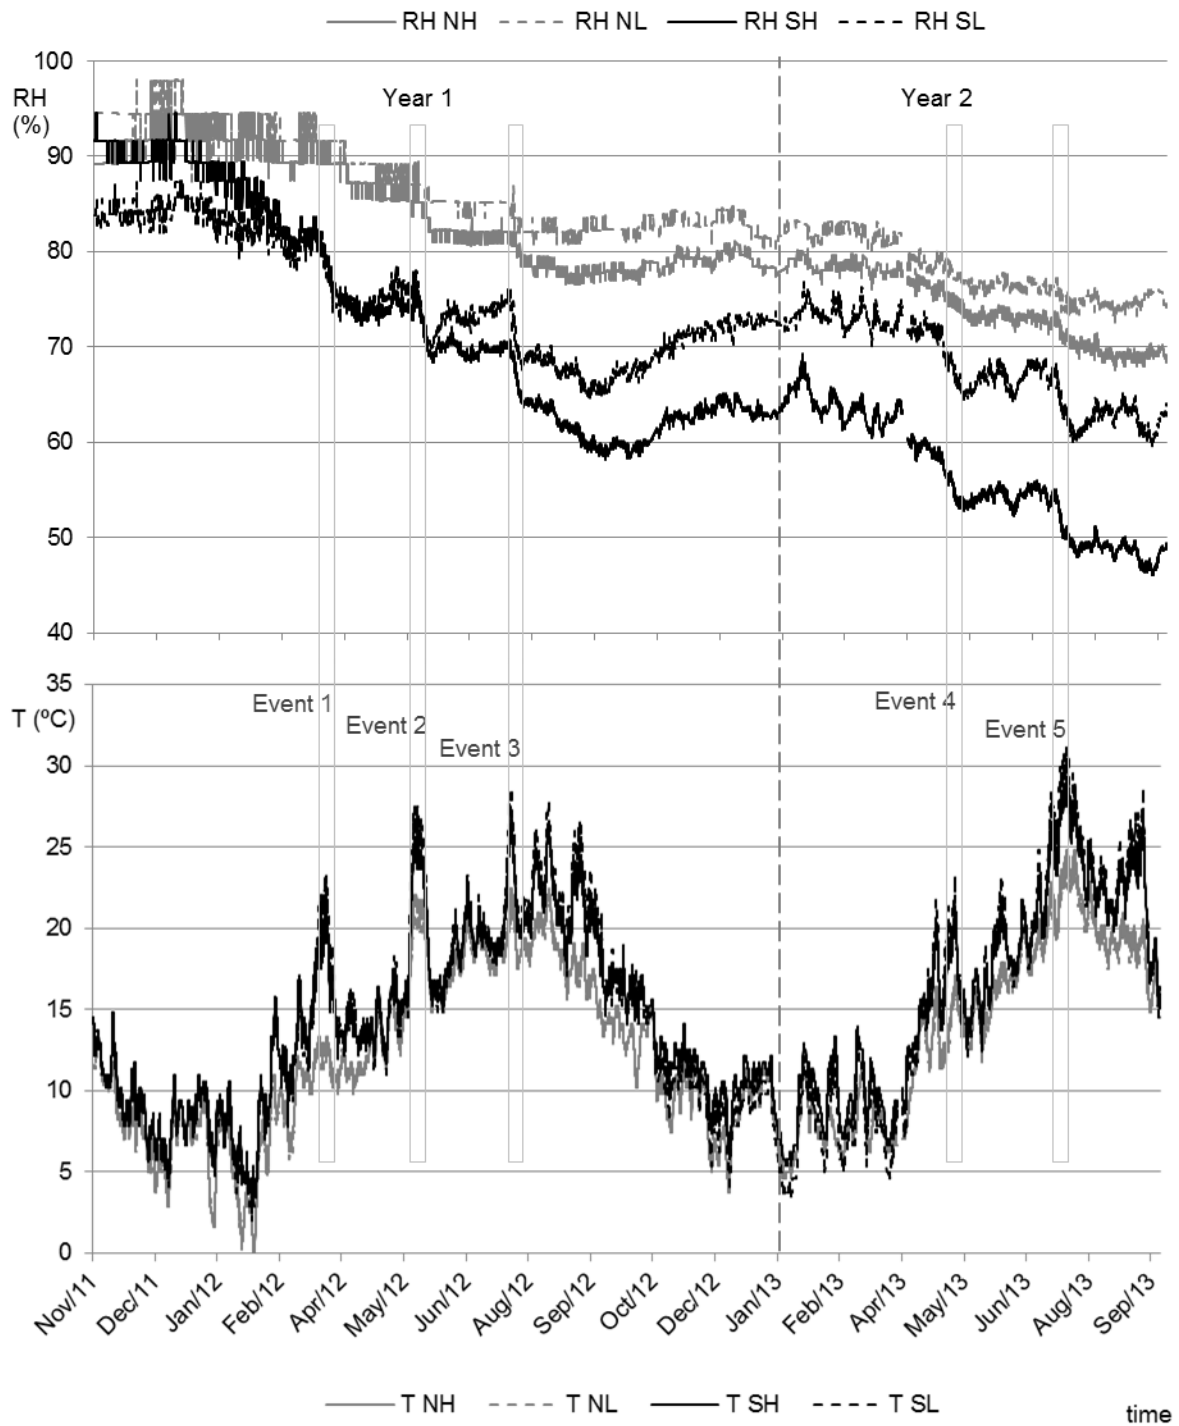
Profiles of relative humidity at the four interstitial locations studied are shown in Figure 3. The initial relative humidity varied from 82 % to 94.6 % as sensors were applied on the surface of the insulation board and surrounded by the bonding coat (wet when applied). The initial moisture of the construction system started drying out after 2 months on the south elevation and 4 months on the north elevation.

As shown in Figure 3, there was a reduction of the interstitial relative humidity in both insulated walls, however with a higher reduction observed in the south-facing wall. In both walls, the relative humidity was lower at the end of the study at high level (NH and SH). Drying occurred approximately from January to September, whereas wetting occurred from September to January.

FIG 3. Relative humidity and temperature measured at four location of the existing wall-insulation interface.

A difference in temperature at the interface of the existing wall and insulation was noted during the events of sudden relative humidity reduction (Figure 3, below), which was not observed during the wetting period. Temperatures at the four locations were comparable; however in the drying period, and in particular during the relative humidity reduction events, the temperature at the interface of the existing wall and the insulation on the south-facing wall was higher than the temperature within the north-facing wall. Table 2 shows the average difference of interstitial temperature between the sensors located in the south wall and the ones in the north wall.

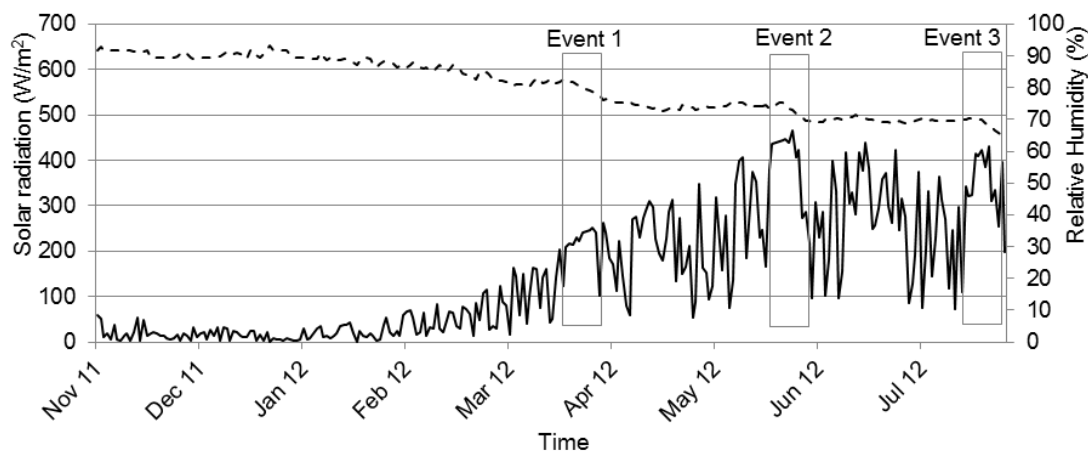
The difference in temperature seems to be related to orientation and more specifically to solar radiation. Direct radiation would allow an increase in surface temperature in the south-facing wall and a higher rate of evaporation compared to the north-facing wall, which is only affected by diffuse radiation. The observed sudden reductions in the internal humidity of the south-facing wall coincided with events reported by the Met Office (2013b) as “remarkably sunny” periods: from the 23rd to 30th March 2012 and from the 21st to the 28th May 2012. The same happened in July 2012, a cold and wet month until the 21st, when the weather became warmer and sunnier. In Figure 4, the monitored relative humidity for the period November 2011 – August 2012 was plotted along with daily averaged solar radiation intensity (W/m^2); events of sudden relative humidity reduction match periods of consistently high solar radiation intensity.

FIG 4. Events of sudden relative humidity (dashed line) reduction and solar radiation (solid line)
