**IN SITU CHARACTERISATION OF READHESION  
TREATMENTS FOR CEILING PAINTINGS USING UNILATERAL  
NMR**

Journal:	<i>Insight</i>
Manuscript ID	INSI-12-2016-OA-0161.R1
Manuscript Type:	Original Article
Date Submitted by the Author:	n/a
Complete List of Authors:	Richardson, Emma; University College London, Material Studies Laboratory Woolley, Elizabeth; Courtauld Institute of Art Corda, Katey; Katey Corda Wall Paintings Conservation Pinchin, Sarah; Historic Royal Palaces Roberts, Zoe; Historic Royal Palaces
Keyword:	Adhesives and bonding, Art, Magnetic methods, Monitoring

In this paper, we present comparative results of two different adhesive treatments employed during the conservation of the baroque ceiling painting in the Queen's Staircase at Hampton Court Palace, analysed with unilateral nuclear magnetic resonance. This non-invasive technique enabled monitoring of the adhesive systems – based on Jun Funori and BEVA<sup>®</sup> 371 – up to a depth of 3,500 um into the ceiling by providing specially resolved proton density profiles before and after treatment. Results offer a unique and pertinent assessment of treatment areas within a strictly limited timeframe. It is shown that the so

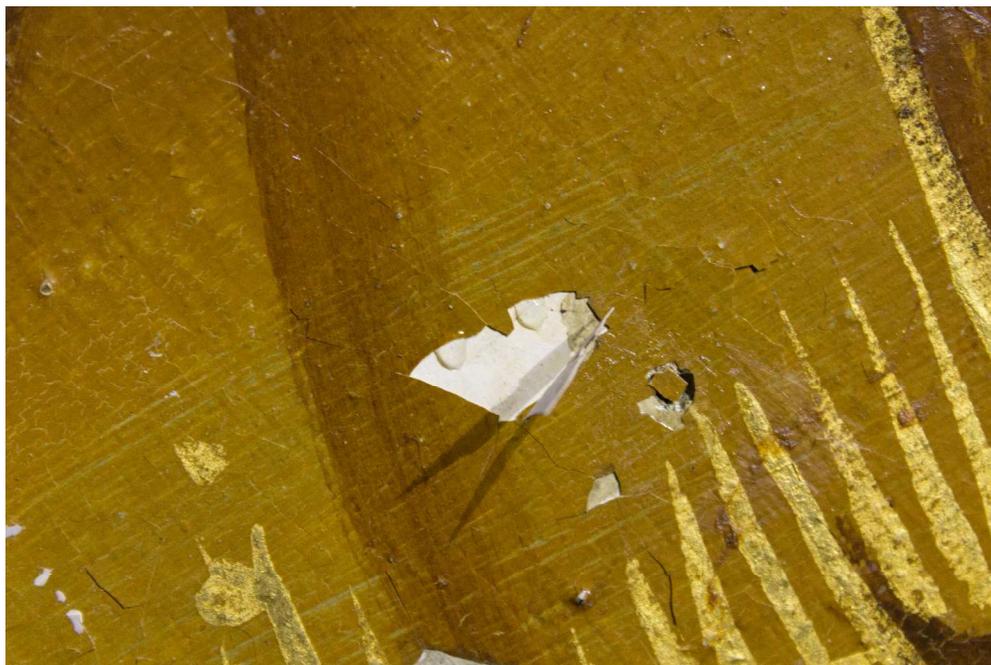
Figure 2

Delamination of paint layers from the plaster substrate and water droplets on hydrophobic BEVA® 371 adhesive from previous treatment

BEVA® 371 is a heat-activated adhesive based on ethylene vinyl acetate copolymer in paraffin wax, and areas previously treated with this adhesive were observed to be hydrophobic in 2016 (Figure 2). Additionally, many solvents suitable for BEVA® 371 also solubilised previously applied varnishes and repainting. These two factors have implications for retreatability, so an alternative adhesive was sought.

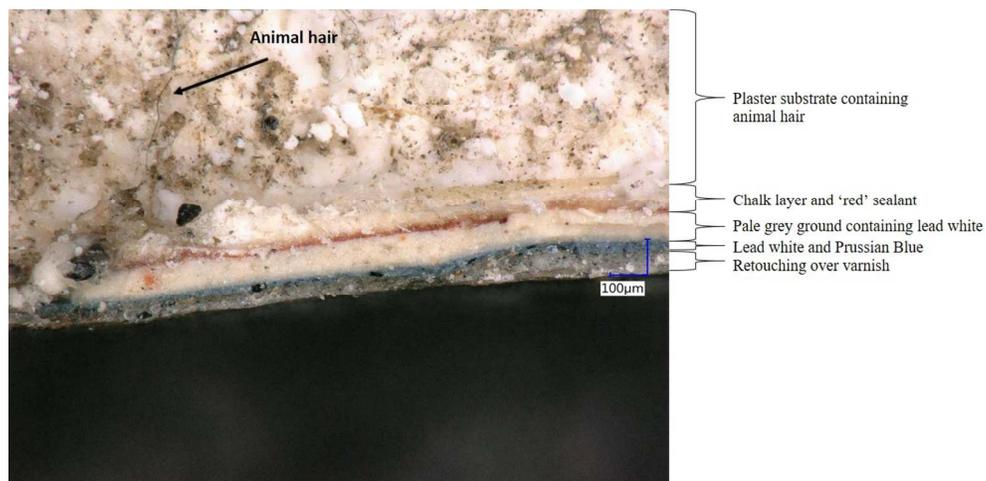
Figure 3

Cross section from William Kent ceiling painting, painted 1734, The Queen's Staircase. Magnification 200x

The detail of these investigations has been recounted elsewhere [4] and is summarised here. The point of original failure was established to be in the ground layer, between the oil paint and the support (Figure 3), possibly as a result of poor preparation [5]. The cause was hypothesised to be an environmental response to original technique and/or physical history i.e. water infiltration from the apartments above [6]. Extensive investigations into environmental controls resulted some retrofitting to better buffer the building [7]. A programme of emergency flake fixing has been used to minimise the impact of losses to the painted scheme, during which trials assessing different adhesives continued, with BEVA® 371 identified as the most satisfactory adhesive [8]. Annual spot inspections take place from a cherry picker lift and in 2010, comprehensive quinquennial condition monitoring from a boarded out bird cage scaffolding began.

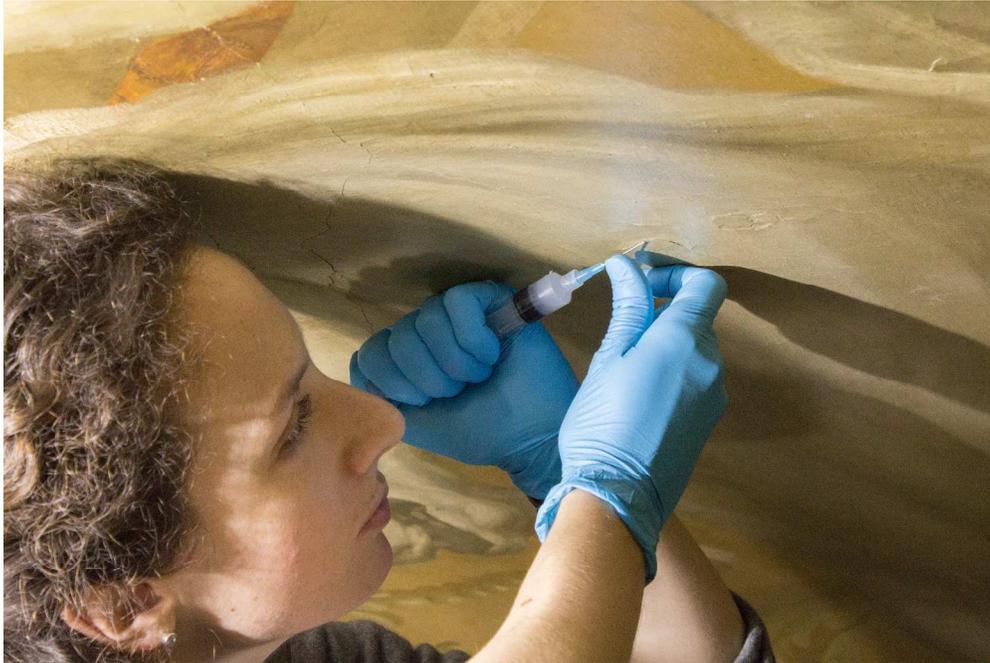
Injection of BEVA® 371 adhesive solution behind paint flake  
Figure 4  
438x292mm (300 x 300 DPI)

A 1:4 weight/volume BEVA® 371 in petroleum spirits was prepared by gently heating to encourage dissolution. Once in solution the BEVA® 371 was injected behind the paint flake (Figure 4) and a few minutes allowed for solvent evaporation before heat activation using a warm spatula; BEVA® 371 has a heat activation temperature of 65 °C and petroleum spirits an evaporation temperature of between 60-80 °C. Warmth also helped the flake soften and relax back into position. Excess adhesive was cleared from the area using petroleum spirits on swabs.

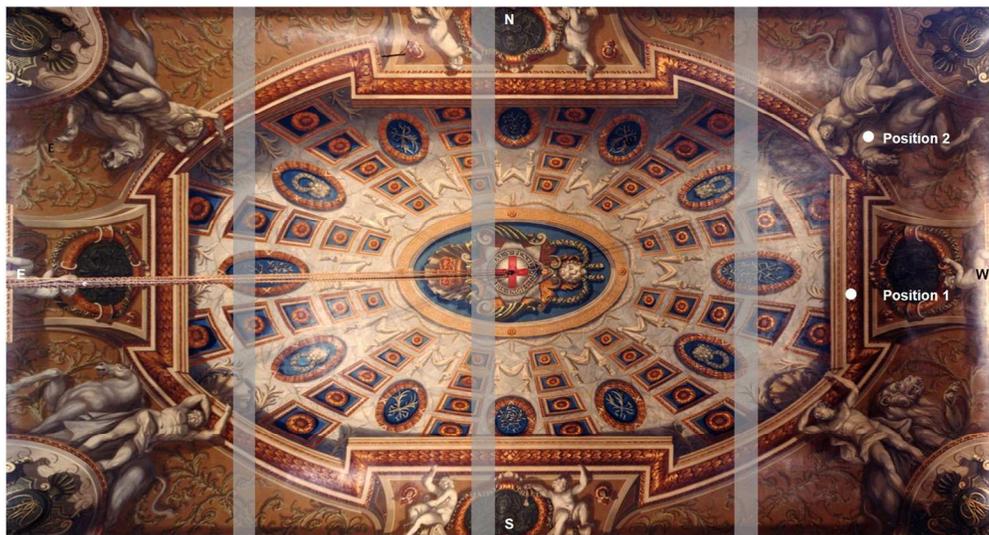
Image of The Queen's Staircase ceiling painting by combined rectified photographs showing locations of NMR analysis and rolled steel joists behind the painting. ©Historic Royal Palaces

Owing to the presence of the magnet, before analysis could start we needed to establish that there were no metal fixings behind the ceiling painting to a) prevent the magnet attracting metal fixtures and b) prevent interference with the magnetization signal [21]. Therefore, before the two regions for treatment and analysis could be identified it was necessary to consult Hampton Court Palace architectural drawings to determine the presence of modern structural reinforcements, such as rolled steel joists (RSJ) positioned above the ceiling. The positions of the joists were subsequently confirmed using a thermal camera and verified through examination of the void above the ceiling painting accessed from the room above. Figure 5 illustrates the positioning of the RSJs behind the painting and the two regions selected for conservation and analysis.

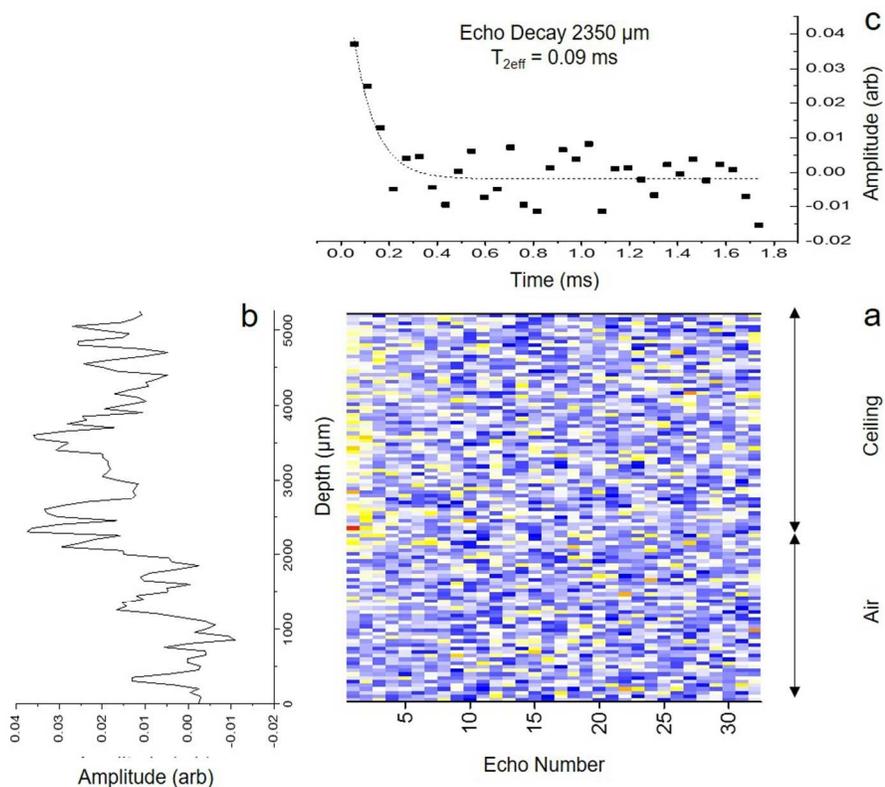
Figure 6  
194x162mm (150 x 150 DPI)

Figure 6 Relaxation data acquired from Position 1 prior to treatment with Jun Funori adhesive (a) 2D contour map showing CPMG echo decays through the depth of the ceiling at 50 μm steps, (b) sum echo amplitude of the 1st through 2nd echoes at each sampling depth at 50 μm steps and (c) CPMG echo decay at a depth of 2350 μm

structure as possible, and the lift programmed to move downwards by 50  $\mu\text{m}$  moving the excitation volume through the ceiling towards the front of the painting. At each 50  $\mu\text{m}$  cross section a CPMG echo relaxation decay was acquired, plotted in Figure 6a as a 2D contour map showing CPMG echo decay against depth of measurement. Although weak, an initial signal is seen to occur at 2,150  $\mu\text{m}$ , equating to a total sampling depth of 3,100  $\mu\text{m}$  into the ceiling at Position 1. From 2,100-0  $\mu\text{m}$  the excitation volume of the instrument is outside of the paint structure i.e. sampling air, which accounts for the low background signal.

The strongest signal is detected at 2,350  $\mu\text{m}$ , 200  $\mu\text{m}$  into the ceiling painting, which is likely to originate from the oil-based paint layers. The paint layers are expected to have the highest proton density in what is essentially otherwise an inorganic structure. Depth 2,350  $\mu\text{m}$  was interrogated more fully by locating the excitation volume of the NMR at this depth to acquire an improved CPMG echo decay (Figure 6c). The echo decay was acquired with an increased number of scans (256) to improve signal to noise and enable the relaxation time to be determined by curve fitting. Figure 6c shows the CPMG echo decay with the excitation volume centred within the paint layer. Fitting a single exponential to the data gives a  $T_{2\text{eff}}$  relaxation time of  $0.09 \text{ ms} \pm 0.02$ . This relatively quick relaxation corresponds to similar findings of Fife et al [16] ascribed to the behaviour of a hardened, crosslinked organic oil binder. Drying oils undergo oxidation and polymerization reactions, which in turn reduces free volume and limits decoherence in the magnetization.

The weaker signal between 2,200-2,150  $\mu\text{m}$  is thought to originate from the presence of a varnish layer. Cross sectional microscopy of a paint flake acquired elsewhere from the ceiling painting suggests an outer, optically transparent layer measuring in the region of 100  $\mu\text{m}$  (Figure 3) Although not a direct comparison to the location analysed in Position 1, cross sections from the paintings have identified a variable palette and in some cases a varnish layer.

Although much reduced after 24 hours, the signal is twice that of the proton density detected prior to treatment and this increase is attributed to the deposit of the adhesive (Figure 6b and Figure 9b). It is apparent from the 2D contour map that the signal spans a larger depth than before adhesive injection; the signal originating from a 50  $\mu\text{m}$  cross section before treatment and a depth of approximately 250  $\mu\text{m}$  after treatment (Figure 9a). Fitting an exponential to the CPMG echo decay at 2,350  $\mu\text{m}$  (Figure 9c) the dry adhesive is shown to have a quicker relaxation time than that of the adhesive dissolved in the solvent carrier; the  $T_{2\text{eff}}$  relaxation time is 0.08 ms  $\pm$ 0.02 compared to 0.17 ms  $\pm$ 0.04.

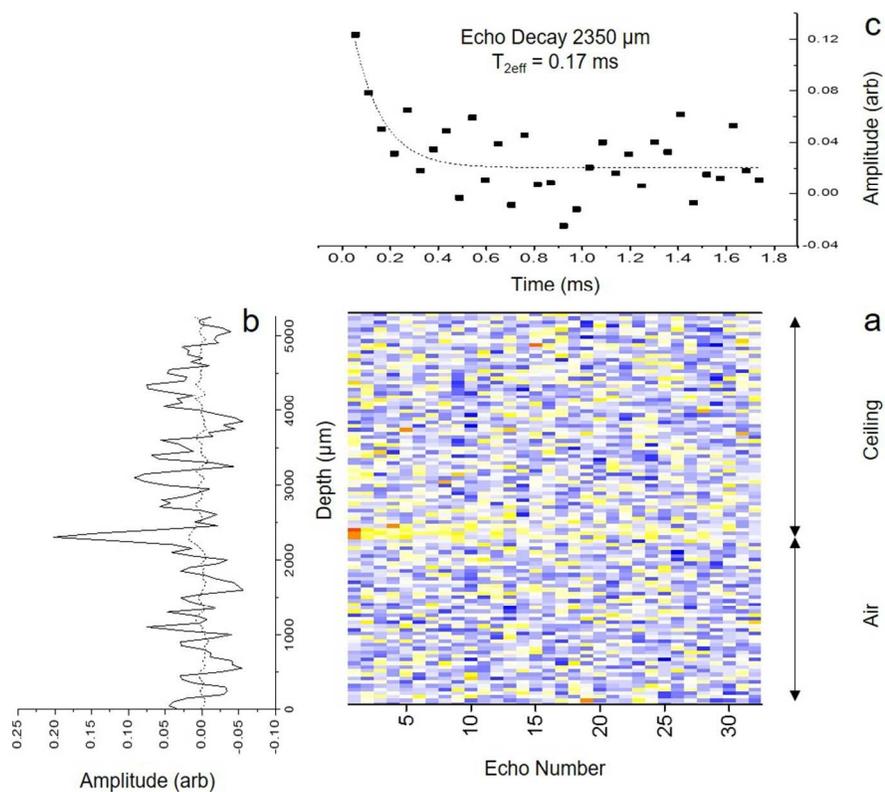
Figure 7 Relaxation data acquired from Position 1 30 minutes after treatment with Jun Funori adhesive (a) 2D contour map showing CPMG echo decays through the depth of the ceiling at 50  $\mu\text{m}$  steps, (b) sum echo amplitude of the 1st through 2nd echoes at each sampling depth at 50  $\mu\text{m}$  steps and (c) CPMG echo decay at a depth of 2350  $\mu\text{m}$

Figure 7a shows the 2D contour map for the first of ten profile scans, directly following treatment with the Jun Funori adhesive in water. The first profile scan was acquired approximately 30 minutes after the initial adhesive injection. It is apparent that the signal in the region of the paint layer has increased fivefold, in line with an increase in the proton density. The most intense signal is also detected across three sampling steps after treatment, 2,350-2,250  $\mu\text{m}$ , compared to one sampling step for the untreated paint layer; the former equating to a depth of approximately 150  $\mu\text{m}$  and the latter 50  $\mu\text{m}$ .

It was not possible to acquire an optimised CPMG echo decay from 2,350-2,250  $\mu\text{m}$  due to the dynamic nature of this particular experiment i.e. running ten consecutive profiles scans to capture solvent movement. However, fitting a single exponential decay to the CPMG echo decay acquired at 2,350  $\mu\text{m}$  during the profile scan suggests a  $T_{2\text{eff}}$  relaxation time in the region of 0.17 ms  $\pm$  0.04 (Figure 7c). This increase in relaxation time reflects the increased mobility and decoherence of the protons in the solvent/adhesive solution.

The average echo amplitude of the 16<sup>th</sup> through 32<sup>nd</sup> echo is plotted in Figure 7b (dashed line). It is shown that there is a low intensity, broad signal across the 2,250-2,400  $\mu\text{m}$  region that indicates that the adhesive layer has not fully relaxed by the end of the CPMG sequence. This is a reflection of the mobility of the protons in the adhesive/solvent solution, increasing the time required for complete relaxation and realignment with the magnetic gradient.

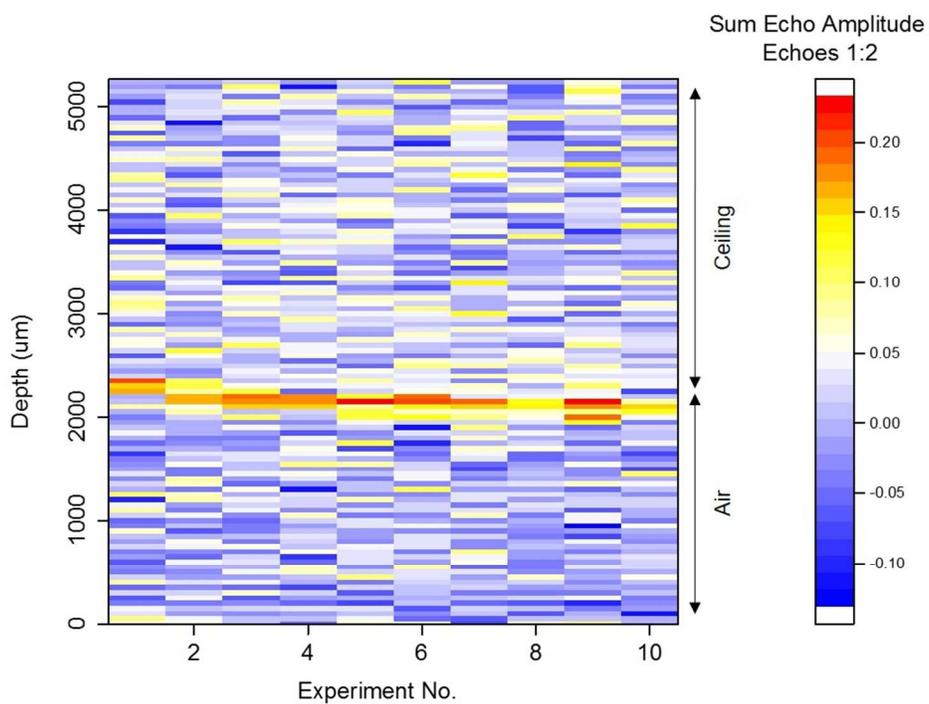
Figure 8  
184x140mm (150 x 150 DPI)

Figure 8 2D contour map of the sum echo amplitude for the 1st through 2nd echoes at each sampling depth over ten consecutive profile scans showing movement of the proton density signal towards the front of the ceiling painting

The 2D contour map in Figure 8 shows the sum of the echo amplitude for the 1<sup>st</sup> through 2<sup>nd</sup> echo at each sampling depth over ten consecutive profile scans. The signal appears to have dispersed across

1,950-2,450  $\mu\text{m}$  by profile scan five, suggesting that the solvent has diffused inside the ceiling painting and to the region immediately in front of the painted surface. Later consecutive scans appear to confirm this as the total proton density originates from the ceiling/air interface rather than into the bulk substrate. The solvent does not move into the plaster layers during drying as no significant increase in signal can be seen in the bulk. This has important implications for the use of water based adhesives in such composite structures. These results indicate that evaporation of the solvent tends towards the front of the ceiling painting, which reduces the possibility of damage to the bulk structure caused by moisture sorption. We are undertaking further work to confirm this interpretation.

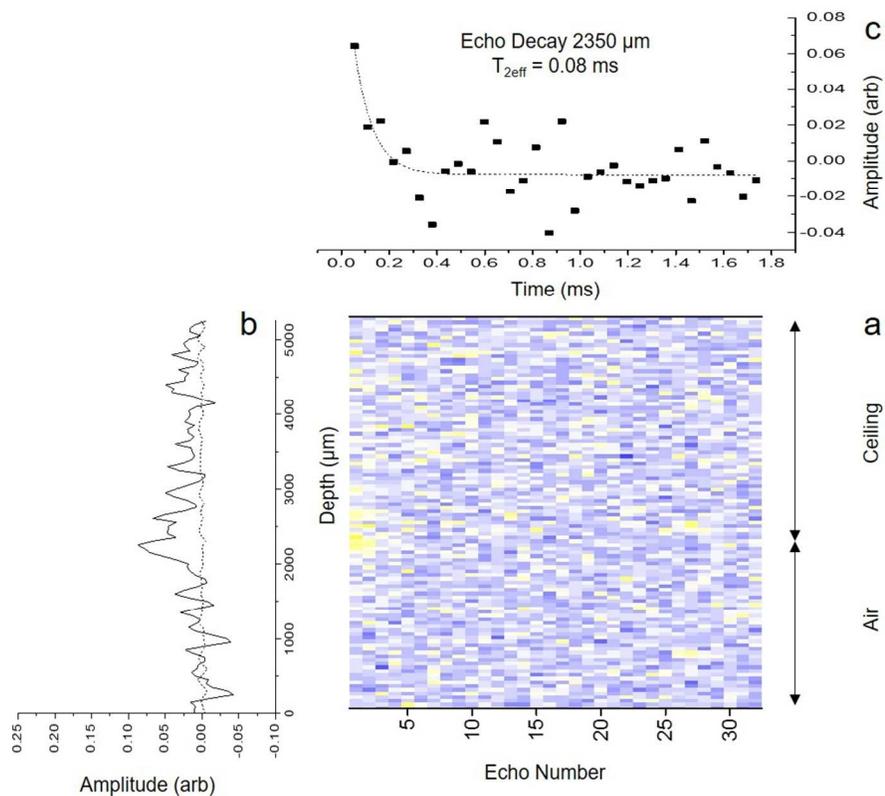
Figure 9 Relaxation data acquired from Position 1 24 hours after treatment with Jun Funori adhesive (a) 2D contour map showing CPMG echo decays through the depth of the ceiling at 50  $\mu\text{m}$  steps, (b) sum echo amplitude of the 1st through 2nd echoes at each sampling depth at 50  $\mu\text{m}$  steps and (c) CPMG echo decay at a depth of 2350  $\mu\text{m}$

The 2D contour map in Figure 9a shows the depth resolved CPMG echo decays acquired 24 hours after the initial injection of the Jun Funori adhesive. It is apparent there is a significant drop in the proton density 24 hours after treatment. The decrease in signal suggests that the solvent has fully evaporated, further supported by the loss of signal in the average echo amplitude of the 16<sup>th</sup> through 32<sup>nd</sup> echoes in Figure 9b (dashed line).

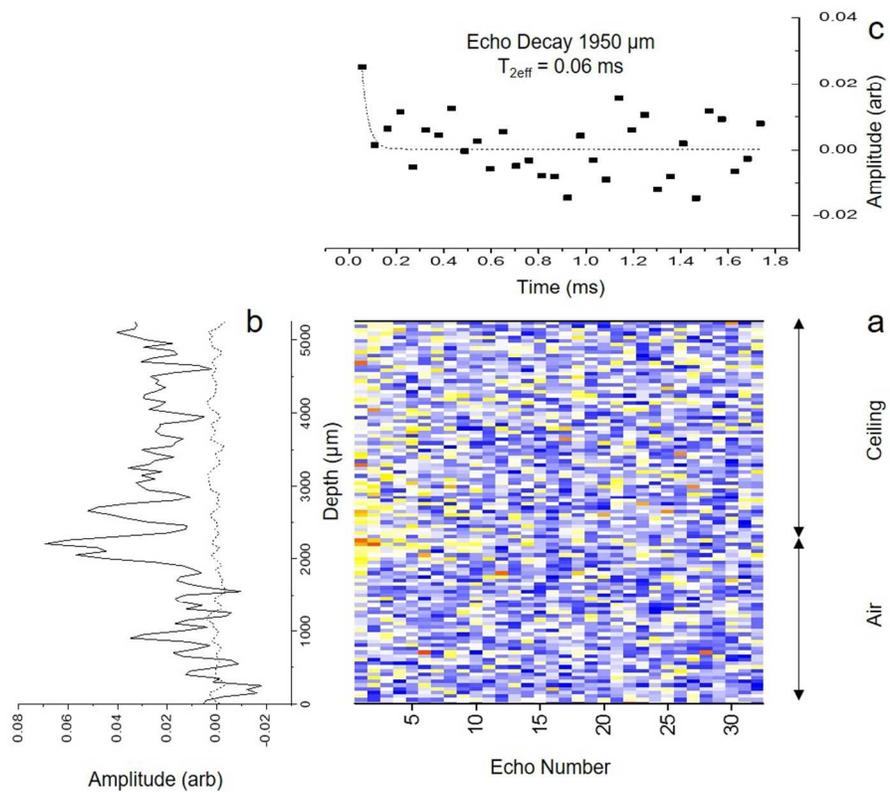
Figure 10  
196x163mm (150 x 150 DPI)

Figure 10 Relaxation data acquired from Position 2 prior to treatment with BEVA® 371 adhesive (a) 2D contour map showing CPMG echo decays through the depth of the ceiling at 50 μm steps, (b) sum echo amplitude of the 1st through 2nd echoes at each sampling depth at 50 μm steps and (c) CPMG echo decay at a depth of 1950 μm

Prior to treatment with BEVA® 371 a depth profile scan was carried out in Position 2, acquiring a CPMG echo decay at 50  $\mu\text{m}$  steps and plotted in Figure 10a as a 2D contour map. It is apparent that the signal covers a larger depth than the region analysed prior to Jun Funori injection. This is likely due to the fact that the paint flake had lifted away from the plaster and is no longer parallel to the ceiling, therefore covered a greater signal depth. This is supported by the sum of the echo amplitude of the 1<sup>st</sup> through 2<sup>nd</sup> echo at each depth shown in Figure 10b. This plot shows that the proton signal spans from 1,750-2,700  $\mu\text{m}$ , a depth of 950  $\mu\text{m}$ . This broad signal appears to indicate that the void measures in the region of 950  $\mu\text{m}$ , which fits well with visual observation.

sampling originates from the stable structure. This signal is also seen at the same depth prior to treatment (Figure 10b).

After treatment with BEVA<sup>®</sup> 371 there is an apparent increase in the background signal throughout the depth of the matrix (Figure 10a and 11a). The analysis was undertaken within 30 minutes of injecting the adhesive/solvent mixture and this increase in signal is thought to be due to solvent migration through the substrate. The solvent carrier used was a relatively volatile petroleum spirit, with a boiling point in the region of 60-80 °C [25], that appears to have diffused through the sampling depth. Unfortunately, due to time constraints on the scaffolding it was not possible to

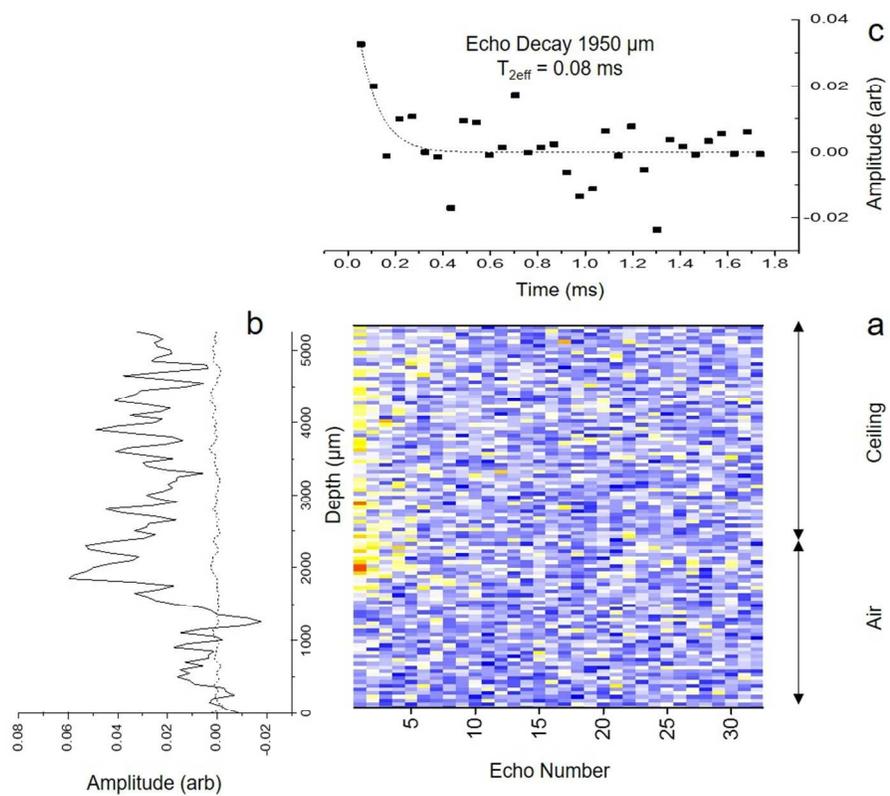
Figure 11  
196x164mm (150 x 150 DPI)

Figure 11 Relaxation data acquired from Position 2 30 minutes after treatment with BEVA® 371 adhesive (a) 2D contour map showing CPMG echo decays through the depth of the ceiling at 50  $\mu\text{m}$  steps, (b) sum echo amplitude of the 1st through 2nd echoes at each sampling depth at 50  $\mu\text{m}$  steps and (c) CPMG echo decay at a depth of 1950  $\mu\text{m}$

The 2D contour map in Figure 11a and echo amplitude plot Figure 11b shows an increased background signal across the entire analysis depth, with the greatest signal increase apparent at the front of the ceiling where the adhesive was injected behind the paint layer. Although the signal spans the entire sampling depth, there are three primary regions of interest, namely 2,400  $\mu\text{m}$ , 2,100-1,750  $\mu\text{m}$  and 1,750-1,550  $\mu\text{m}$ .

The signal at 2,400  $\mu\text{m}$  is believed to originate from the adjacent area of non-flaking paint i.e. paint from the stable regions surrounding the delaminated paint flake. Spanning just over 50  $\mu\text{m}$  in depth and exhibiting a strong signal, it seems likely that this signal sitting further back within the depth of

Directly in front of this region spanning 2,100-1,750  $\mu\text{m}$  is another strong, broad signal, which is assigned to the bulk adhesive and delaminated paint layer. The signal originating from this region has increased by a third following treatment and the corresponding CPMG echo decay shows an increase in  $T_{2\text{eff}}$  relaxation from 0.06 ms  $\pm$ 0.02 to 0.08 ms  $\pm$ 0.04. The exponential decays are fitted to data derived from the profile scans, which were optimised for time, rather than fitted to individual CPMG data optimised to improve signal to noise. Therefore it should be noted that these  $T_{2\text{eff}}$  values are tentative, exhibiting high errors and values close to that of a single echo time (0.05 ms).

There is a weaker more defined signal across the region of 1,750-1,550  $\mu\text{m}$  at the outmost surface of the ceiling, possibly due to the presence of a varnish layer. A signal of the same intensity is seen before injection of the adhesive, although after treatment appears to have moved forwards by approximately 100  $\mu\text{m}$  relative to the signal at 2,400  $\mu\text{m}$ . This suggests that the adhesive has prevented full alignment of the paint flake back into the recess and that the paint flake standing proud of the surrounding paint work. The total depth of the signal before and after treatment with BEVA<sup>®</sup> 371 also supports this interpretation and is likely due to the deformed flake not fully flattening back into place with heat. However, on visual inspection the conservation treatment did appear to have significantly reduced the void. Perhaps readhesion is via anchoring of a few discrete points, rather re-bonding of the complete flake area.
