Methodology for the Seismic Assessment of Earthen and Timber Historic Churches

Application to Peruvian Heritage

Doctor of Philosophy in Earthquake Engineering

UNIVERSITY COLLEGE LONDON

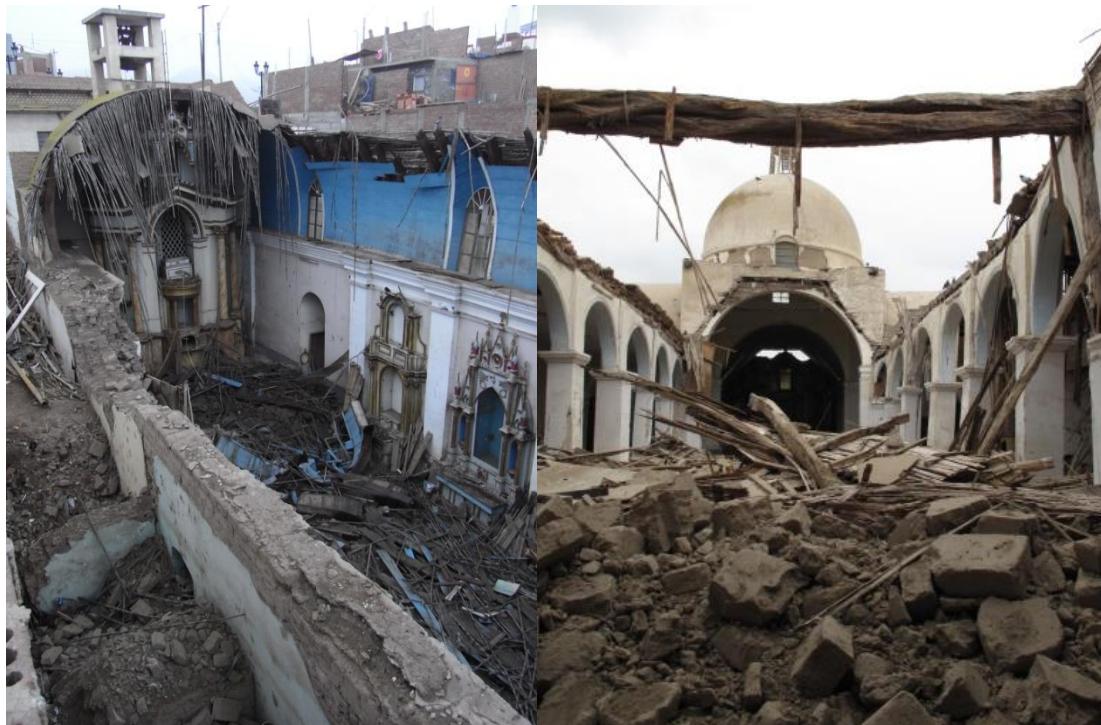
Figure 1.4 Examples of planked timber vaults that collapsed during the 2007 Pisco earthquake

In terms of historic churches, the most important lesson of the 2007 Pisco earthquake was the collapse of many planked timber vaults (Figure 1.4). This problem has not been only observed in Peru but also in Chile after the February 2010 earthquake (for details the reader can refer to D'Ayala and Benzoni, 2012).

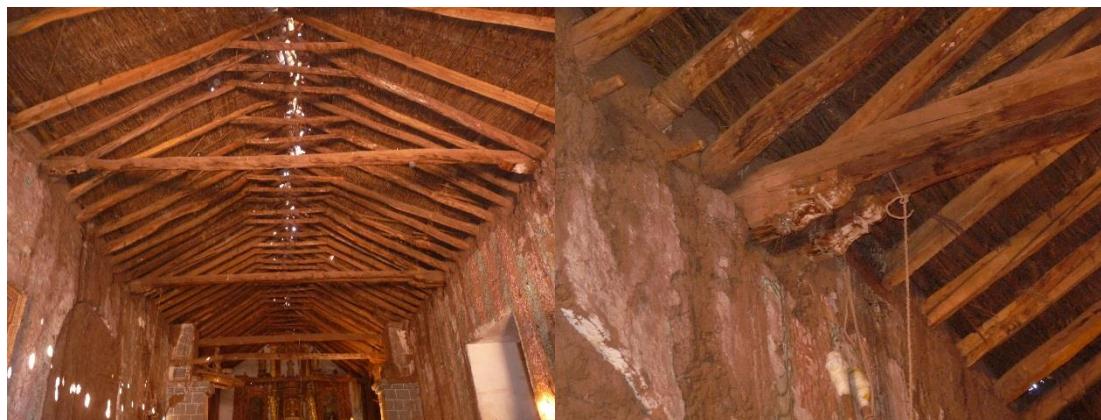
a) Tie-beams at the far North side of the church b) Connection tie-beam & corbel/adobe wall

In the central portion of the nave, two of the tie-beams are closely placed together, almost forming a pair, which causes a discontinuity in the wall plate which is placed at the same height. For this reason, the rafter located in-between the pair of tie-beams is directly embedded in the wall.

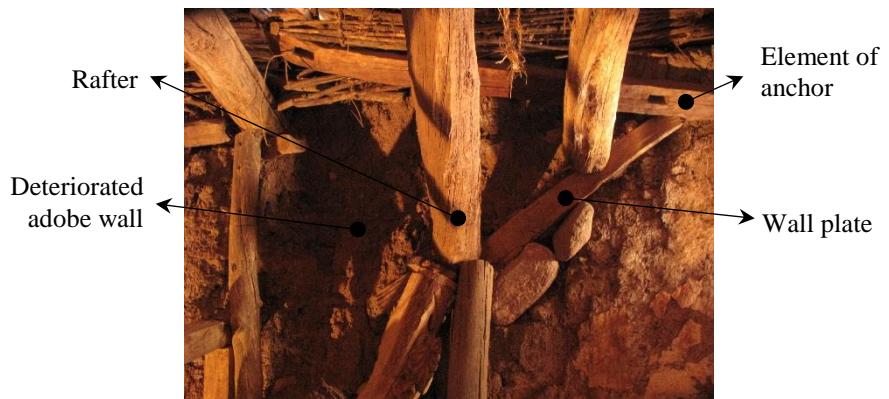
Figure 4.19 Failure of rafter, tie-beam and anchor due to deterioration of the wall

The existence of anchor AN2.1 indicates that possibly a tie-beam was connecting walls WI.2 and WI.4 at the location of the mezzanine. However, the tie-beam failed most probably due to the decay of WI.4 at the location of the tie-beam's anchorage. This is further shown by the failure of the wall plate and supported rafter in this portion of the wall (Figure 4.19).

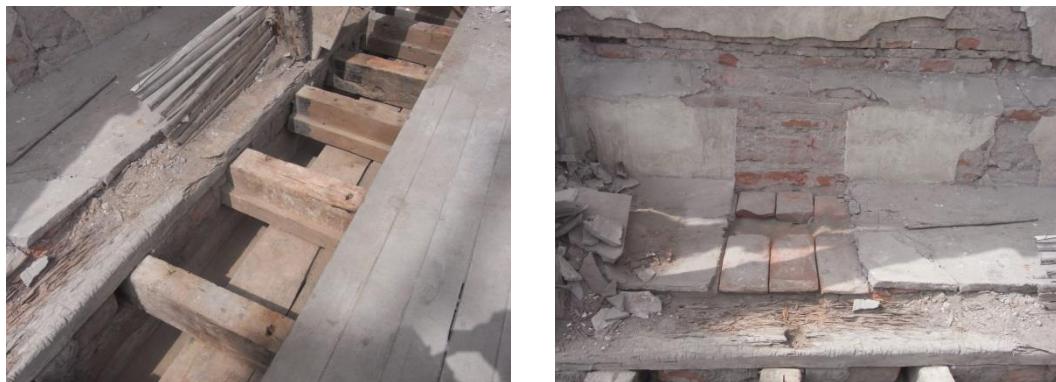
Figure 4.37 Choir loft's joists sitting on the façade

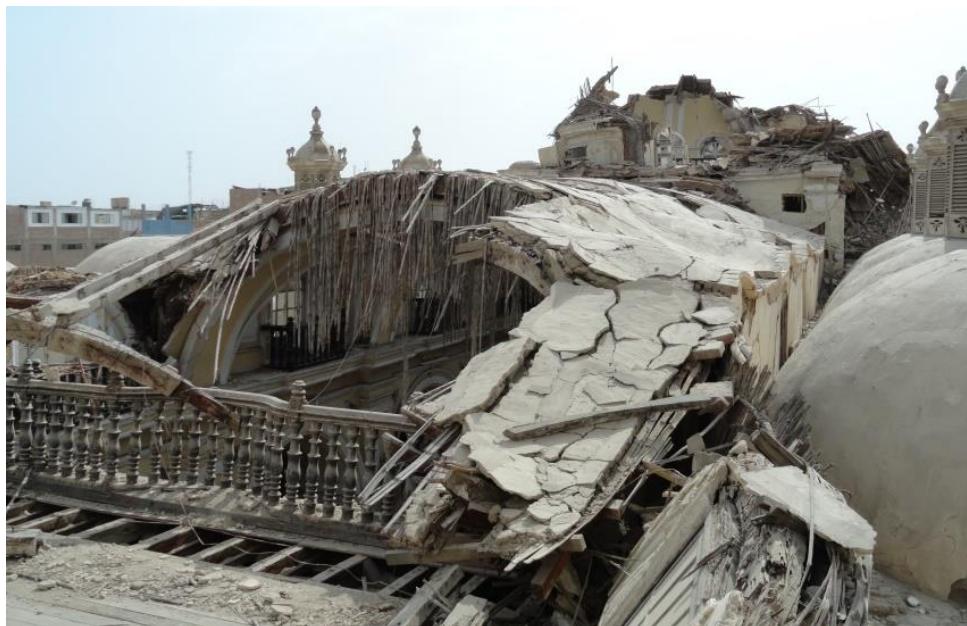
Figure 4.42 Damage state of the timber vault and principal dome of the Cathedral of Ica in 2011
(courtesy: Erika Vicente, PUCP)

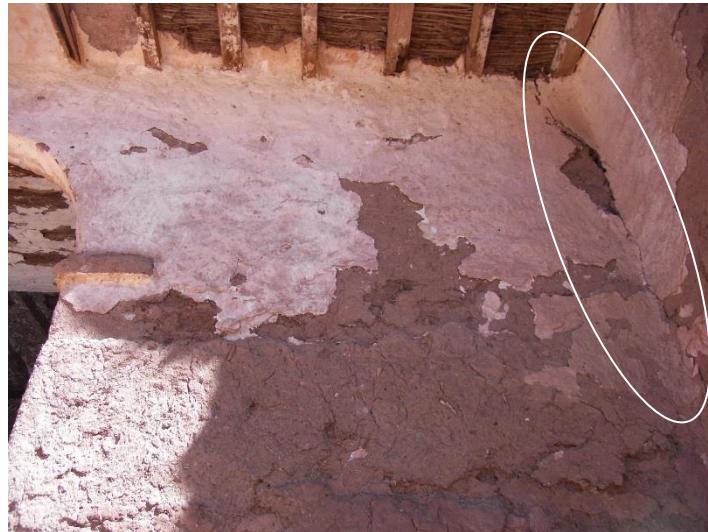
Figure 5.2 Crack at the interface WI.1/WI.4

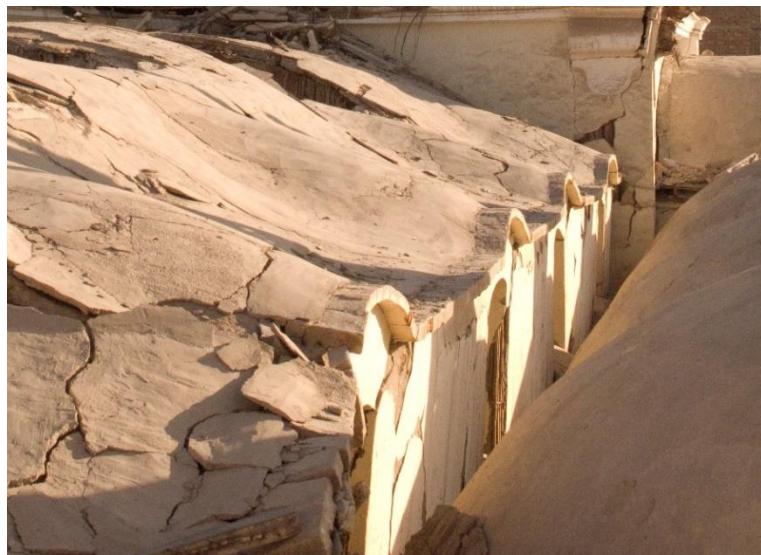
Figure 6.32 Generalized cracking of the roof of the Cathedral of Ica (courtesy of Claudia Cancino)

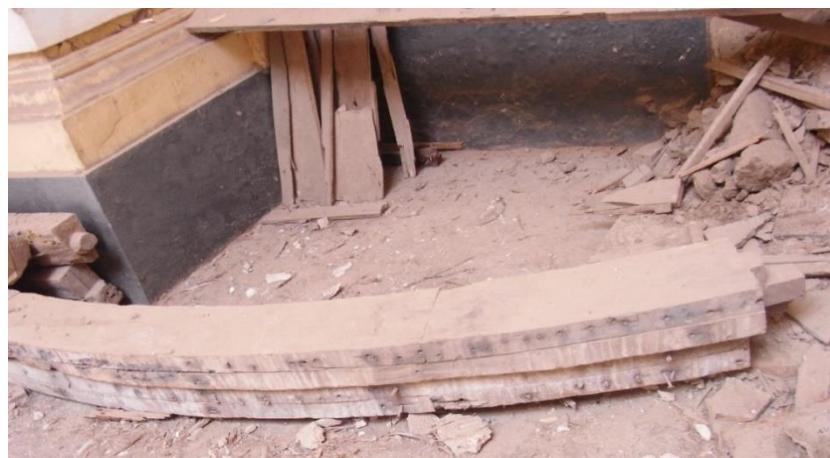
Figure 6.35 Collapsed internal arches on the ground of the Cathedral of Ica, showing that the canes were fixed to only one alignment of planks in each arch

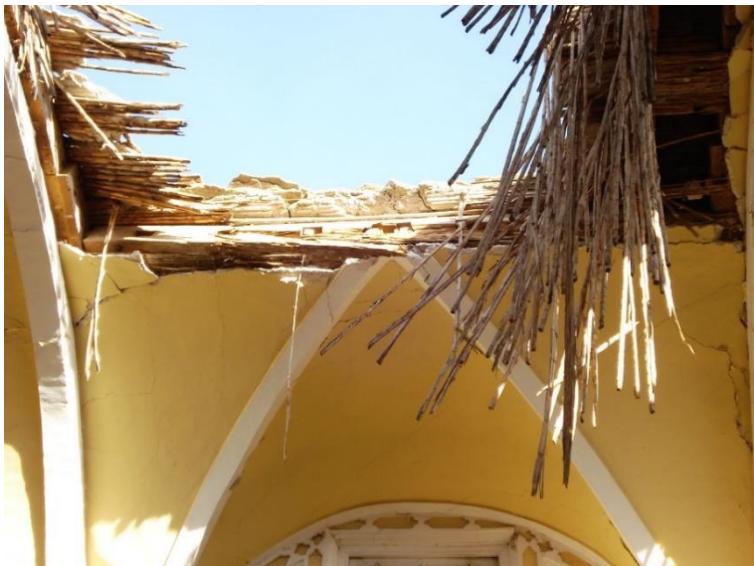
Figure 6.36 Failure of the composite layers after the 2007 Pisco Earthquake (courtesy of Erika Vicente)

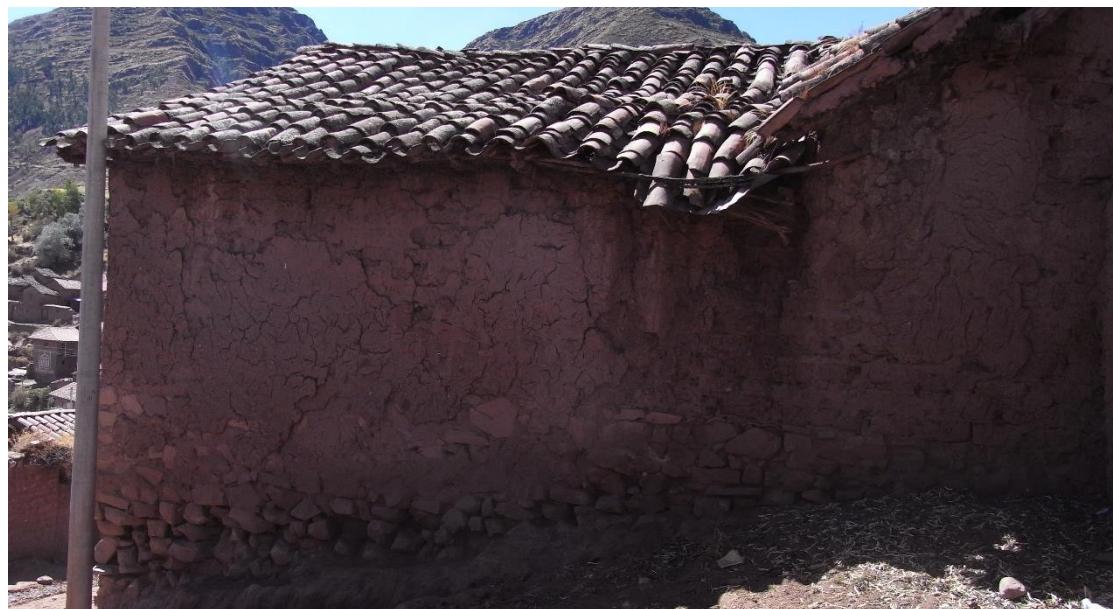
Figure 7.12 Deteriorated plaster in WL3

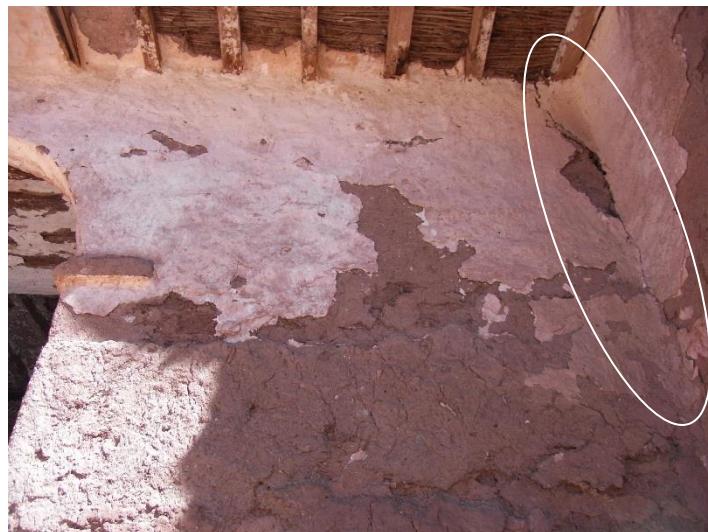
Figure 7.14 Crack at the interface WI.1/WI.4

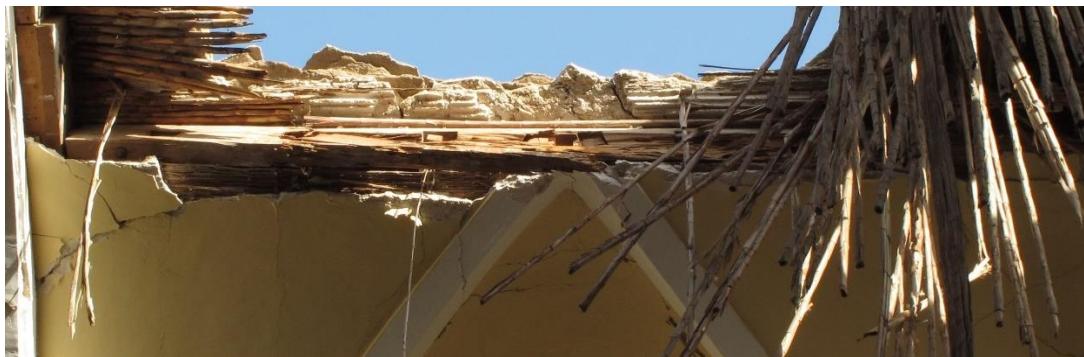
Figure 7.31 Splitting of the beam at the top of lunettes

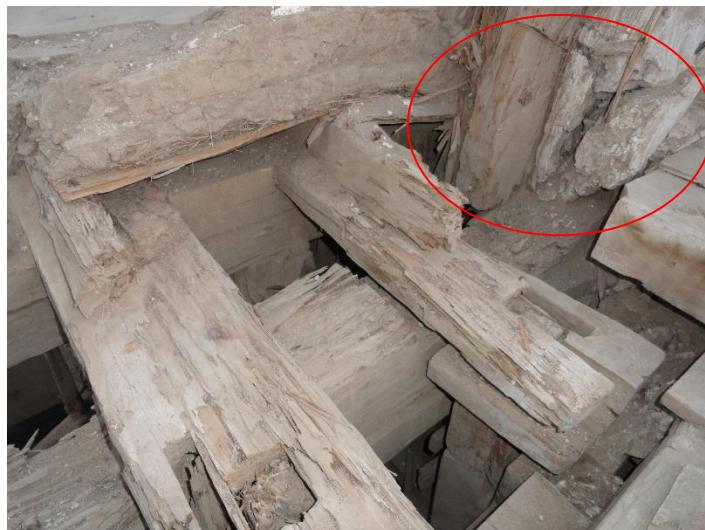
Figure 7.46 Poor construction quality: connection of a lunette's arch to a longitudinal beam in bay 2
(courtesy of Erika Vicente, PUCP)
