**STRUCTURAL APPRAISAL OF A ROMAN CONCRETE VAULTED MONUMENT:
THE BASILICA OF MAXENTIUS**

A. Albuerne¹ and M.S. Williams²

RUNNING HEAD: Basilica of Maxentius

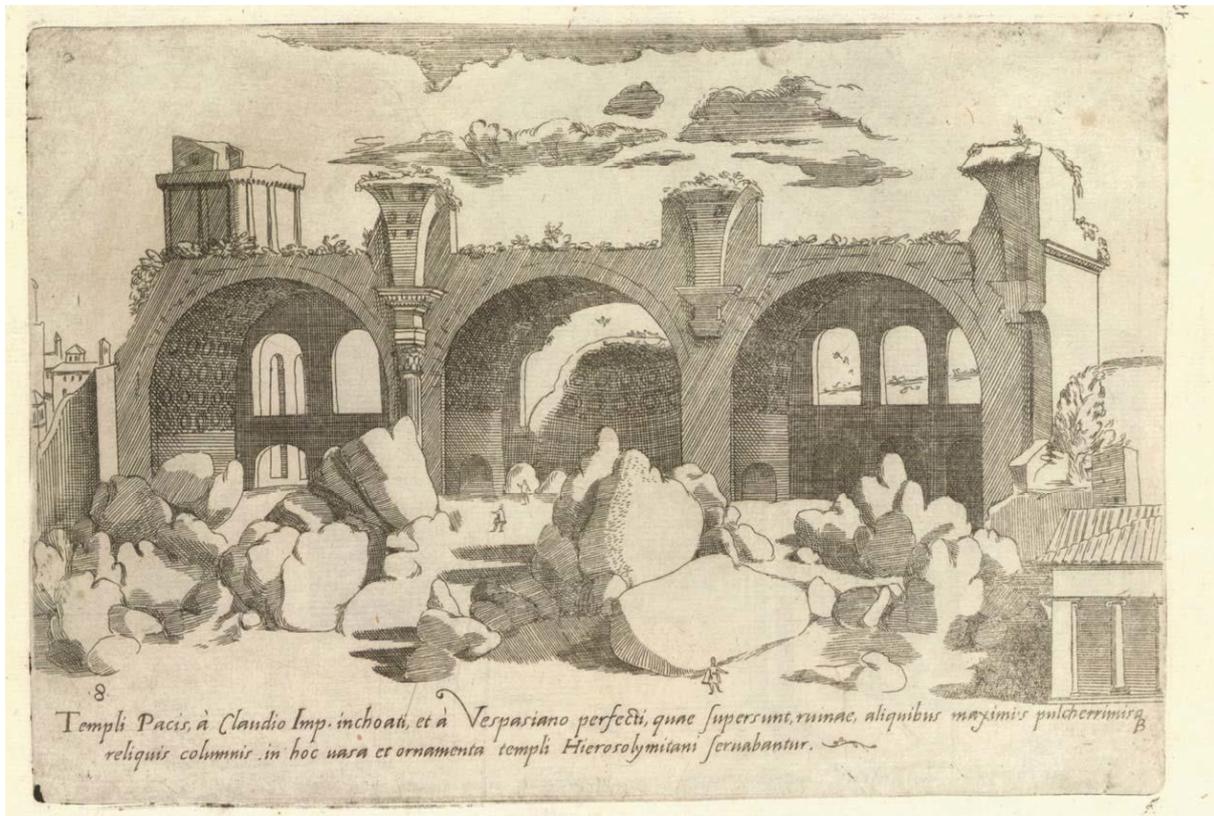
Fig. 2. Engraving of the Basilica of Maxentius (Giovanni Battista Cavalieri, 1569)

The more recent history of the site can be traced through the numerous drawings and engravings of the remains made from the 15th century onwards. These have been collated and summarised by Albuerne (2016); an example from the 16th century is shown in Fig. 2. After the collapse, the ground level is estimated to have been raised by around 7m, at least partially due to the presence of rubble remains of the collapsed parts. Much of the rubble remained on the ground for many centuries, as evidenced by early engravings, suggesting that no great efforts were made to restore the building or re-use the site. The earliest image showing most of the rubble cleared dates from 1629 (Mercati 1629).

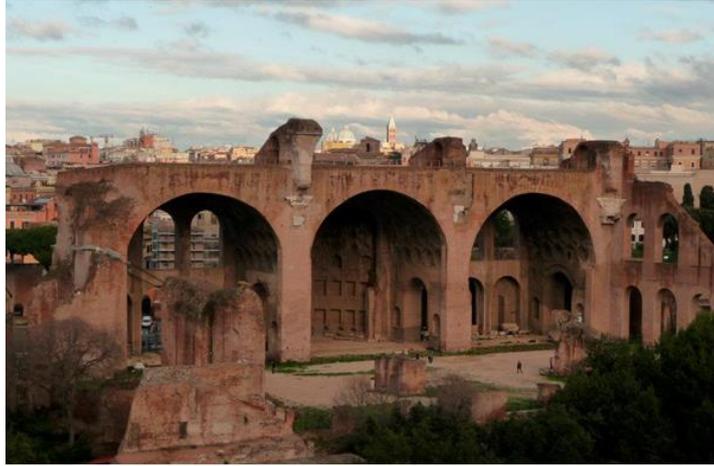
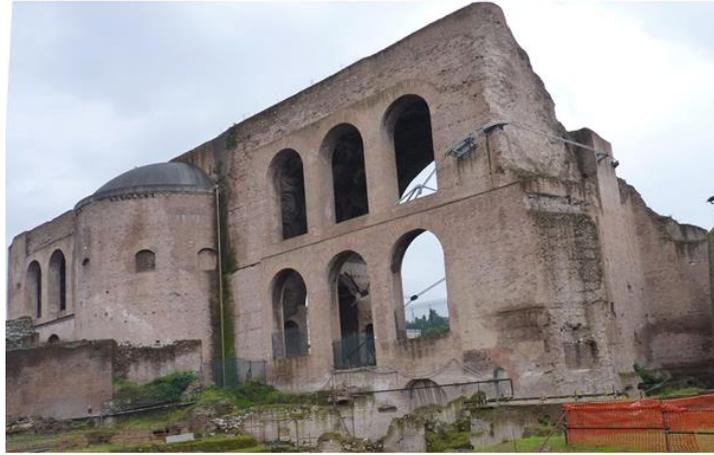
Fig. 3. North nave: a) view of the interior, from the south, and b) exterior, from the north

over the stability of the west façade, a steel cable restraint has been fitted. Two recent views of the north nave barrel vaults are shown in Fig. 3.

The subsequent excavations, first inside the building and more recently outside the west wall, have a clear justification in archaeological terms, enabling us to learn more about the building's history and returning it closer to its original state. However, they have had a negative impact on the safety of the structure, reducing its geometric factor of safety and necessitating the installation of the intrusive steel tie system visible in Fig. 3.

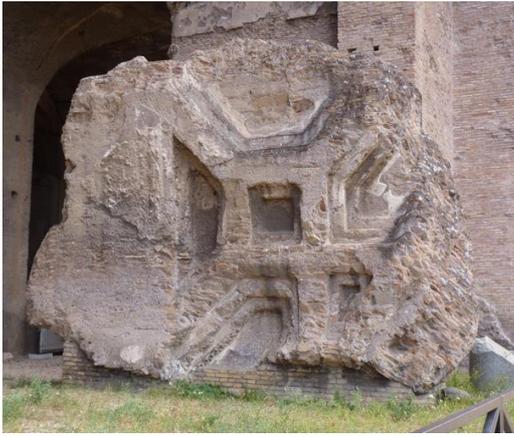
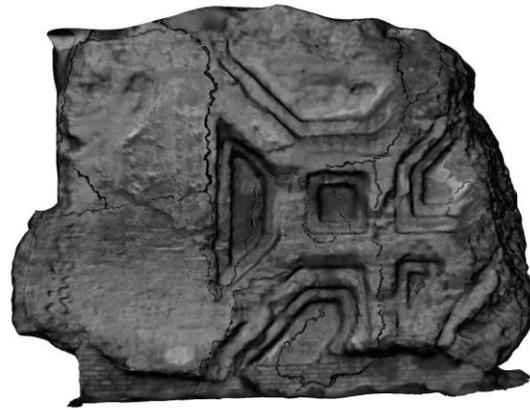
Fig. 6. Photo of vault fragment A, and 3D model created by digital photogrammetry

The software 123D Catch by Autodesk was selected for use. This generates a 3D mesh and surface rendering that can be processed by graphic software such as AutoCad and Rhino. It was applied to particular areas of the Basilica where particularly detailed models were desired, including fragments of the broken vaults and the cross vault springings and buttresses. The 3D models were scaled and oriented using total station measurements as reference; a typical result, for the largest extant segment of cross-vault, known as fragment A, is shown in Fig. 6.

The form of the cross-vault was inferred from the 3D photogrammetric model of fragment A. This was positioned within the reconstructed vault using the surface decoration as a guide. The decoration pattern was projected onto the intrados of a 3D reconstruction of

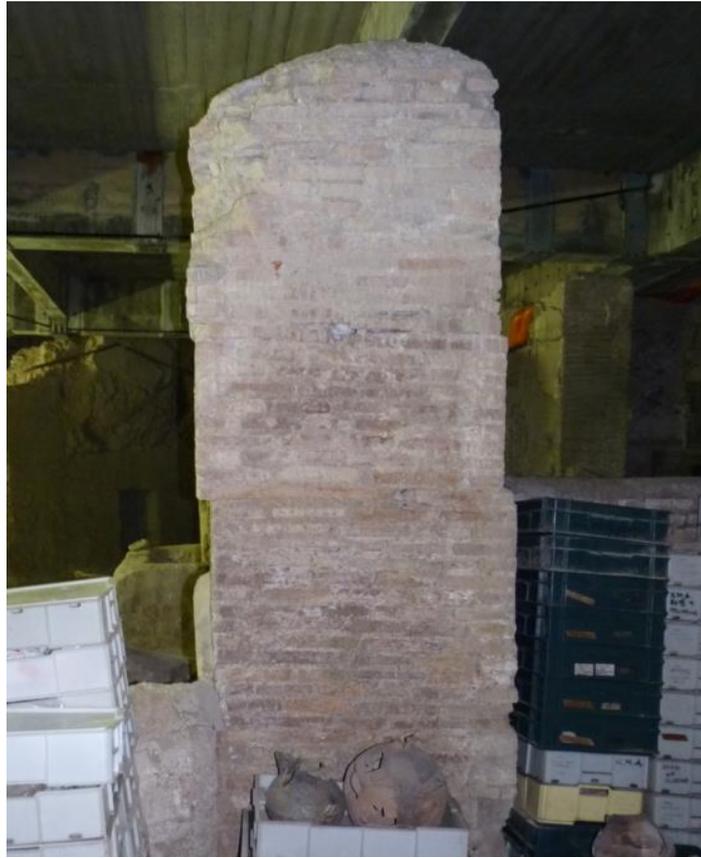
Fig. 7. Remaining wall of the *horrea piperataria* showing lateral slip at *bipedale* layers

Within these underlying structures, evidence was found that the structure had previously experienced large lateral loads. These included diagonal cracking and substantial inclination of some Roman concrete walls. One of the most striking examples is shown in Fig. 7, which shows a wall originally part of the *horrea piperataria* that has undergone lateral deformation at a series of slip planes. It is known that Romans used layers of *bipedales* every 1–1.5m within walls (Choisy 1873), to act as bonding courses connecting together opposite brick facings. These layers gave a very smooth horizontal surface with a much

lower frictional resistance than the concrete core, leading to the observed deformation. From this and other observed foundation damage, it appears likely that the site was subjected to a significant horizontal seismic loading, with its strongest component parallel to the longitudinal axis of the Basilica.

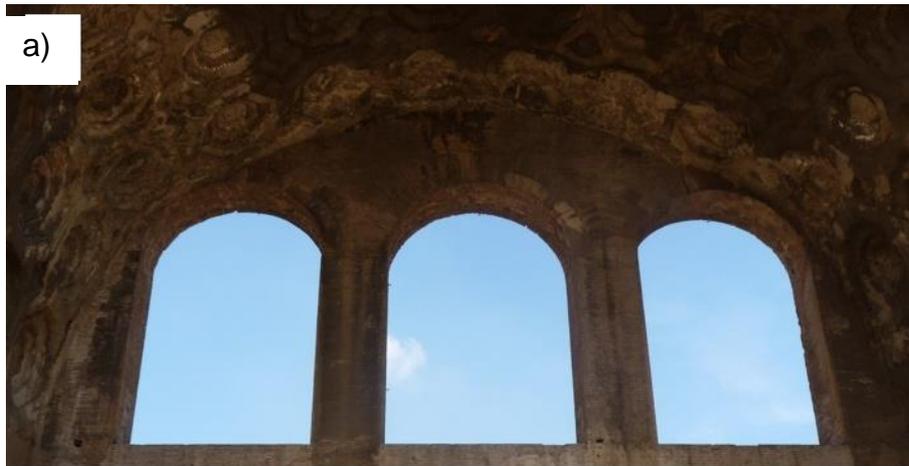
Fig. 8. a) Distortion of east barrel vault around windows on north façade, b) surveyed profile compared to ideal circular profile; the outer circle indicates the maximum radial discrepancy from the intended vault radius (inner circle)

All three surviving barrel vaults show a deviation from the ideal semi-circular shape, as can be seen in Fig. 8. This is most extreme adjacent to the north façade, with cross-sections further to the south becoming closer to circular in form. Rather than being the result of deformations under load, we believe this to be an accommodation of a construction error. There is evidence that the northern wall was constructed before the vaults; the brick arches around the windows in the northern wall are partly hidden on the inside by the vaults (Albrecht 2009). It appears that the windows in the top row were positioned either too high or too far apart, so that they did not fit within the intended semi-circular profile of the vault (see

Fig. 8). Therefore the geometry of the vault had to be altered in order not to obstruct the windows.
