# A HYGROTHERMAL MONITORING AND MODELING OF A HISTORIC ROOF

Sung H. Hong, Ian Ridley and Tadj Oreszczyn  
Faculty of the Built Environment  
Bartlett School of Graduate Studies  
University College London  
London, United Kingdom  
ucftshh@ucl.ac.uk

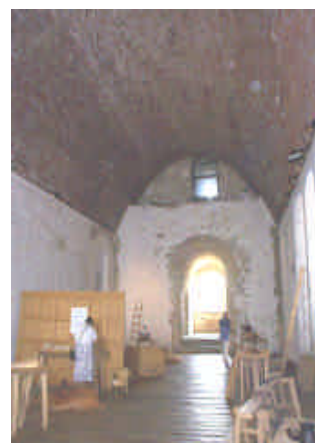
The two case study chambers – east chamber and west chamber – are located in the second storey of the 12<sup>th</sup> century, main keep building at Dover Castle. Each chamber is rectangular in shape with a floor dimension of 17m x 7m. The average thickness of the chamber exterior wall is about 6m and is constructed out of limestone with a mixture of slate, pebble and chalk for the wall core. There are various smaller chambers, galleries and circular stairwells within the thickness of the wall. The floor is of timber construction. Each chamber is spanned with a 3m to 5m thick brick vault. A typical roof section is shown in figure 2 (English Heritage, 1995). The soffit of the vault is exposed brick, and the chamber walls are finished in lime plaster up to the level of vault springing which starts at 4m height from the floor level. The vault reaches a maximum height of 7m from the floor level.

Figure 1 Typical chamber

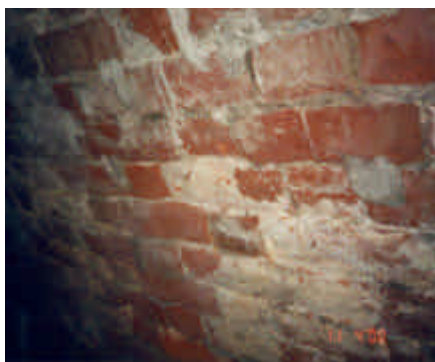
Material analysis also revealed a high concentration of soluble salts within the vault fabric originating from the bricks. Figure 3 shows two types of salt activity presently taking place in the ceiling: Efflorescence and crypto-efflorescence.

Figure 3 Efflorescence and crypto-efflorescence damages on the vault ceiling

The two salt activities differ in the following way: “Efflorescence occurs when there is a plentiful water supply, but if the water supply is limited, the liquid front retreats inwards, resulting in crypto-

*efflorescence ... Whereas efflorescence is merely unsightly, crypto-efflorescence causes delamination, spalling and cracking of the external brickwork surface as a result of the expansive crystallization of soluble salts within the brick pore structure” (Harrison, 1998).*

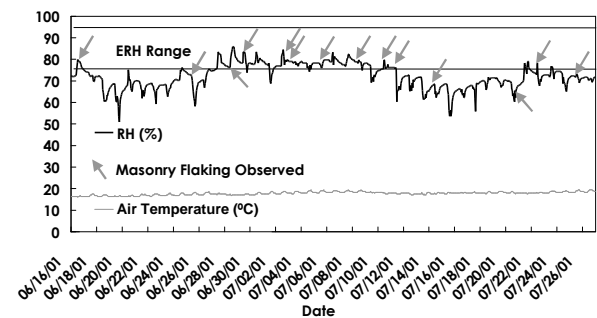
Figures 5 and 6 show the monitored RH and air temperature during summer 2001 for the west and east chambers. Both figures show increased frequency of flaking with RH in the ERH range as indicated in grey arrows. The monitoring of the flaking activity was carried out only in summer 2001.

Figure 5 West chamber air temperature, RH and observed incidences of flaking activity

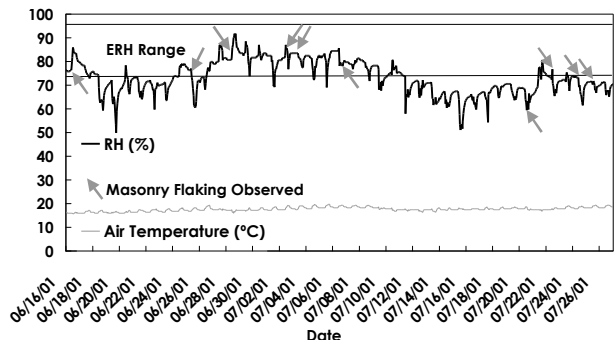
Figure 6 East Chamber air temperature, RH and observed incidences of flaking activity

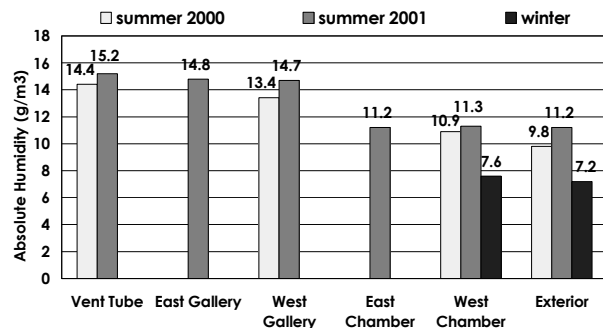
Absolute Humidity - The average absolute humidity of the two summers and winter are compared in figure 7. The higher absolute humidity level observed in all monitored locations in comparison to the exterior indicates moisture source from within the building.

Figure 7 Comparison of average absolute humidity levels of all monitored locations

The steady decrease in the absolute humidity level from the ventilation tube to the chambers also reflects the relative degree of ventilation experienced in these areas with the ventilation tube experiencing the least, the chambers the most and the galleries somewhere in between.

The steady decrease in the absolute humidity level difference between the interior and the exterior from summer 2000 to summer 2001 – vent tube:  $4.6\text{g/m}^3$  to  $4.0\text{g/m}^3$ ; west gallery:  $3.6\text{g/m}^3$  to  $3.5\text{g/m}^3$ ; west chamber:  $1.1\text{g/m}^3$  to  $0.1\text{g/m}^3$  – suggests drying of the building fabric over a single year.

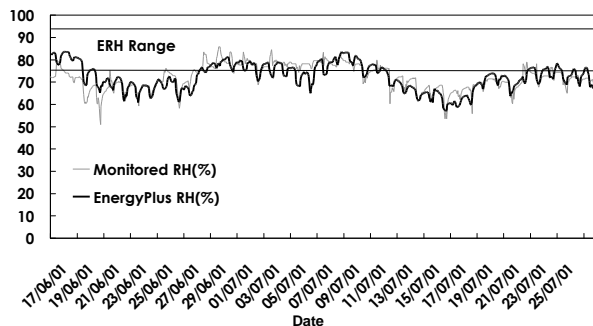
Tables 3 and 4 compare the EP modeled average air temperature, absolute humidity, RH and hours within the ERH band against the monitored data for summer 2001 and winter 2000. Figures 8 and 9 compare the monitored and modeled RH for summer 2001 and winter 2000.

Figure 8 Monitored vs. EnergyPlus RH prediction for summer 2001

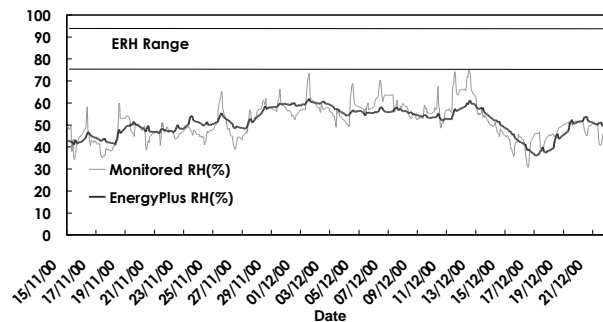
Figure 9 Monitored vs. EnergyPlus RH prediction for winter 2000

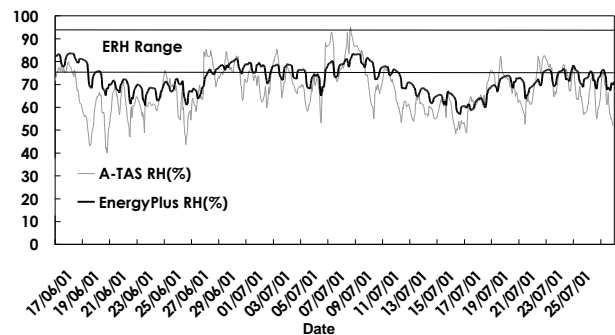
As a further test of the EP model, particularly the effectiveness of using its EMPD algorithm in simulating a moisture pervious environment, a comparison was made with A-TAS model which ignores moisture transfer characteristic. The suitability of EP model for the case study chamber is evident in figure 10 by its ability to simulate time-delayed RH response and in table 5 by its close prediction against the monitored data.

Figure 10 EnergyPlus vs. A-TAS RH prediction for summer 2001

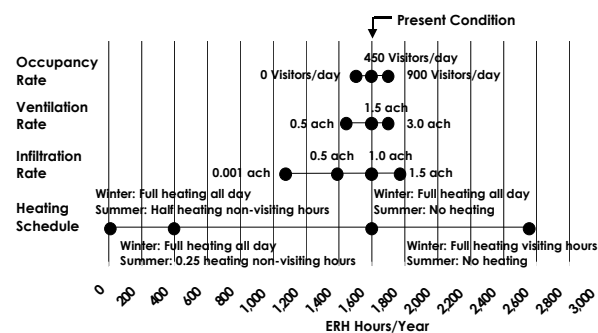
Figure 12 shows that controlling the occupancy rate from zero to 900 visitors per day affects the annual ERH range by only 130 hours. Varying the ventilation rate from 0.5 ach to 3.0 ach also results in a small change in the ERH range of 180 hours. Varying the infiltration rate from 0 ach to 1.5 ach results in a larger range of 700 hours. Finally, the heating strategy provides the greatest potential in reducing the ERH hours close to zero by supplementing the current heating strategy with non-visiting hour summer heating at half the current winter level.

Figure 12 ERH sensitivity under varying internal condition

The sensitivity study indicates that an increase in the ventilation rate increases the ERH hours by increasing the chamber RH. This is surprising since the exterior always exhibited a lower absolute humidity than the chamber (summer 2001: exterior  $11.2\text{g/m}^3$  vs. west chamber  $11.3\text{g/m}^3$ ; winter: exterior  $7.2\text{g/m}^3$  vs. west chamber  $7.6\text{g/m}^3$ ). On the other hand, a comparison of the average air temperature shows that the exterior air temperature was always lower than the chamber and in winter lower by about  $11^\circ\text{C}$  (summer 2001: exterior  $16.7^\circ\text{C}$  vs. west chamber  $17.8^\circ\text{C}$ ; winter exterior  $6.4^\circ\text{C}$  vs. west chamber  $17.6^\circ\text{C}$ ). It is the effect of the lower external temperature that causes the chamber RH to rise with increased ventilation and infiltration rates. The infiltration rate has a greater impact on the ERH hours because of the entry of the cooler night-time air.

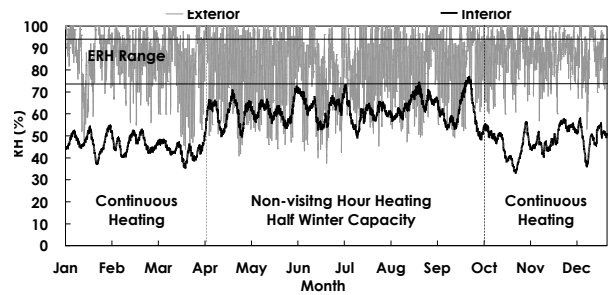
Figure 13 38 predicted annual ERH hours under full winter and partial summer heating

To maintain the RH level below the ERH range, a combination of building air-tightness measures to decrease the background infiltration rate and an increase in the length of indoor heating hours should be considered. The effect of the heating strategy alone is shown in figure 13 where the annual ERH hours is reduced to 38 hours.

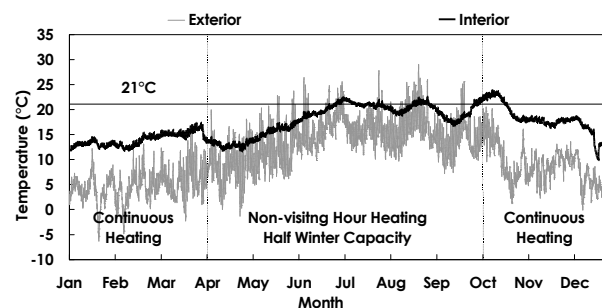
Figure 14 shows that with the introduction of partial summer heating, the internal air temperature rises above  $21^\circ\text{C}$  for 977 hours per year (40 days per year) with  $23^\circ\text{C}$  being the maximum air temperature in the month of October.

Figure 14 977 predicted annual hours above  $21^\circ\text{C}$  under full winter and partial summer heating

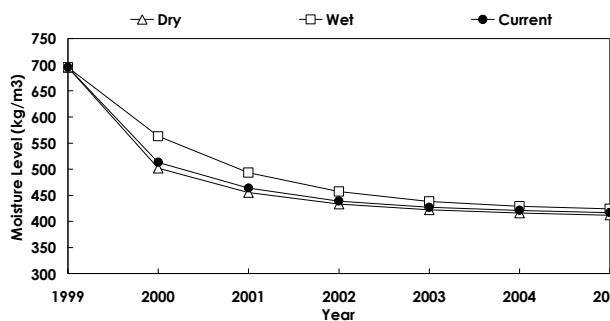
WUFI modeling was performed over six consecutive years beginning with the 1999 moisture level and substituting the modeled year-end moisture condition as the initial moisture level for the subsequent year. The drying rate of the brick vault under the three environmental conditions is compared in figure 15.

The model shows that the moisture decay rate within the fabric is greater with increased dryness in the chamber environment. However, the difference in the rate diminishes after several years and tapers off to a moisture level of about 420kg/m<sup>3</sup> (60% of original moisture level) at the end of the sixth year.

Figure 15 Vault interstitial moisture level over a period of six years of drying period

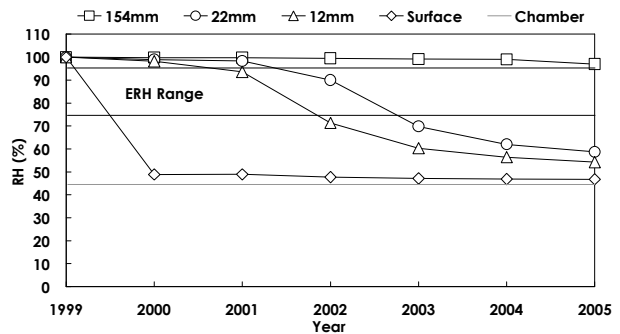
Figure 16 compares the year-end RH values at four different depths of the brick vault over a six year period assuming the internal environmental condition remains unchanged. The following depths were

selected for investigation: Brick vault surface over the chamber, 12mm depth, 22mm depth and 154mm depth. For 2001, the year that flaking was monitored, the model indicates flaking taking place at a depth between 12mm to 22mm. The model also indicates that the interstitial RH will eventually enter the ERH range at progressive depths as the drying front moves into the vault fabric predicting the potential of continued vault flaking until stabilization is reached.

Figure 16 Interstitial RH at four vault depths
