Structural Response of Masonry Infilled Timber Frames to Flood and Wind Driven Rain Exposure

Victoria Stephenson, Ph.D[1]; Dina D'Ayala, Ph.D[2]

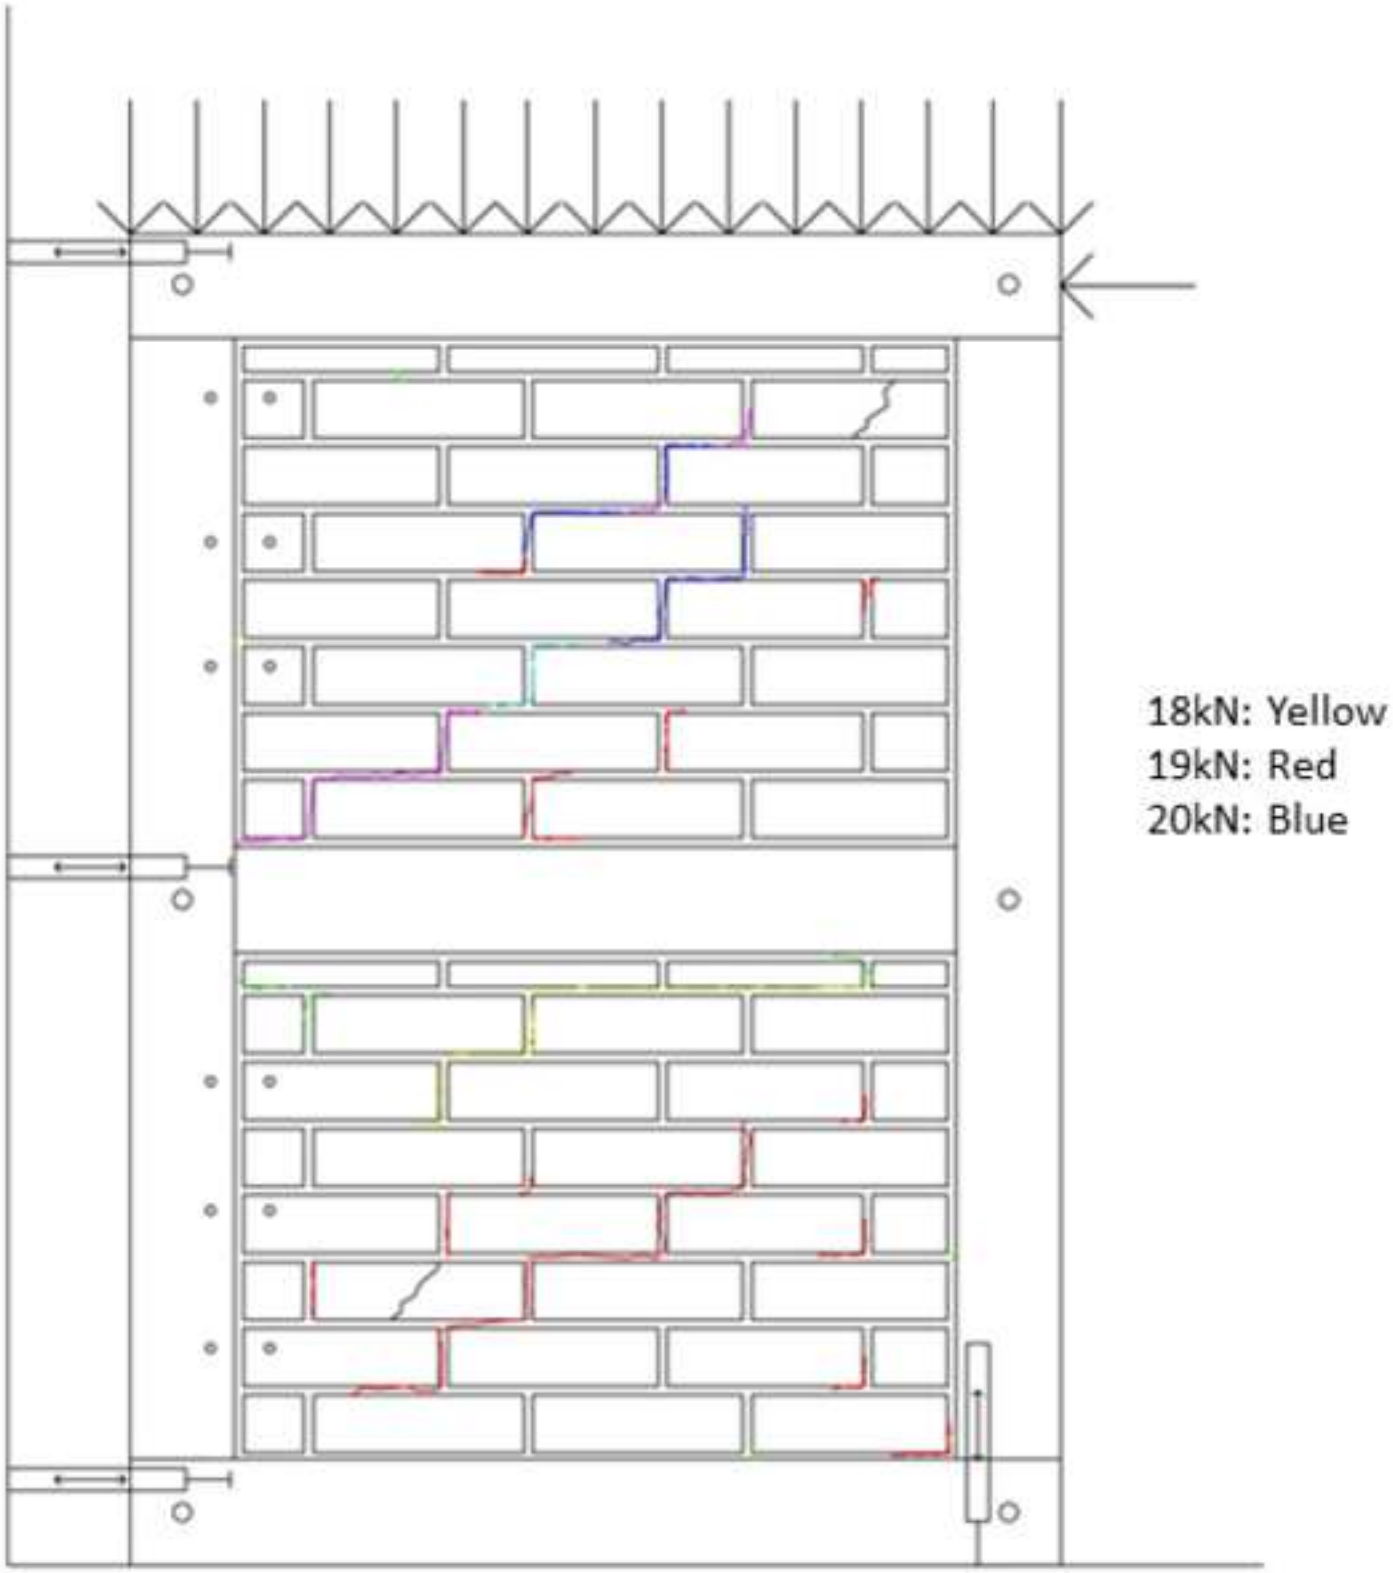
Lines 458-463
Figure 11 shows structural cracks in Frame 1 (control specimen) but no cracks formed in Frame 2. Is that correct? This should be discussed.
Figure 12 shows the structural crack pattern for Frame 2 on the right hand side.

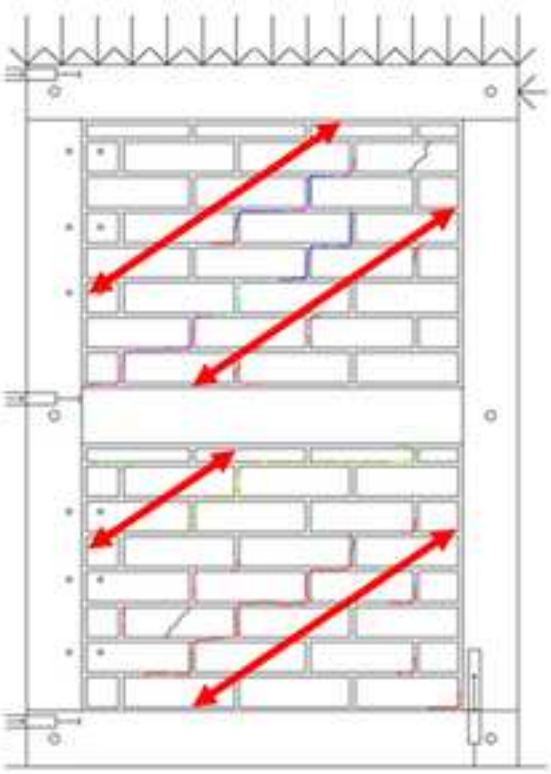
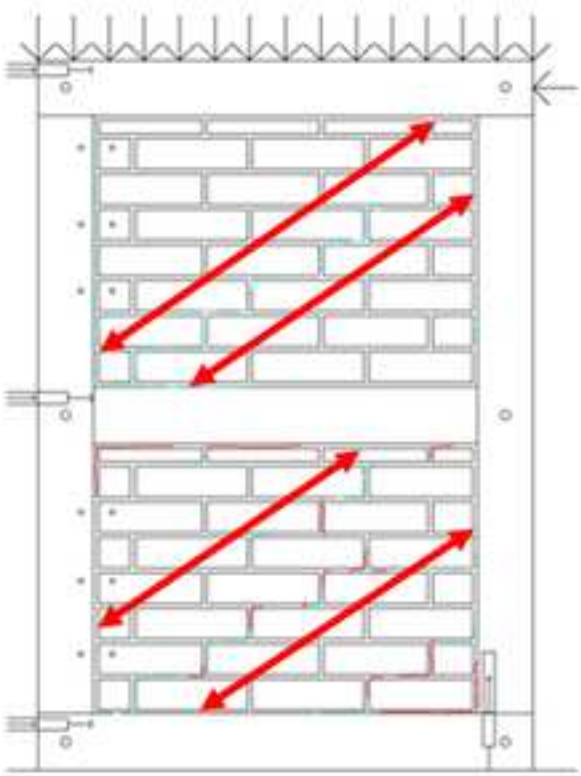
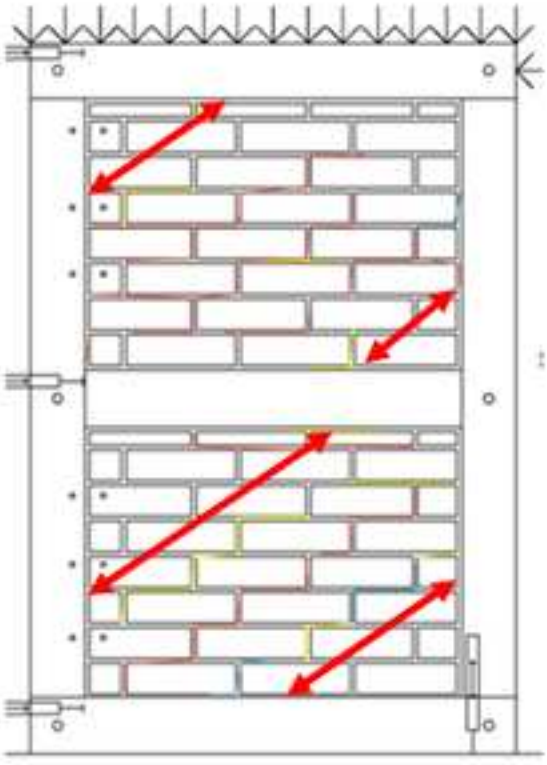
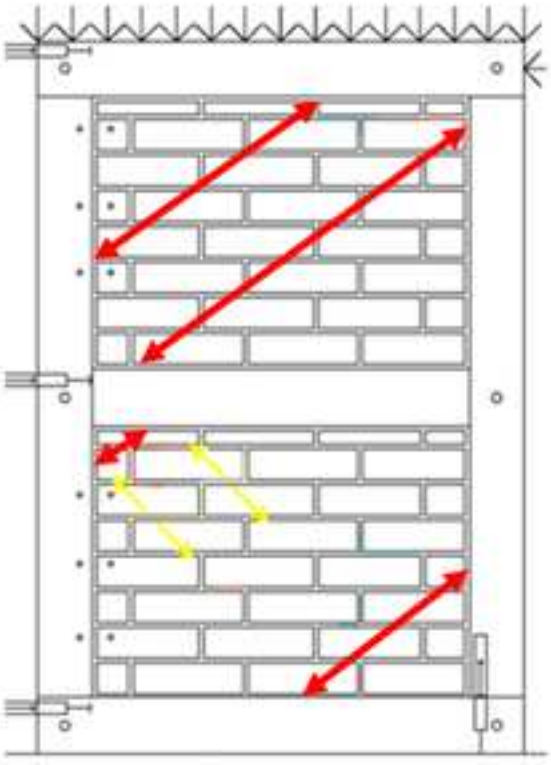
Applying the struts as shown in Figure 17 the theoretical deflection in Frames 1 to 4 is calculated at the lateral load corresponding to maximum cracking, highlighted in the envelopes in Figure 10. The table below compares the deflection observed in the post-yield portion of the envelope up to final cracking load, with the theoretical deflection according to the diagonal struts extracted from the crack patterns, computing also the percentage difference between empirical and analytical values.

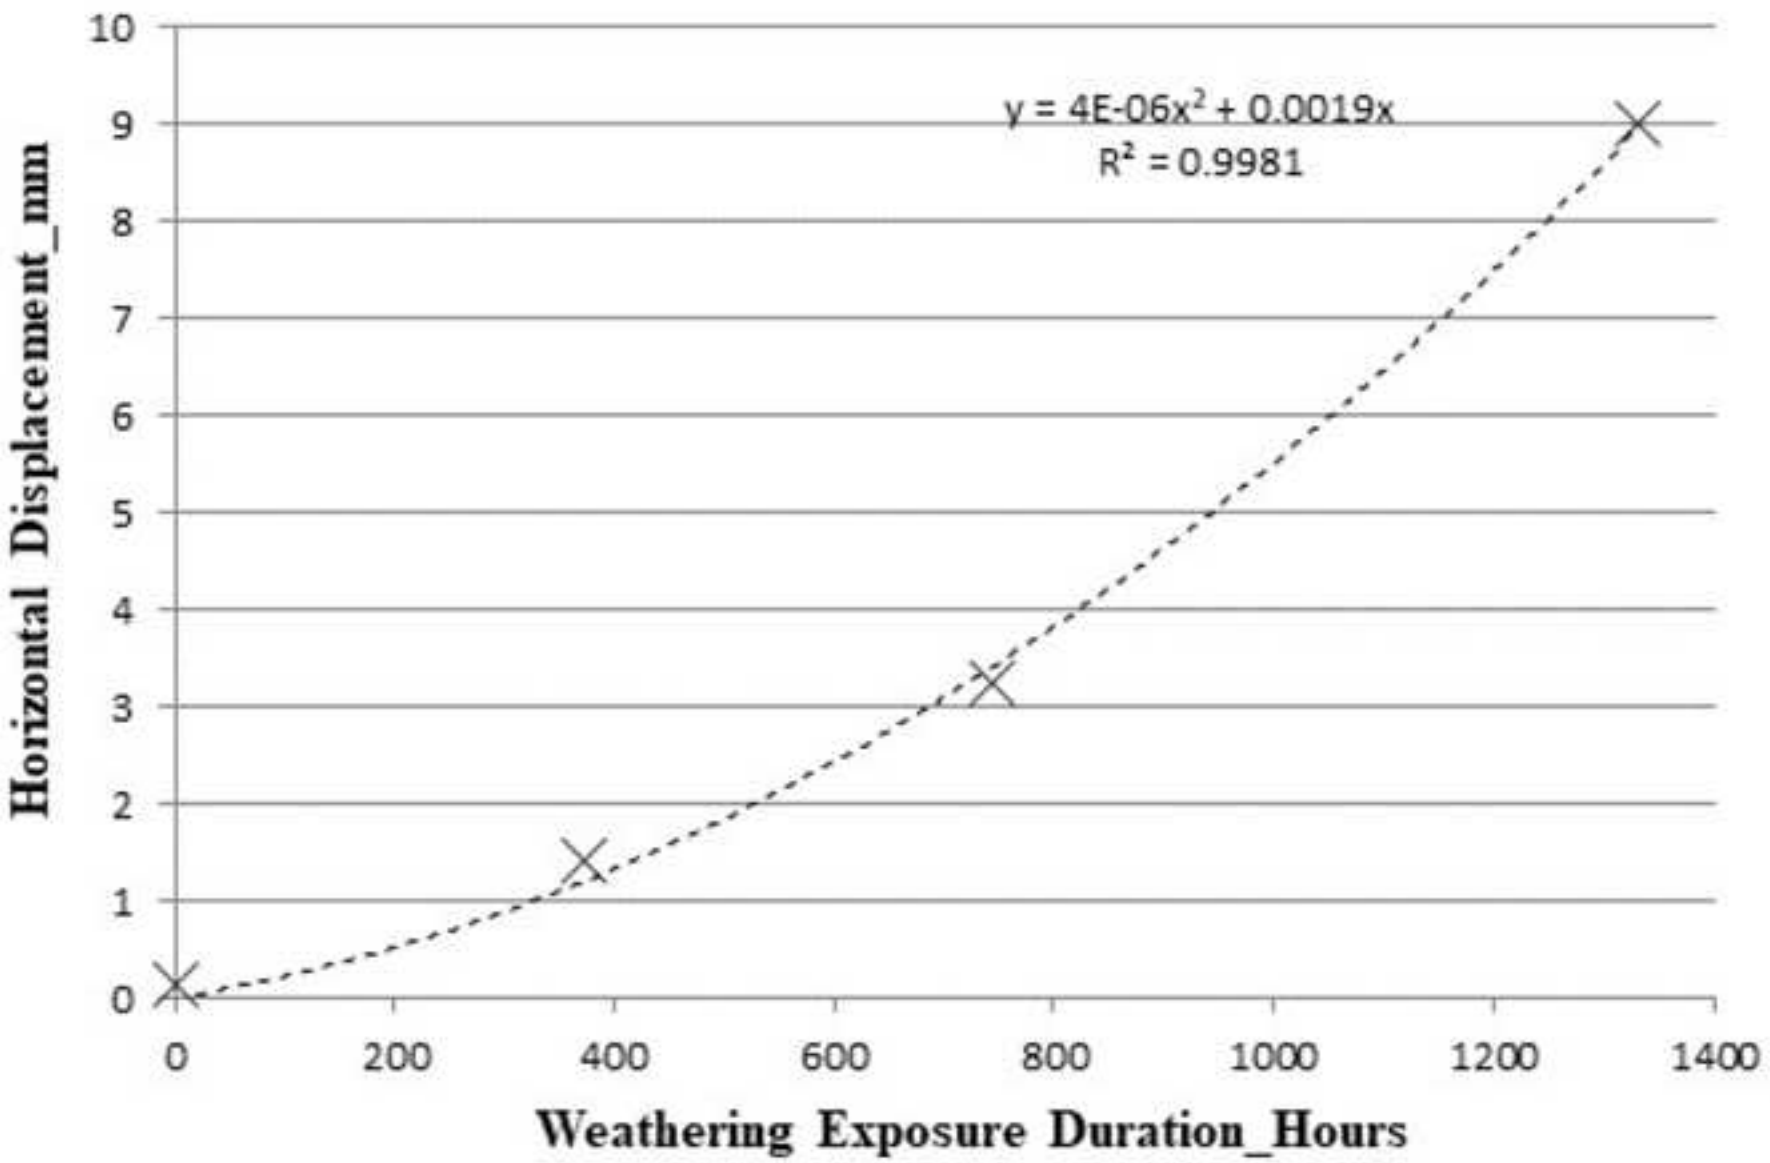
584 recorded, and after 200 cycles, 3.25 mm. In the case of Frame 4 where the wetting
585 and drying was extended with longer drying periods, this displacement had increased
586 to 9mm.
587
588 This trend is shown in Figure 18 where the displacement is correlated with the total
589 test duration in hours, which was used in order to derive a single measure of hazard
590 severity that could be applied to the different weathering simulations. A second order
591 polynomial relationship is fitted to the data, and highlights that there is an increasing
592 rate of loss observed as the hazard increases, described by the upwards curve of the
593 trend line. Upwards trends in hazard severity as climate change further unfolds
