1 **Enhanced Composite Plate Impact Damage Detection and Characterisation using**
2 **X-Ray Refraction and Scattering Contrast Combined with Ultrasonic Imaging**

3 D. Shoukroun^{1,4}, L. Massimi¹, F. Iacoviello², M. Endrizzi¹, D. Bate³, A. Olivo¹, P. Fromme⁴

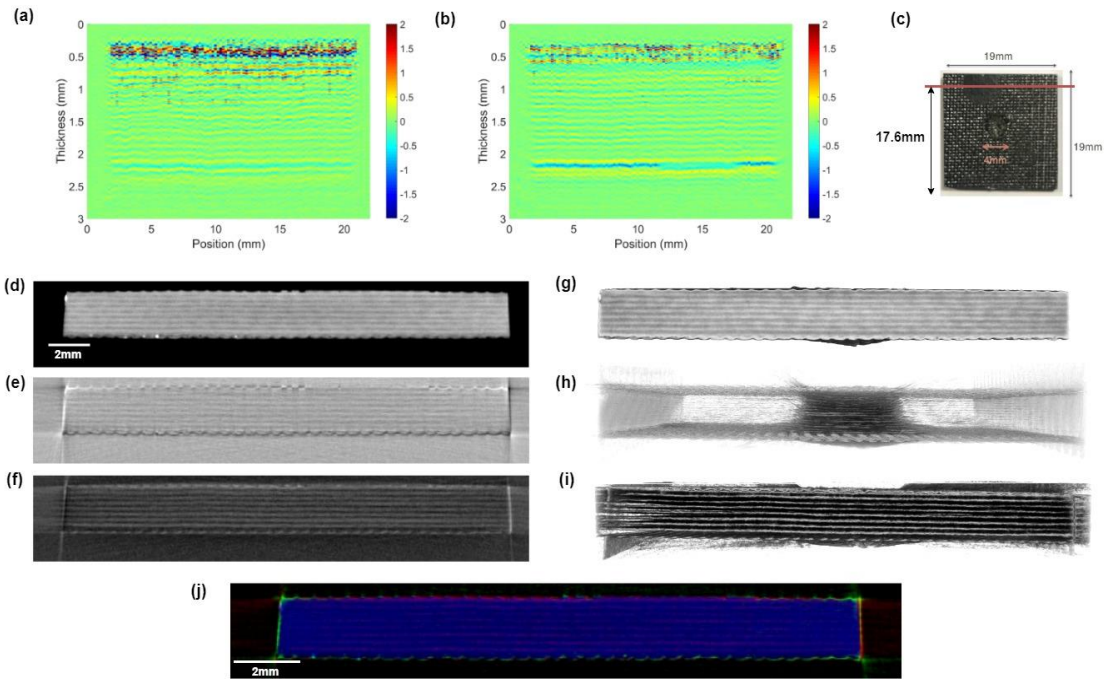
510 **Figure 5**

204 For an undamaged part of the composite sample, the ultrasonic B-scans (Fig.
205 5a/b) and the X-ray images (Fig. 5d/f) show reasonably uniform ply layers. The ultrasonic

206 B-scan images show strong reflection from the surface and back wall, with weaker
207 reflections from the inner plies. Due to surface unevenness, the reflection from the front
208 (impact side, Fig. 5a) is larger and more irregular than that from the back surface (Fig.
209 5b). The reflections from the inner plies in both B-scans indicate reasonably
210 homogeneous and aligned plies, but potentially with some waviness.

211 The matching X-ray absorption CT slice (Fig. 5d) shows contrast due to the cross-
212 ply layup of the sample, with regular plies visible. The contrast can be enhanced (Fig. 5g)
213 for the uneven sample surfaces to be observed better. Plies are clearly defined, with a
214 signal from the ply interfaces visible in the refraction image (Fig. 5e), with the intensity
215 of the intra-ply area matching the background grayscale. This points toward a
216 homogeneous distribution of plies and ply alignment. This homogeneity is more clearly
217 visible in the 3D rendering of the refraction signal in Fig. 5h, where the contrast was
218 adjusted to highlight the interfaces in the sample, resulting in a strong signal from the
219 surfaces of the sample and a lack of signal from the intraply area within the sample. The
220 only visible signal is due to the impact damage at the center of the sample, as opposed

222 The scattering images (Fig. 5f/i) show clear signals from the ply layer interfaces,
223 suggesting small, sub-pixel inhomogeneity. Figure 5e/f shows some imaging artefacts in
224 the CT reconstruction at the specimen edges due to the specimen shape. The 3 X-ray
225 retrieved images were superimposed in Fig. 5j to highlight the complementarity of the
226 signals. For the undamaged part of the sample, the edges are clearly visible, and an
227 indication of the ply layers can be observed from the absorption (blue) and scattering
228 signal (red).

472 **Figure 5:** Undamaged area of sample: ultrasonic B-scan with (a) front surface (indent)
473 and (b) back surface (protrusion) facing the transducer (colour scale signal voltage in
474 volts); (c) position of B-scans and cross sections within the sample; cross-section of
475 retrieved X-ray (d) absorption, (e) refraction, (f) scattering CT reconstructions; 3D
476 rendering of the sample for retrieved (g) absorption, (h) refraction, (i) scattering; (j)
477 superposition of the retrieved EI XPCi CT images with absorption (blue), refraction
478 (green), scattering (red).
