# The Collapse of World Trade Center 7: Revisited

Mhd Anwar Orabi<sup>1</sup>, Liming Jiang<sup>1,\*</sup>, Asif Usmani<sup>1</sup>, Jose Torero<sup>2</sup>

<sup>1</sup>*Research Centre for Fire Safety Engineering, Department of Building Environment and Energy Engineering,  
The Hong Kong Polytechnic University, Hong Kong*

<sup>2</sup>*Department of Civil, Environmental, and Geomatic Engineering, University College London*

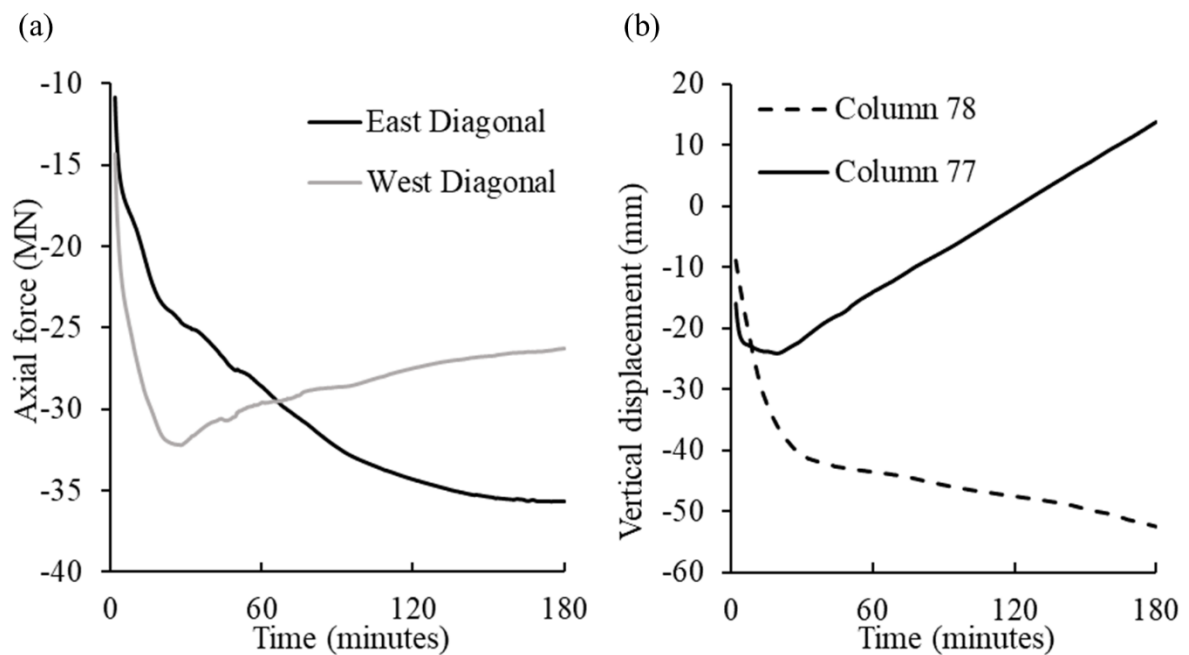
Fig. 11. Thermomechanical response of Truss 2 (a) axial force in the diagonal members, and (b) deflections of columns 77 and 78

The thermomechanical analysis was run twice: once assuming the diagonals were protected with 22 mm of SFRM, and once assuming they were left unprotected. With the protected diagonals, the transfer structure did not fail. Multiple unessential members, such as the lateral beams of the transfer structure, buckled. However, their failure did not compromise the overall stability of the structure. Maximum deflections reached during the heating phase of the fire were up to 0.97 m in the east of the mechanical floor. The axial force in the diagonal members against time is plotted in Fig. 11 (a), and the displacement of columns 77 and 78 are shown in Fig. 11 (b). The western diagonal axial force appears to unload, but no large out-of-plane deformations were recorded in it thus ensuring that it did not fail in buckling. This indicates that the reduction in its load is due to the longer eastern diagonal member taking on more of the load and thus effectively unloading it. The diagonals push column 77 upwards as seen in Fig. 11 (b) and thus the axial forces they are subjected to is limited by the vertical load of the column. The tip of column 78, which is supported by MG-23, deflects downward because the girder is thermally bowing due to its thermal gradient. The bottom flange of the built-up girder pushes against the connection between the hanger and column 77, which offers a significantly lower restraint than that provided at the seventh floor by the slab and floor framing, thus allowing the thermal gradient effects

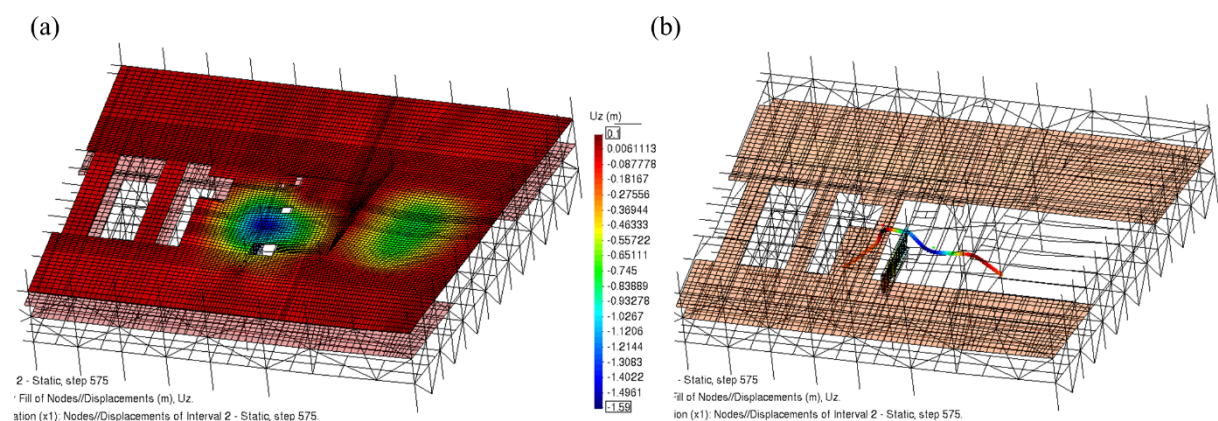
Fig. 12. Deflections due to Truss 2 failure (a) displacement in the slab of floor 7, and (b) buckled transfer structure

Assuming the diagonal members were unprotected, their average temperature would rise to about 300 °C in 15 to 20 minutes, and about 1100 °C after three hours. Model 1 was analysed again under this condition, which results in the deflections shown in Fig. 12 (a), caused by the buckling of the diagonals as shown in Fig. 12 (b). The maximum displacement at the tip of column 77 was 1.59 m. It is noted from Fig. 12 (a) that the vertical deflections are skewed west (deflected surface approaches column line 80-81) but are otherwise centred around column 77 which lost its support. The fixed conditions at the western edge of the model do not affect the overall deflected shape as the thermally-induced deflections near the edge and away from the fire are negligible. The deflections in the east bay of the building were caused by the thermal loading which continued up to about 120 minutes. The thermomechanical analysis was terminated after two hours of heating because the transfer truss had failed resulting in a dynamic collapse event that will be analysed using Model 2.

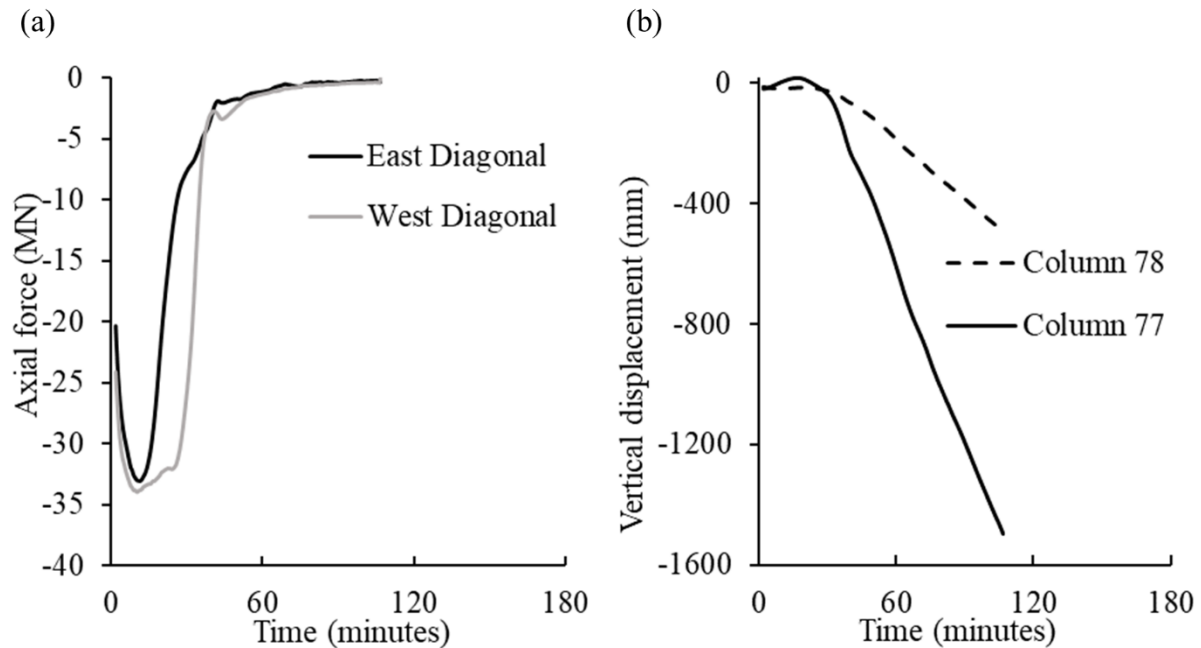
Fig. 13. Response of Truss 2 members and supported columns (a) axial forces in diagonal members, and (b) vertical displacement of columns 77 and 78

The buckling of the diagonal members of the transfer structure is indicated clearly by the axial force developed in them as shown in Fig. 13 (a). The axial force reached about 34 MN in the east diagonal after ten minutes and then was followed by buckling of the west diagonal member some 20 minutes later. Column 77 initially deflects upwards as shown in the vertical displacement of the column tops in Fig. 13 (b). Soon after, however, it began to fall rapidly reaching a maximum deflection of nearly 1.6 m in what is dynamically about 0.5 s but over 1.5 hours of fire pseudo-time. Column 78, partially supported by column 78A (see Fig. 4), had a lower deflection rate but also appears to have failed.

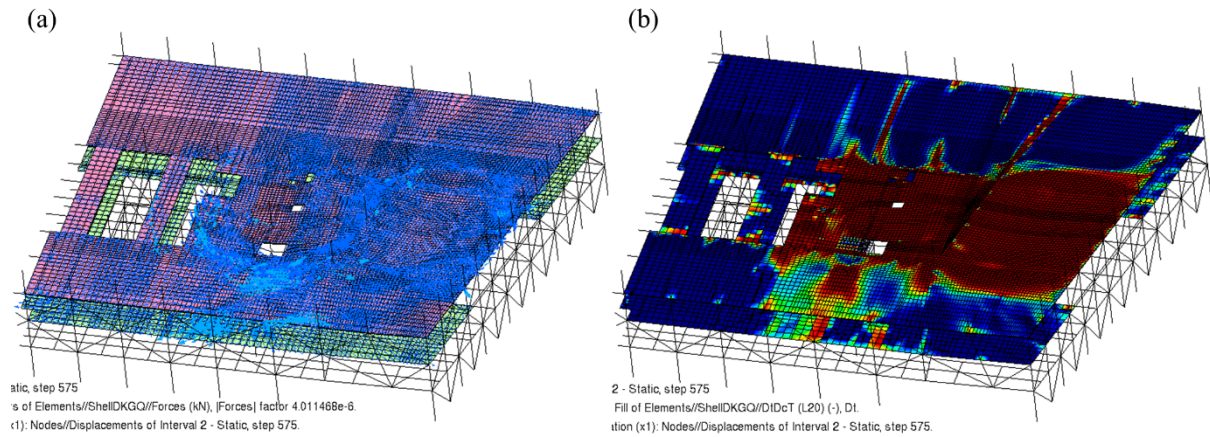
Fig. 14. response of the slab to the failure of Truss 2 (a) tractions, and (b) compressive damage in the top concrete layer

As the truss failed, the slab resisted the failure by adopting a compressive ring around the failed region as shown in Fig. 14 (a). Another compressive ring is formed about the heavily heated eastern bay. The concrete damage indices of the top layer of the slab presented in Fig. 14 (b) show that it has cracked within the heated region. Tensile damage also accumulated over the end of the girder MG-23 and towards the south edge of the building.

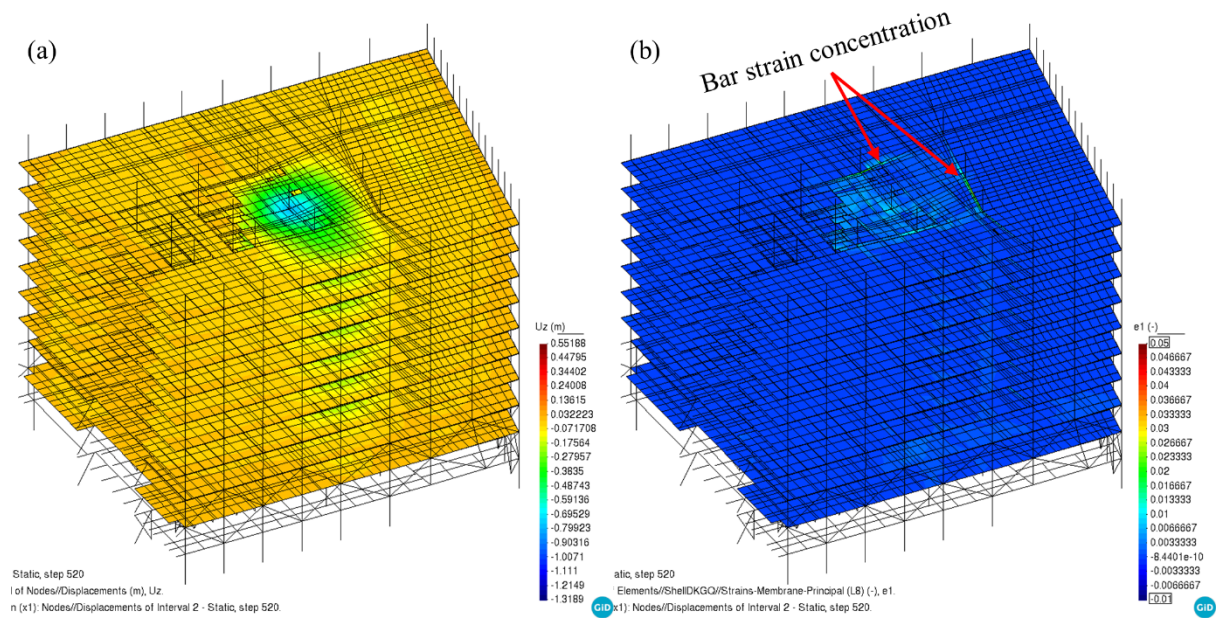
Fig. 15. Model 2 simulation results (a) vertical deflections, and (b) strain in the reinforcement layer

The destabilisation of column 77 due to the failure of Truss 2 is resisted by the floor framing and slabs on all floors above. Despite this, the 17.5 MN load applied to the top of column 77 and loss of the main support provided by Truss 2 caused the deflections shown in Fig. 15 (a). The failure propagated from the failed transfer structure up to the 14<sup>th</sup> floor slab as the figure shows and caused floor deflections in the order of 0.8 m after 2 seconds. Naturally, the deflection of the floor is cantered over the failed transfer structure and columns 77 and 78. The large deflections in the core caused strain concentrations in the floor reinforcement bars over the east and north edges of the core. This is shown in Fig. 15 (b) which visualises the first principal strain in the J2 reinforcement layer.

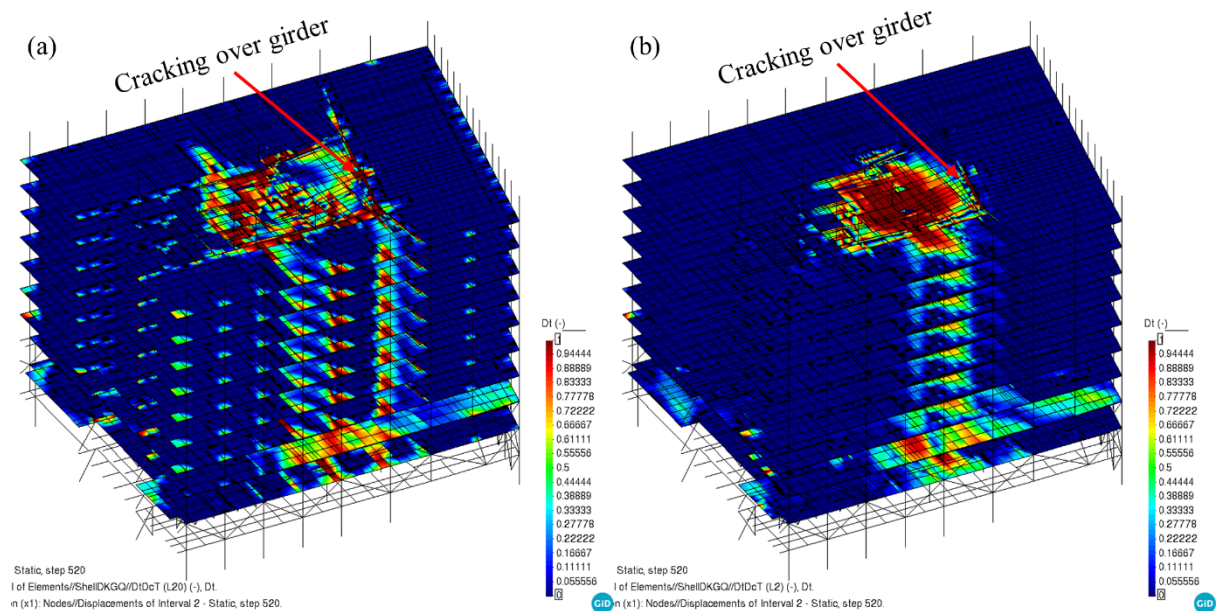
Fig. 16. Tensile damage in slab (a) top concrete layer, and (b) bottom concrete layer

Likewise, the concrete of all floors cracks over the girder at the edge of the core, as well as within the region supported by columns 77 and 78. Fig. 16 (a) and (b) show the tensile cracking in the floors using the damage indices of the concrete damage plasticity material. The cracking of both the bottom and top concrete layers at the edge of the core, and the concentration of the reinforcement strain at this location indicates that the slab may be susceptible to failure at this location.
