## HYBRID EEFIT MISSION TO FEBRUARY 2023 KAHRAMANMARAŞ EARTHQUAKE SEQUENCE

**Abstract:** *The southwestern part of Türkiye was hit on 6 February 2023 by an Mw 7.8 (epicentre: Pazarcık) and then an Mw 7.5 earthquake (epicentre: Elbistan). The event was followed by tens of thousands of aftershocks including the Mw 6.3 event on 20 February (epicentre: Uzunbağ). This paper reports on the preliminary findings of the mission organised by the UK's Earthquake Engineering Field Investigation Team (EEFIT) to the Kahramanmaraş Earthquake sequence of February 2023. This mission followed a hybrid model, combining field and remote investigation techniques, to investigate the characteristics of the earthquake sequence, its impact on buildings and infrastructure, as well as the efficacy of relief, response and recovery operations. The key messages include that the building stock is hard to categorise which brings along difficulties with damage assessment, that the recovery and reconstruction require multi-sectoral engagement of key stakeholders, and that the auditing and quality control mechanisms within the construction industry need revisiting in the way forward for better disaster resilience i

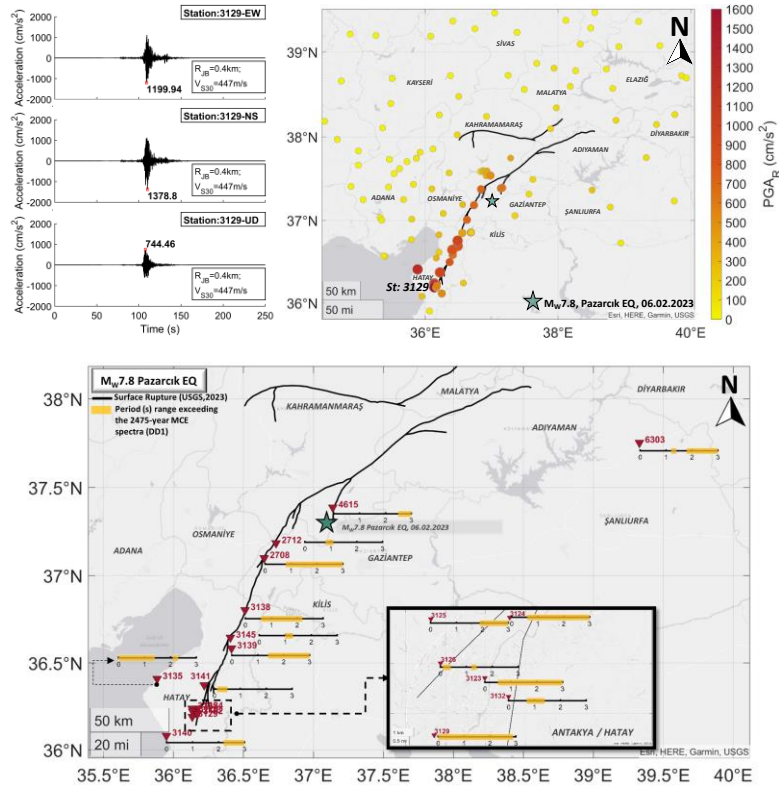
Strong ground motions of Kahramanmaraş earthquake sequences can be attributed to the peculiar source, path, and site characteristics, such as near-fault effects, multiple wave packages due to segmental rupture features, and basin effects, which result in high PGAs in both horizontal and vertical directions, high pulse-like velocities, large spectral accelerations at specific periods etc. The spatial distribution of resultant peak ground acceleration ( $PGA_R$ ), which is one of the most frequently employed indicators for rapid assessment of the extent of shaking, is illustrated in Figure 1 along with the largest horizontal acceleration time histories ( $PGA_{3129,NS}=1379 \text{ cm/s}^2$  in an Antakya basin station) for  $M_w7.8$  Pazarcık event.  $M_w6.3$  Uzunbağ event also yields the largest

ground motions in one of the Antakya basin stations ( $PGA_{3125,EW} \approx 769 \text{ cm/s}^2$ ) as well. In  $M_w7.5$  Elbistan event, which predominantly impacts the region's north, the closest station to the fault rupture (station 4612) produces  $636 \text{ cm/s}^2$  in the East-West component. Due to the extensive rupture length of particularly  $M_w7.8$  and  $M_w7.5$  events (350–400 km in the case of the  $M_w7.8$  earthquake and 150–200 km in the case of the  $M_w7.5$  earthquakes), the Joyner–Boore distance ( $R_{JB}$ ), which is defined as the closest horizontal distance to the vertical projection of the rupture surface, yields more meaningful evaluation. The stations positioned nearby the fault ruptures (small  $R_{JB}$ s) give significant PGA values as exemplified for the  $M_w7.8$  event in Figure 1(top).

Figure 1. (top) Geographic distribution of resultant peak ground accelerations (PGARs) with respect for  $M_w7.8$  Pazarcik event (bottom) Geographic distribution of stations with period ranges of exceedances of MCE level design spectra of 2018 Türkiye building earthquake code (TBEC 2018) for  $M_w7.8$  Pazarcik event. (black lines on the maps correspond to the surface rupture given by USGS).

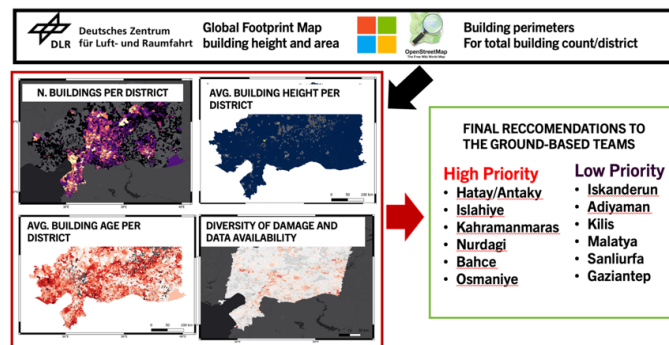
Figure 8. Actionable products generated for delineating the top six high and low priority areas for the EEFIT Türkiye remote sensing mission.

The activities of the RS team resulted in the identification of six high-priority areas where a variety of buildings are located and are highly diversified by height, building age and spaceborne damage maps (Figure 8). These six high-priority AOIs are: Hatay/Antakya, Islahiye, Kahramanmaraş, Nurdagi, Bahçe, and Osmaniye. Additionally, the team was asked to produce a list of six low-priority AOI that presented a lower diversity of damage and building characteristics. These low-priority AOIs are located close to the six high-priority areas and could simplify the logistics of the ground-based team.
