1 **Damage to monumental masonry buildings in Hatay and Osmaniye following the 2023 Turkey earthquake sequence:**
2 **the role of wall geometry, construction quality and material properties**

16
17 **Abstract** This paper reports on the findings of an investigation on 29 historic stone masonry buildings located in the cities of
18 Hatay and Osmaniye following the 2023 Turkey earthquake sequence. The earthquake couplet on 6 February (with moment
19 magnitudes 7.8 and 7.5) and the following events (including another earthquake which occurred on 20 February with a moment
20 magnitude of 6.3) resulted in significant damage to the buildings. To understand why, the examined buildings were assigned an
21 EMS-98 damage level (ranging from 1 to 5) and descriptive response categories (masonry disaggregation, local mechanism and
22 global response). Overall damage statistics indicated that masonry disaggregation was common and coterminous with local
23 mechanism response. Wall geometry and construction quality indices were then investigated to explore why these were the
24 dominant damage mechanisms. Wall geometry indices highlighted insufficient amount of walls to resist the local seismic

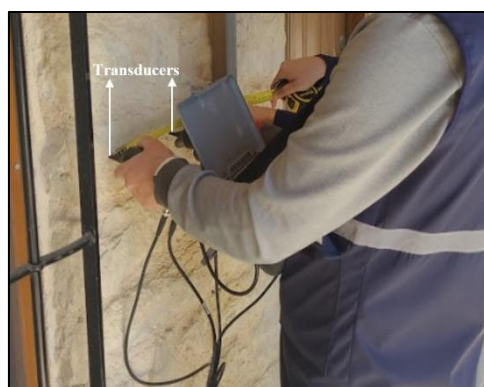
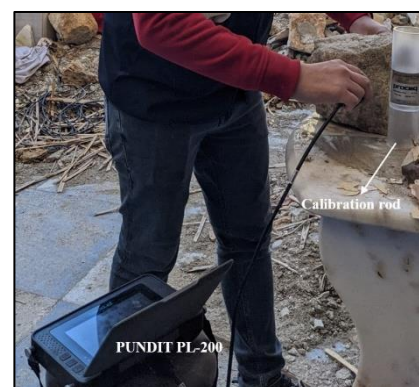
361 When measuring stones in-situ, UPV tests were performed using indirect transmission (Fig.8a). The direct transmission
362 technique was used when measurements were conducted on loose stones (Fig.8b). PUNDIT PL-200 testing device with 54 Hz
363 exponential transducers were used. The exponential transducers were preferred as they can conduct measurements on rough
364 surfaces without coupling agents (Wróblewska et al., 2021). The UPV device was calibrated regularly (e.g. when the subject
365 wall or building changed) using the special calibration rod (see Fig.8b) to minimize measurement errors. The velocity
366 measurements were repeated three times and averaged to obtain V_p .

369 Fig.8. a) Indirect UPV measurement on an in-situ stone from R4, and b) direct UPV measurement on a disaggregated stone from
370 C3

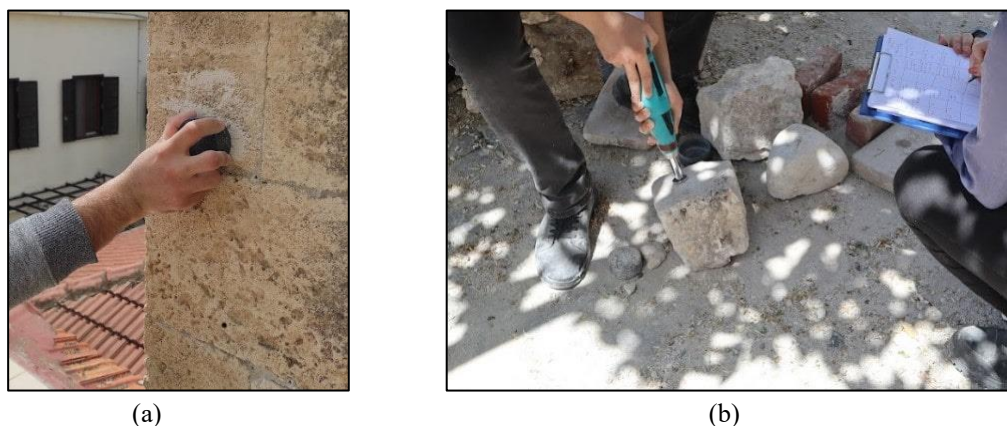
402 Fig.9. a) Preparing phase of a stone for SRH test in building C2 b) SRH measurement on a stone from a collapsed wall of M1

403 Before applying the SRH, the surface of the stones is cleaned with polishing tool (Fig.9a). Fig.9b shows the SRH test being
404 performed on a loose stone sample. Ten readings were obtained by conducting rebound measurements in small area. Readings
405 are averaged to obtain the Q value that is used to calculate the compressive strength of stone (f_s):

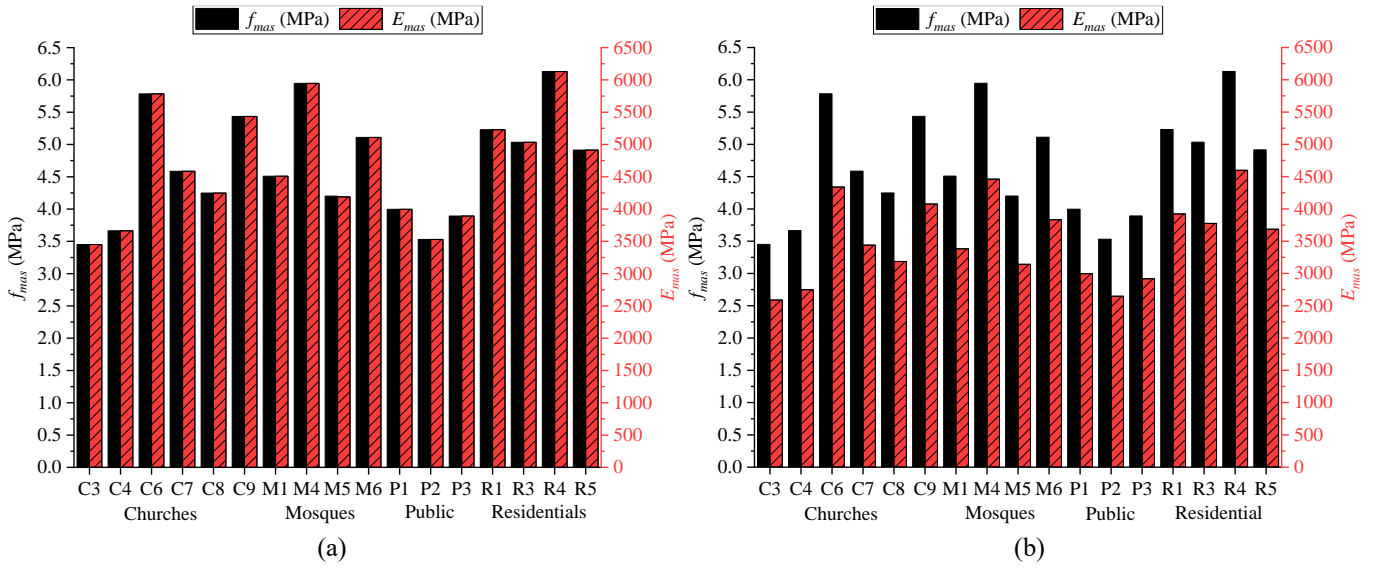
Fig.12. Compressive strength and elastic modulus values for masonry a) using EC6 equations b) using TBEC2018 equations

Using Eqs.(10-11), the f_{mas} and E_{mas} values are calculated. These are presented in Figs.12a-b for EC6 and TBEC (2018). f_{mas} ranges between 3.4 and 6.2 MPa according to EC6 and TBEC (2018), while E_{mas} varies between 3450-6130 MPa and 2585-4600 for EC6 and TBEC (2018), respectively.
