Lessons Learnt From the 2009 Padang Indonesia, 2011 Tōhoku Japan and 2016 Muisne Ecuador Earthquakes

Keywords: earthquakes, Padang, Tōhoku, Muisne, buildings, foundations, landslides, geospatial tools

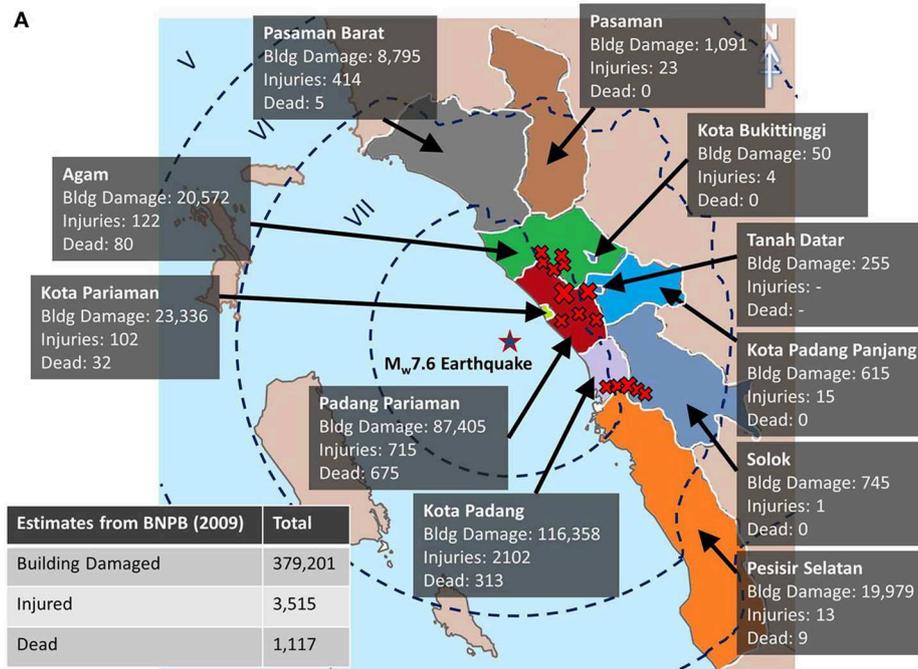
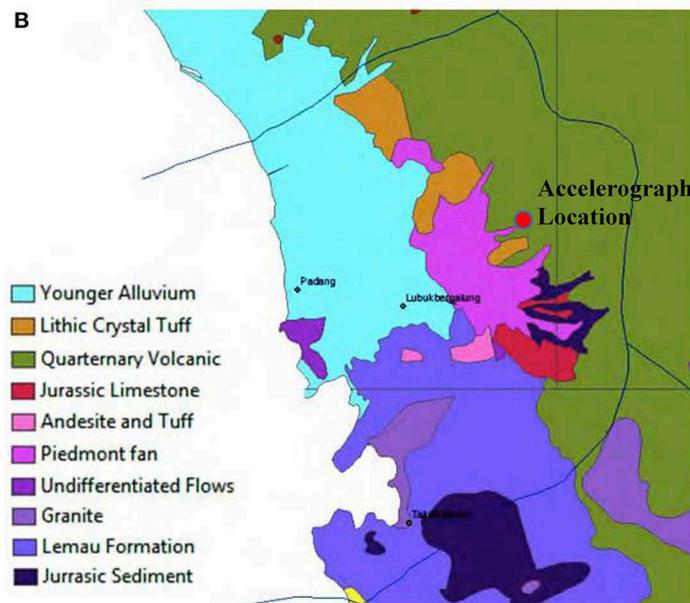
Damage to buildings and human casualties in each affected district are shown in **Figure 1A**. The distribution of the damage agreed with the degrees of shaking estimated based on the Modified Mercalli Intensity (MMI) by the USGS, with populous districts near the coast suffering the heaviest damage. These low-lying coastal areas and settlements are located on young alluvium sediment (**Figure 1B**) are expected to amplify shaking, considerably leading to higher damage to infrastructure. In the uplands, steep slopes and weathered Quaternary volcanic sediments are highly prone to landslides in periods of heavy rainfall or under seismic shaking.

FIGURE 1 | Location and geological map of Padang. **(A)** Distribution of losses and MMI scale felt in the district of Padang [after Badan Nasional Penanggulangan Bencana (BNPB), 2009; United States Geological Survey (USGS), 2010a]. **(B)** Geological map of Padang (ESDM, 2009).

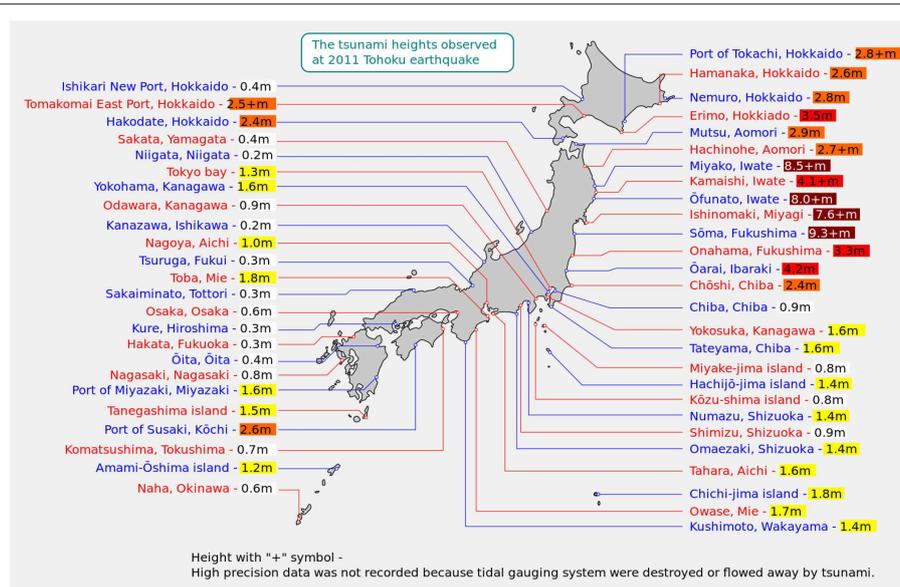
The earthquake triggered a large tsunami along the Tōhoku coast as indicated in **Figure 2** [Japan Meteorological Agency (JMA), 2013], which damaged hundreds of kilometers of sea defenses and more than 900,000 buildings in Iwate, Miyagi, Fukushima and Ibaraki Prefectures (Ministry of Land Infrastructure Transport and Tourism, 2011). More than 129,000 buildings were completely destroyed and 264,000 partially

FIGURE 2 | Tsunami affected locations along the east coast of Japan [Japan Meteorological Agency (JMA), 2013].

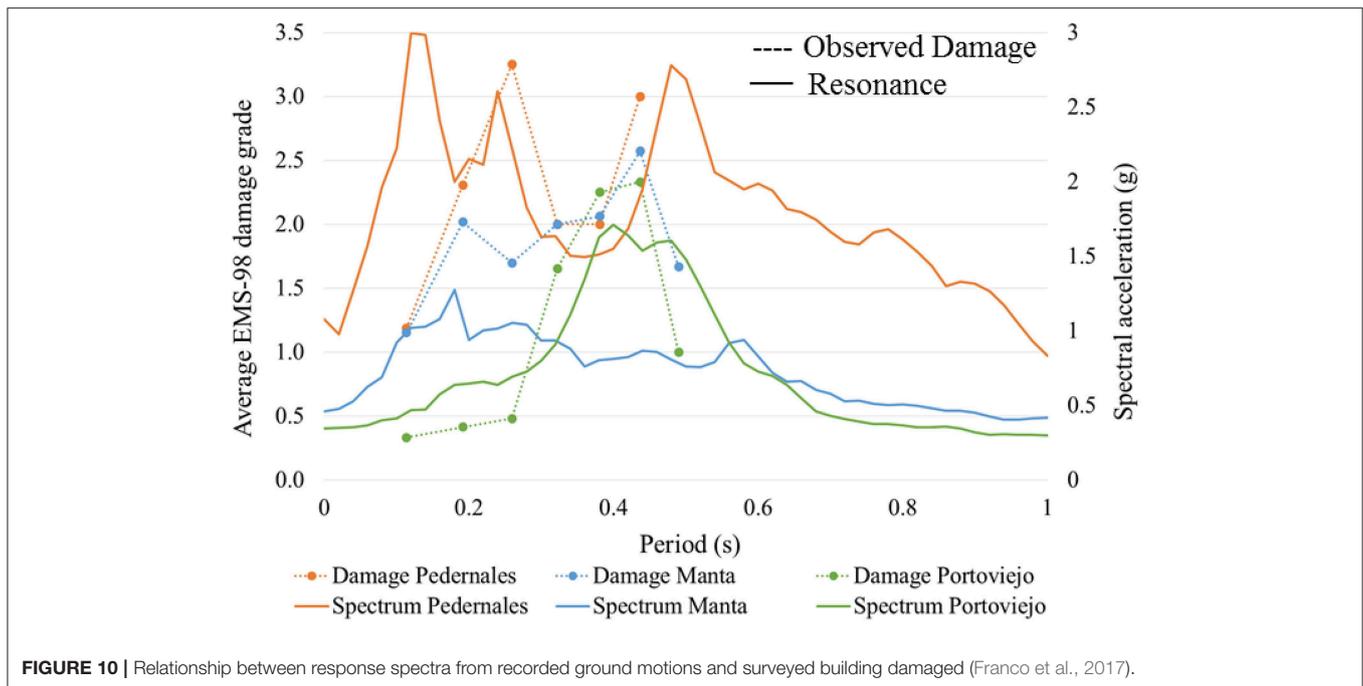
Figure 10 compares the spectral accelerations recorded at stations in Pedernales, Manta, and Portoviejo, with the average damage grades of RC and timber/bamboo structures of different fundamental periods estimated based on their typology and height. It can be observed that higher grades of damage generally coincide with higher spectral acceleration of the shaking in

Pedernales, Manta and Portoviejo at similar periods. This confirms damage attributed to structural resonance which is in line with findings in Padang and Tōhoku earthquakes. Significant damage was observed for two- to five-story buildings at Pedernales which coincides with the dominant periods of 0.2 and 0.5 s. Similarly, two- to four-stories buildings were observed to be most heavily damaged at Manta and Portoviejo, respectively which coincides with young Quaternary sediments according to the geological map in **Figure 3B**. In contrast, high-rise buildings >10 stories were most affected at Chone where dominant shaking period was 1.3 s. It is worth noting that earlier versions of the seismic code in Ecuador (e.g., Código de Práctica Ecuatoriano, 2001; CPE INEN 5:2001) were based on US seismic codes of the time (e.g., Uniform Building Code, 1997). The latest version has been updated in recent years (Norma Ecuatoriana de la Construcción, 2015), maintaining however the manner in which seismic actions are derived. Microtremor recording using a TROMINO Zero[®] instrument, non-invasive, passive geophysical method, was conducted at several locations in Manta, Portoviejo, Pedernales, and Bahia to ascertain the fundamental frequency and shear wave velocity profiles for each site for site response analysis. The method is based on measuring ambient seismic noise and translating it through time domain

FIGURE 10 | Relationship between response spectra from recorded ground motions and surveyed building damaged (Franco et al., 2017).

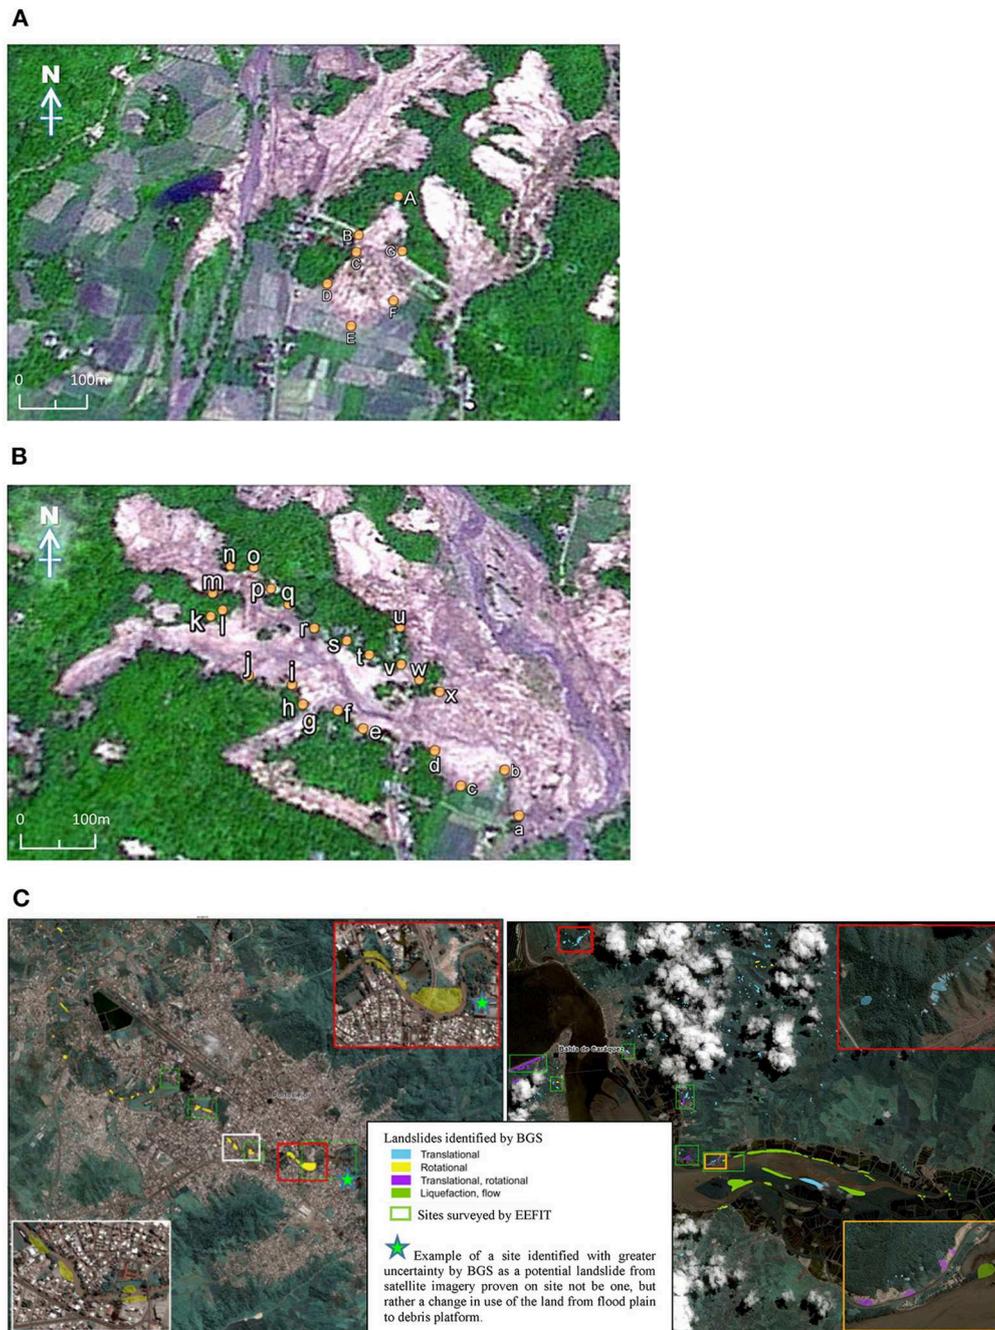
FIGURE 15 | Landslides in Sumatra and Ecuador identified from satellite imagery. **(A)** Locations of Landslide I boundary points at Pariaman, superimposed on SPOT-5 satellite image, acquired by Center for Remote Imaging, Sensing and Processing, National University of Singapore. **(B)** Locations of Landslide II boundary points at Pariaman, superimposed on SPOT-5 satellite image, acquired by Center for Remote Imaging, Sensing and Processing, National University of Singapore. **(C)** Landslide in Ecuador identified from satellite imagery, left: Portoviejo; right: Bahia de Caraquez (British Geological Survey, 2016a,b).

90 m in spatial resolution. Landslide *I* (a small landslide at Pulau Air Village, **Figure 15A**) and Landslide *II* (a large scale landslide at Cumanak Village, **Figure 15B**) were selected to: (1) assess repeatability between different data sources, (2) ascertain any influence the size of landslide may have on the deviation
