RECONNAISSANCE OBSERVATIONS BY CIGIDEN AFTER THE 2015 ILLAPEL, CHILE EARTHQUAKE AND TSUNAMI

Abstract

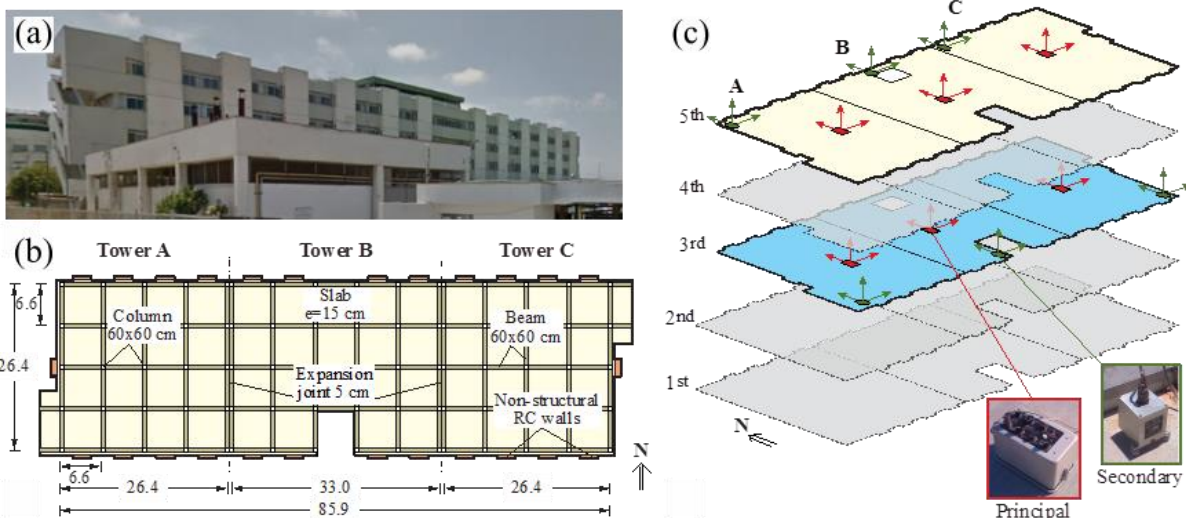
Part of the reconnaissance team performed an instrumentation campaign at the Coquimbo hospital with the objective to measure the dynamic properties of the structure and estimate the effects of the earthquake, particularly on building vibration periods. Ambient vibrations and aftershock instrumentations were deployed in the hospital, finding a period elongation relative to a previous measurement. The hospital is composed by three independent 5-story towers, each of them based on a RC beam-column frame system (60x60 cm) arranged on a regular square grid of 6.6 m in plan, combined with RC non-structural walls located around the perimeter of the floor plan, and concrete partition walls (Fig. 6b).

Fig. 6 – (a) General view of the Hospital, (b) structural plan view of 5th floor (units in meters), and (c) sensor layout in building and sensors used

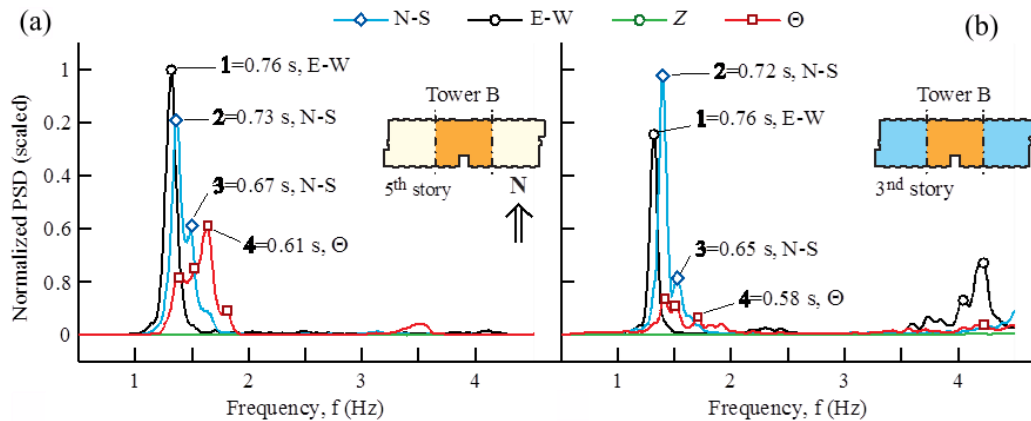
The recorded accelerations were base-line corrected and filtered to remove spurious noise. Power Spectral Density (PSD) spectra were computed for lateral N-S, E-W, vertical (Z), and torsional (Θ) components. To identify the predominant direction and comparable measurements between directions, a normalized PSD was used [15]. Figures 7a and 7b show the normalized PSD of Tower B at stories 5 and 3, respectively, where the first 4 modes are clearly identified. It is observed that the 5th and 3rd stories have similar fundamental periods and the modal direction coincide for the first 3 modes, which is also observed for towers A and C. Indeed, the maximum difference between 5th and 3rd story periods is 4.2%. Close values in lateral and torsional modes (modal tuning) and lateral-torsional coupling are also observed. Additionally, the 3rd story spectra in Tower B (Fig.7b) shows non-negligible PSD near 4 Hz, which is also observed for measurements in towers A and C. This effect may be due to ambient vibrations such as human operations, elevators, highways (Route 5), and railway line close to the building, which pulses are stronger in lower stories.

Fig. 7 – Normalized Power Spectral Density (PSD) of recorded ambient vibrations measured by sensors at (a) 5th story; and (b) at 3rd story of tower B, in N-S, E-W, Z and Θ -directions
