P. Fromme, "Composite structures defect imaging," Proc. SPIE 10600, Health Monitoring of Structural and Biological Systems XII, 106000C (27 March 2018); doi: 10.1117/12.2294522

# Composite Structures Defect Imaging

## ABSTRACT

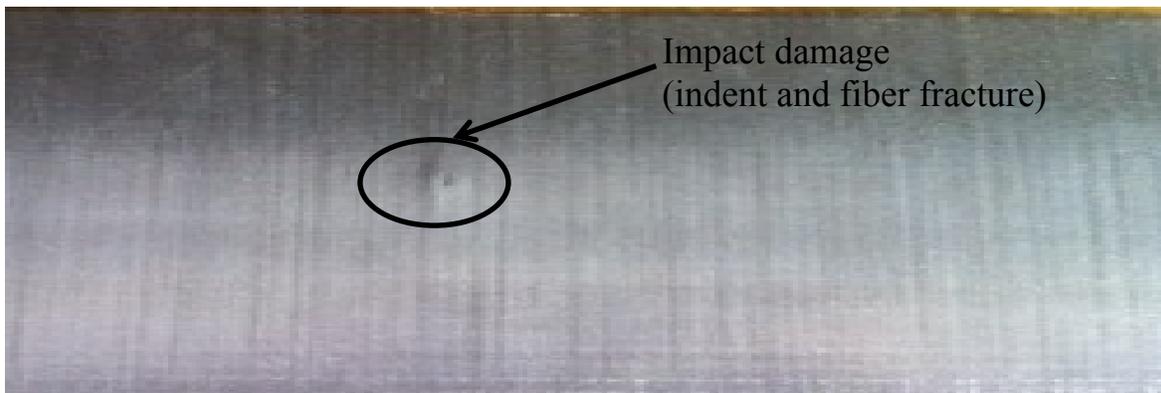
Figure 1: Composite specimen with barely visible impact damage (indent and fiber fracture) marked.

Two cross-ply composite specimens had been manufactured and previously studied by the Composite Systems Innovation Centre at the University of Sheffield, UK [1]. The specimens (990 mm x 110 mm) were manufactured using unidirectional pre-pregs (Cytec 977-2/ Tenax HTS) and autoclave curing. The specimens consist of 8 pre-preg layers with a symmetric, cross-ply layup sequence of  $[0/90]_{2s}$ , resulting in an overall specimen thickness of 2 mm. Using standard drop weight impact procedures, impact damage in one of the specimens had been generated using a standard drop weight impact (7.4 J energy, hemispherical 15 mm impactor head). Some limited indentation and fiber fracture on the impacted plate was observed (Fig. 1).

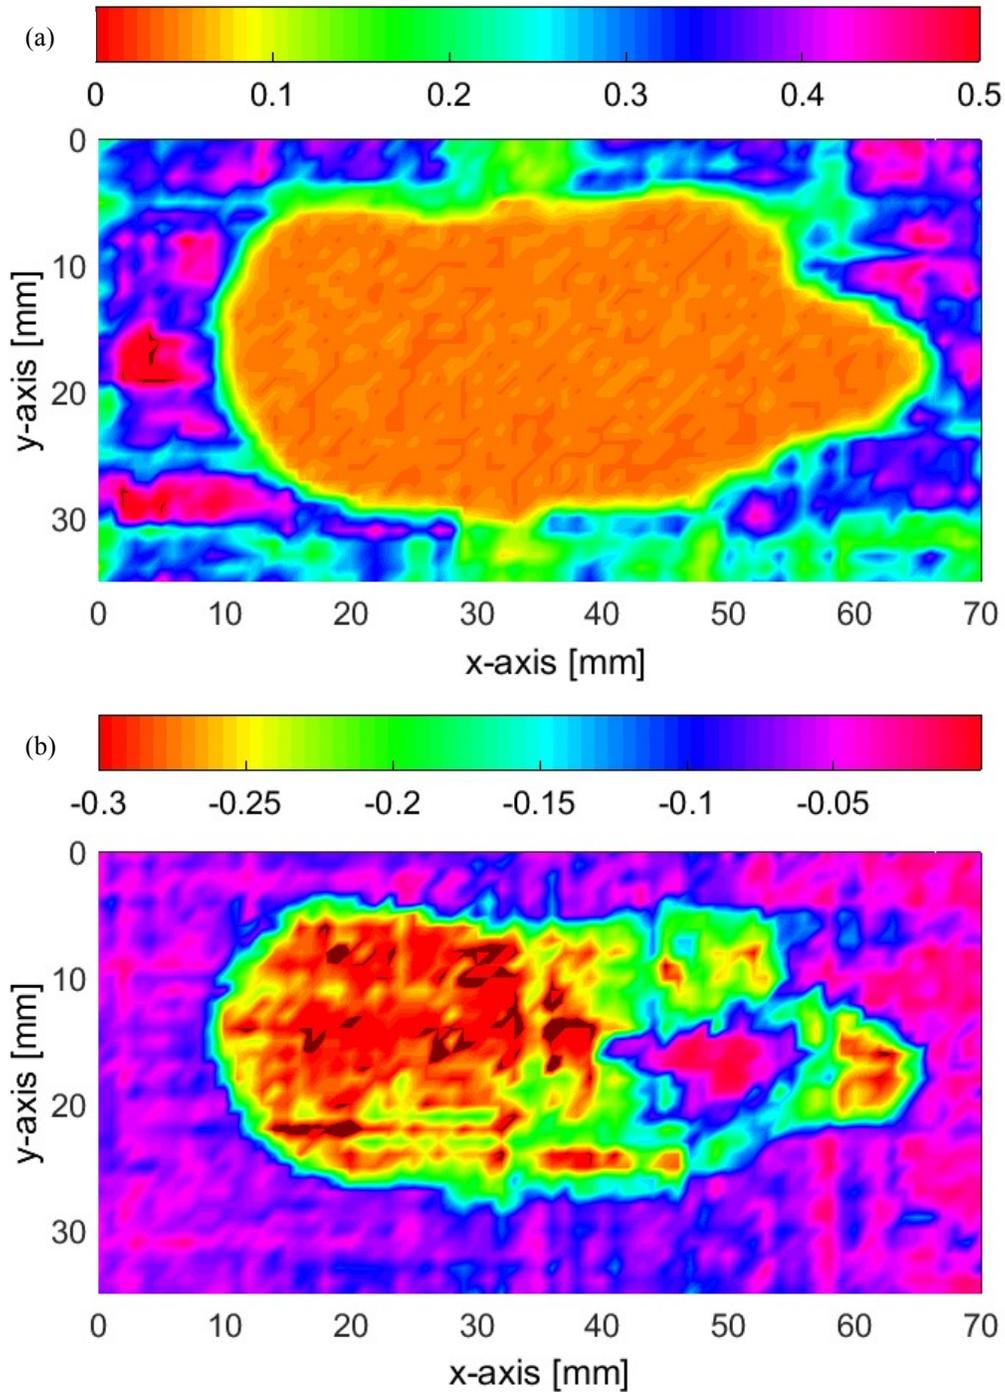
Figure 2: Color-coded ultrasonic immersion C-scan images of damaged composite specimen (scan area: 70 mm x 35 mm, step size: 1mm); maximum amplitude of ultrasonic signal, 10 MHz immersion transducer: (a) double-through transmission; (b) pulse reflection.

Figure 2 shows the images obtained from the double-through transmission (Fig. 2a) and pulse reflection (Fig. 2b) immersion C-scans of the damaged area. The center of the impact was located approximately at  $x = 50$  mm,  $y = 20$  mm. The resulting image for the double-through transmission (Fig. 2a) shows the delamination area (extent about 60 mm in  $x$ -direction, 25 mm in  $y$ -direction) with consistent low amplitude (orange) due to the interruption of the wave propagation. Within the area of higher amplitude (blue-purple) around the delamination, a pattern due to variations in the ultrasonic transmission and reflection linked to the internal structure and surface of the specimen can be discerned. Furthermore, vertical and horizontal lines of lower amplitude (yellow-green) at distinct locations can be seen, which might indicate damage extending along the fiber orientations for the cross-ply composite plate.

The image showing the amplitude of the reflection C-scan is shown in Fig. 2b. The delamination area can be seen as the increased reflected signal (red-blue, negative amplitude), matching quite well the area found from the double-through transmission C-scan (Fig. 2a). The small, visible surface impact damage (Fig. 1) corresponds to the lower amplitude (around  $x = 55$  mm,  $y = 25$  mm), which is not at the center of the delamination area. Similar to the double-through transmission image, some pattern in the area around the delamination can be observed (pink), which corresponds to variations of the composite structure. The wavelength corresponding to the transducer frequency (10 MHz) was not small enough to allow resolution of the individual ply layers.

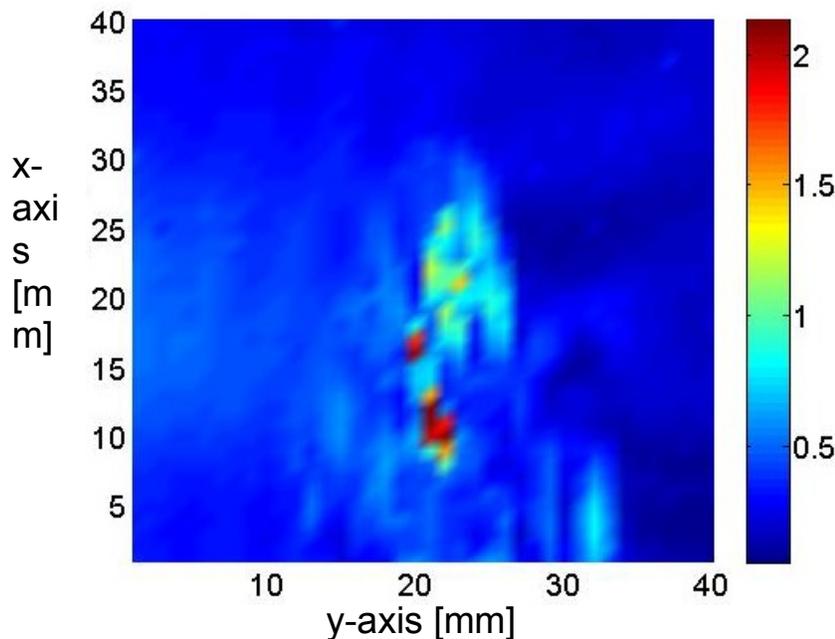
Figure 3: Guided wave amplitude, area around impact damage; fundamental  $A_0$  mode, 100 kHz excitation center frequency; 1 mm step size in both directions; maximum amplitude of time trace.

Figure 3 shows the amplitude of the guided wave field, scattered at the impact damage, with the incident wave propagating from left to right ( $y$ -direction). The scattered field shows an irregular area and pattern of high amplitudes, coinciding with the visible, small indent and center of the delamination. The area of higher amplitudes corresponds reasonably well with the delamination area observed from the ultrasonic immersion C-scans (Fig. 2, rotated by 90 degrees). A significant drop of the amplitude of the guided wave field behind the impact damage ( $y = 30$ -40 mm) compared to the incident amplitude ( $y = 0$ -10 mm) can be observed. This can be correlated to the scattering of the incident guided wave at the impact damage, with limited transmission beyond the defect. As the two ultrasonic methods employ significantly different wave propagation and frequencies, the interaction with the impact damage and thus sensitivity for specific damage mechanisms is different.

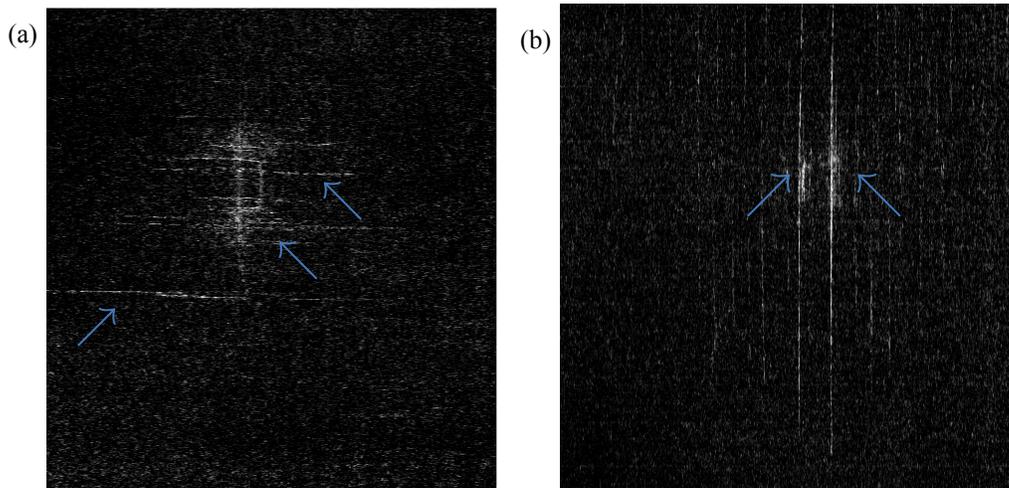
Figure 4: Dark-field X-ray images of composite damage: (a) horizontal; (b) vertical orientation of specimen.

The dark-field EI phase contrast images of the damage location are shown in Fig. 4. No dye penetrant was used for the X-ray imaging. The two images were obtained for rotation of the composite specimen by 90°. The phase contrast imaging is sensitive to the damage orientation relative to the mask. In both images, impact damage can be seen, and is highlighted by the arrows. As the X-ray imaging methodology is sensitive to the orientation, the two images show the extent of damage along the two fiber directions of the cross-ply composite specimen.
