1 **Characterisation of Local Damage in Pultruded GFRP Road Bridge Decks with**
2 **Random Fibre Mat Misalignments**

9 **Abstract:**

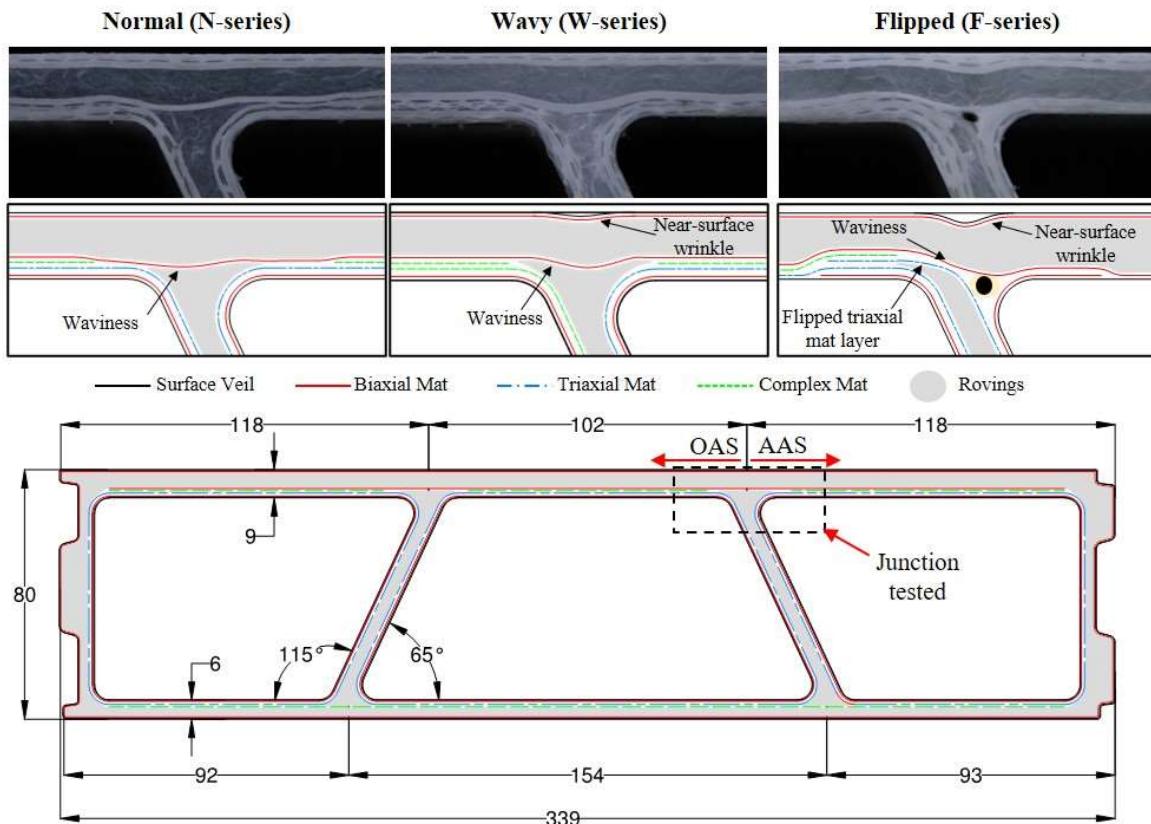
Figure 1: Geometry of GFRP deck with illustrations of the fibre mat positions

105 From resin burn-off tests, the fibre architecture was observed to comprise rovings, a surface veil, and
106 three types of mat: a triaxial mat with +45°, -45° and 0° fibre bundles, a biaxial mat with 90° and 0° bundles and
107 a complex mat that consisted of 90°/0° woven bundles stitched to a layer of continuous filament mat (CFM).
108 The unidirectional rovings formed a single, thick layer within the core of the material, and on the outer surfaces
109 there was a veil that consisted primarily of CFM and 0° bundles. The diagram at the bottom of Figure 1 shows
110 how these mats and rovings were arranged in the deck.

111 Tests were conducted only on the internal junction at the top of the right-hand inclined web, which is
112 labelled in Figure 1. Henceforth, the left- and right-hand sides of the junction as seen in Figure 1 are referred to
113 as OAS (obtuse angle side) and AAS (acute angle side), respectively. Junctions from *three* different pultrusion
114 batches were selected for testing, named Normal (N-series), Wavy (W-series) and Flipped (F-series), images of
115 which are shown at the top of Figure 1.

125 In the present study, three different categories of misalignment were observed within the selected
126 junctions, which are labelled in Figure 1: a flipped triaxial mat layer, a near-surface wrinkle at the top of the
127 junction, and waviness of the biaxial mat in the middle of the junction. The flip was only present in the F-series,
128 whereas the wrinkle and waviness were present to varying degrees in all three junction types. The scatter in
129 degree of wrinkling and waviness is presented in Section 4.1. Finally, the fibre layups were identical for each
130 junction, except for the W-series that, on the OAS side, had a complex mat in place of a triaxial mat layer.

100 Figure 1 shows the geometry of the GFRP deck used in this study, which is a rectangular unit that
 101 encloses two inclined webs to form three cells. The GFRP material consists of E-glass fibre mats and rovings
 102 embedded in an isophthalic polyester resin. This deck has been used in highway and pedestrian bridges around
 103 Europe, including a 73m span pedestrian bridge in Germany completed in 2019 [40]. The top flange of the deck
 104 is thicker (9 mm) than the bottom flange (6 mm) to provide adequate resistance to local tyre loads.

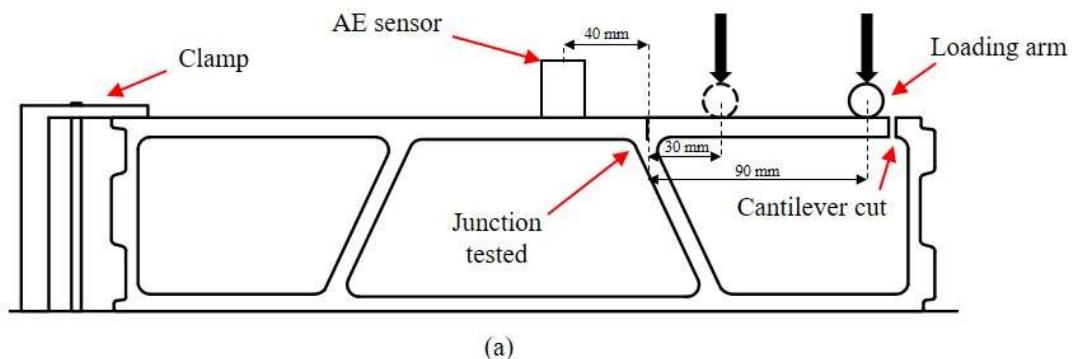
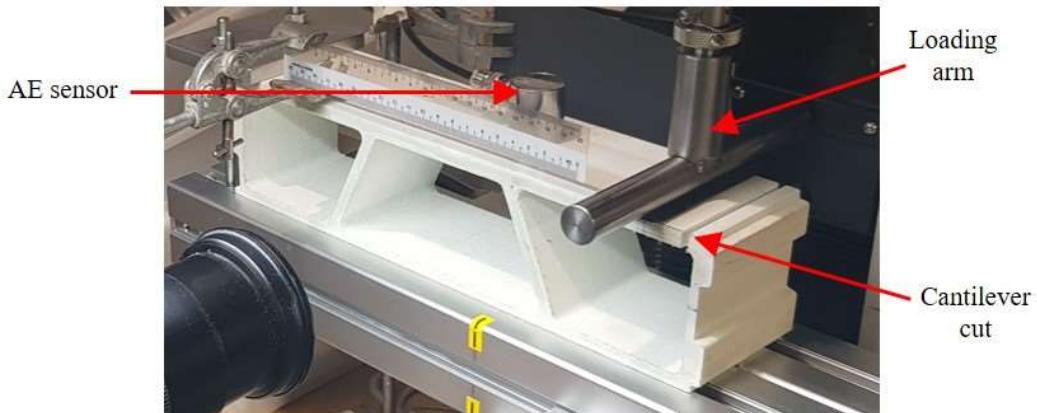
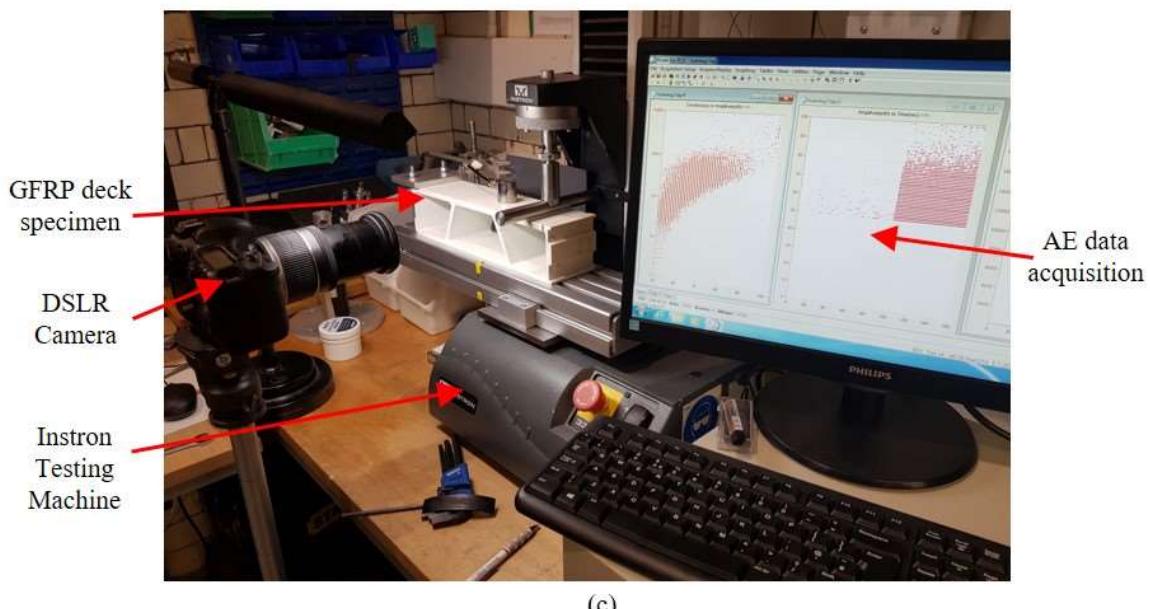
Figure 2: (a) Diagram of test setup, (b) close-up image of specimen and (c) image of instrumentation.

134 across the 80 mm width of this flange near to the external right-angle junction, as shown in Figure 2(a) and in
135 the close-up image of the specimen in Figure 2(b). The 80 mm width was chosen to ensure the junctions failed
136 within the 5 kN load capacity of the testing machine. It is important to note that the GFRP deck was initially
137 provided in seven short panels, typically 330 mm wide, of which two contained a ‘Normal’ junction, two a
138 ‘Wavy’ junction, and three a ‘Flipped’ junction. It was possible to cut four 80 mm wide specimens from most
139 panels. The specimens cut from the same deck panel are assigned to a unique subgroup, and the mat
140 misalignments and failure behaviours of these subgroups are presented independently throughout the remainder
141 of the paper.

142 Figure 2(c) shows an image of the experimental setup that includes the test machine, real-time AE
143 acquisition data displayed on the monitor, and video camera. The tests were conducted on an Instron 3345,
144 which had a compressive load capacity of 5 kN. The load was applied using a 100 mm wide, 20 mm diameter
145 steel bar placed across the width of the cantilever, with a 1 mm thick rubber strip between this bar and the
146 specimen to prevent local crushing of the GFRP material. The distance from the centreline of the junction to that
147 of the loading arm was varied between 30 mm and 90 mm, see Figure 2(a).

148 The specimens were secured to the machine using a clamp applied directly above the vertical web on
149 the opposite side of the junction being tested (Figure 2(a)). This acted as a translational and rotational restraint
150 that adequately replicated the in-situ boundary conditions, whereby the deck would be adhesively bonded to
151 adjacent units. The cantilever was loaded under displacement control at a rate of 1.8 mm/min, which is within
152 the range recommended by BS ISO 15024:2001 [41] for a double cantilever beam test on GFRP specimens. The
153 vertical force and displacement were acquired at a rate of 100 Hz from the Instron machine using Bluehill 3
154 software.

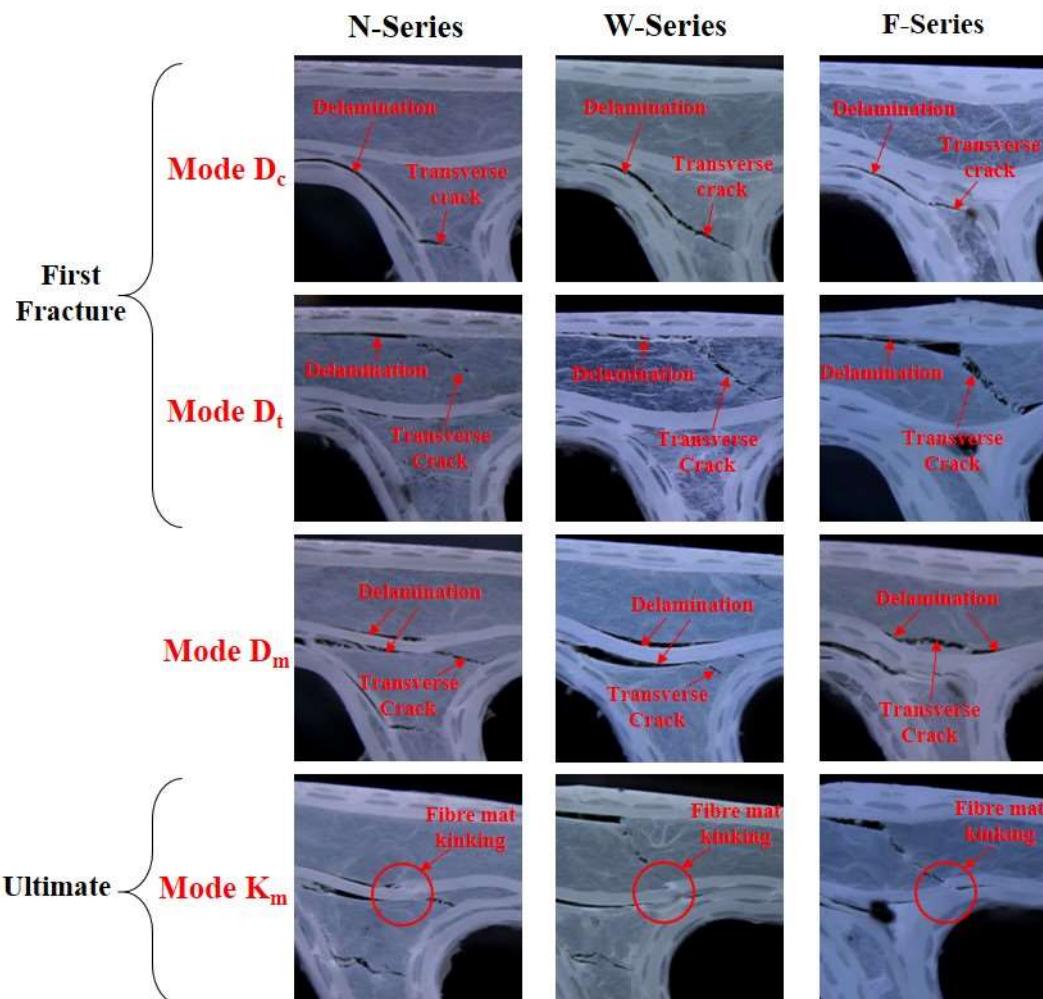
182 Failure of the junctions consisted of a series of distinct crack initiation events, each of which
183 corresponded to one of *four* damage modes. Figure 3 shows, for each junction type, example images of the four
184 damage modes, which are described below:

- 185 • Mode D_c: delamination within the corner of the junction's OAS side, combined with a transverse
186 crack within the web's roving core that extended from the base of the delamination across the

width of the web. For the N- and F- series, the delamination occurred between the $+45^\circ$ and -45° fibre layers within the triaxial mat, whereas in the W-series the delamination occurred between the complex mat and roving layers.

- Mode D_c : delamination at the top of the junction between the wrinkled 90° fibre layer and the roving layer, combined with a transverse crack within the roving layer that extended diagonally from the right edge of the delamination to the mat layer below.
- Mode D_t : delaminations in the middle of the junction along both the top and the bottom edges of the wavy 90° fibre layer. A transverse crack accompanied the delaminations in the rovings either side of the mat layer.
- Mode K_m : kinking or buckling of the wavy 90° fibre layer at the middle of the junction. Kinking initiated at the point of steepest tangent angle, which for most junctions was on the AAS.

Figure 3: Classification of different damage modes observed within each junction type.

The previous section showed that damage in the junctions manifested in four distinct modes (shown in Figure 3). An important observation is that each mode can be linked to one of the three different categories of misalignment present within the junction. Damage modes D_c , D_t and D_m/K_m were influenced by, respectively, the flip, near-surface wrinkle and waviness. This means that, for example, the effect of near-surface wrinkles on the first fracture loads can be assessed by looking *only* at first fractures that occurred in mode D_t . Likewise, looking only at measures of damage severity for mode D_t can give additional insight into the effect of near-surface wrinkles on the junctions' load-carrying capacity. To that end, the following section presents the strategy for digitally evaluating the degree of misalignment within the junctions. Following this, a set of damage indices are defined based on the load-displacement and AE energy data for each test. These indices are then used to evaluate, in turn, the damage-inducing effects of the flip, near-surface wrinkle and waviness. The discussion at the end of the section then links the results of this analysis back to the trends in the moment-shear failure envelopes described in the previous section.

Second, the W-series had a slightly higher (7%) average M_f than the N-series, despite having a similar near-surface wrinkle amplitude. One explanation for this is that, as can be seen in the images in Figure 3, for the W-series the mode D_c delamination occurred between the complex mat and roving layers, whereas for the N-series the delamination occurred between the $+45^\circ$ and -45° layers within the triaxial mat. Hence, the bond strength of the complex mat/roving interface may have been greater than the $+45^\circ/-45^\circ$ interface, leading to an increase in M_f in the W-series.

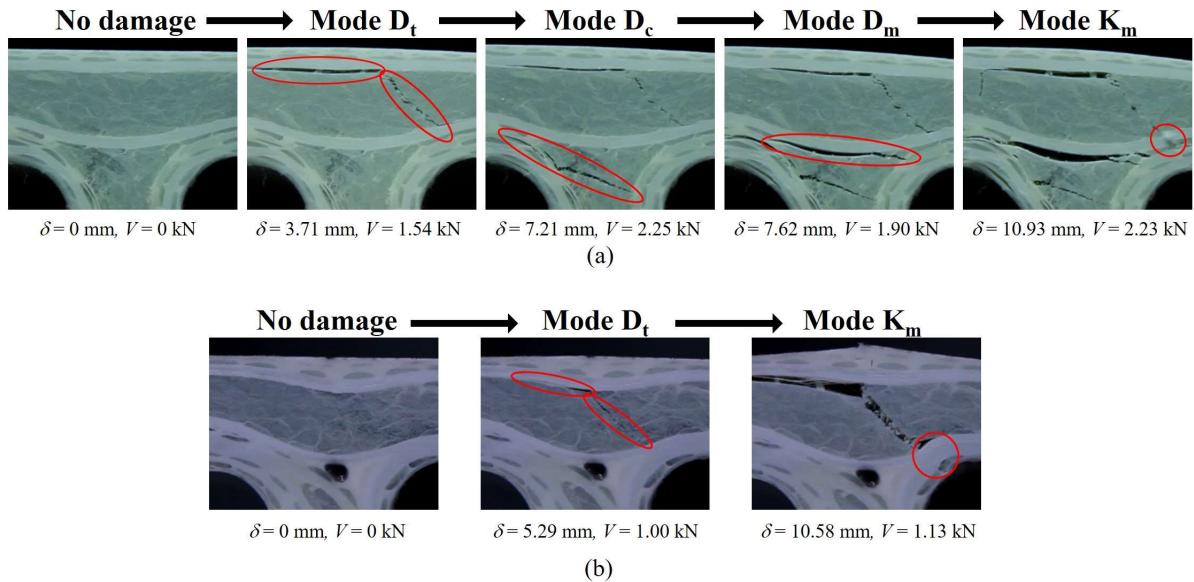
198 When loaded, the junctions exhibited initial linear behaviour up to a point of first fracture, which
 199 occurred in either mode D_c or D_t . When loaded further, some intermediate damage modes developed that
 200 eventually led to failure of the junction, which typically occurred in mode K_m . Figure 4 shows two examples of
 201 this damage evolution: in test W-1-70 (Figure 4(a)), first fracture initiated in mode D_t , which was followed by
 202 intermediate modes D_c and D_m , and finally the ultimate state was reached in mode K_m . In a different test (F-1-
 203 90, Figure 4(b)), only two modes developed: mode D_t at first fracture and mode K_m at ultimate. Across all tests,
 204 the sequence of damage modes was highly inconsistent and sensitive to both the lever arm of the loading and the
 205 misalignment profile within the junction.

Figure 4: Examples of damage evolution in junctions under load: (a) test W-1-70 and (b) test F-1-90.

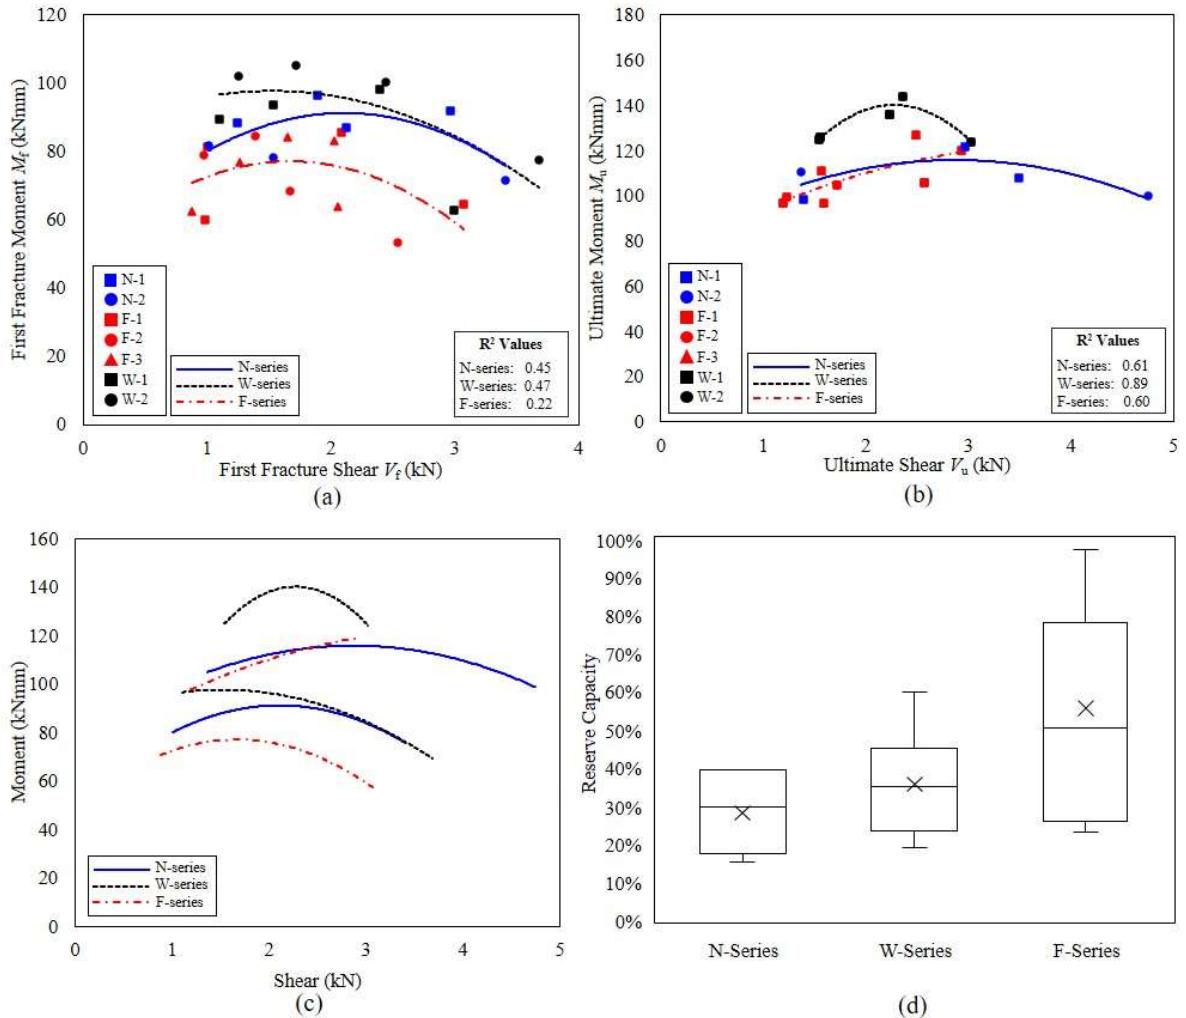
206 Given that, by varying the distance between the applied load and the cantilever root, the junctions were
 207 subject to various combinations of moment and shear, it is natural to define moment-shear failure envelopes for
 208 each junction type. To that end, Figure 5(a) and (b) show scatter plots of, respectively, the first fracture moment
 209 (M_f) and ultimate moment (M_u) as a function of shear (V_f , V_u). The M - V envelopes were estimated by plotting
 210 2nd order polynomial best-fit curves, which gave the lowest R^2 values compared to other functions. For
 211 comparison, Figure 5(c) shows only the best-fit curves for both first fracture and ultimate.

Figure 5: Moment-shear envelopes for (a) first fracture and (b) ultimate; (c) best-fit curves for both first fracture and ultimate and (d) reserve capacities for all junction types.

The M - V failure envelopes show several key trends:

- There is significant scatter in the moment/shear at first fracture (Figure 5(a)), although the points for each junction type are distributed primarily along the *horizontal* axis, which suggests that the first fracture was governed mostly by the applied moment. The scatter along the *vertical* axis is partially accounted for by clear differences in M_f between the junction types: compared to the W-series, M_f was on average 7% and 20% lower for the N- and F-series, respectively.
- Even within each junction type, there is still significant scatter in M_f , as evidenced by the low R^2 values shown in the bottom right corner of Figure 5(a). The N- and W- series both have R^2 values close to 0.5 and, upon closer inspection, it is seen that this scatter was primarily due to differences between the junction subgroups. For example, on average M_f was 11% lower for

- The ‘n’-shape of the envelopes in Figure 5(a) suggests that the maximum M_f was achieved only when there was a coexistent shear applied to the junction. For all junction types, the maximum moment was achieved at shear forces of between 1.5-2 kN, which equates to 19-25 kN/m width. This trend suggests that a small amount of shear *increased* the moment required to initiate first fracture up to a point, beyond which further increases in shear were detrimental.

- For ultimate (Figure 5(b)), the points are also distributed primarily along the horizontal axis, although the average M_u was approximately equal for the N- and F-series (both 19% lower than the W-series). This difference was due to the F-series having almost double the reserve capacity (the remaining load as a percentage of the first fracture load) of the N-series, as shown in Figure 5(d). Note also that the *range* of reserve capacities for the F-series was also double that of the other junction types.

- Within each junction type, the R^2 values for ultimate were all higher than for first fracture, although this was probably due to there being fewer data points, as many tests at high shear reached their ultimate state not within the junction, but rather in one of the adjoining flanges. This type of failure is explored in more detail in Section 5.1.

- The envelopes for ultimate (Figure 5(b)) are relatively flat, which suggests that the ultimate state was less sensitive to changes in shear. There was, however, a small drop-off in M_u with decreasing shear, similar to that observed for first fracture.

Using the results from the systematic analysis of each misalignment and the associated damage presented above, some of the key trends in the moment-shear failure envelopes in Figure 5 can now be explained.

Third, Figure 15 also provides insight into why the M_f initially increased and then rapidly decreased as a function of shear, resulting in the ‘n’-shaped envelopes seen in Figure 5(a). Although the damage evolution was highly inconsistent across all tests, at a 90 mm lever arm 80% of first fractures occurred in mode D_t , while at a 30 mm lever arm 80% of first fractures occurred in mode D_c . This suggests a transition from mode D_t at low shear to mode D_c at high shear, although there was no consistent point at which the mode switch occurred. Thus, it is reasonable to conclude that, for damage mode D_t , a small increase in shear force may have *reduced* the stress demand at the interface between the top fibre mat and roving layers, and hence *increased* the moment required to initiate delamination. Further increases in shear, however, switched the dominant damage mode to a delamination within the OAS of the junction (mode D_c), which led to a subsequent reduction in M_f .

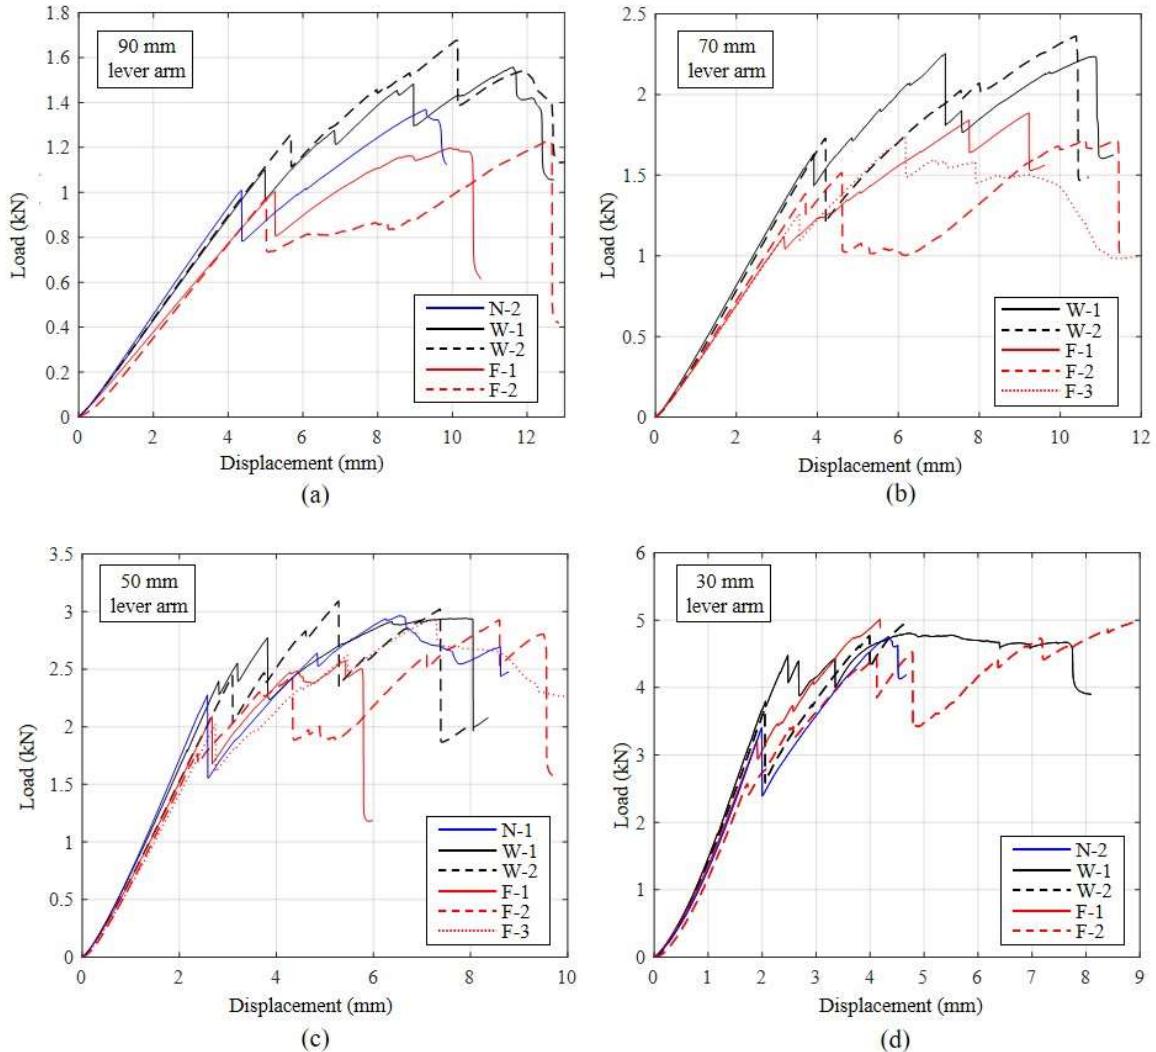
The inconsistency in failure behaviour is demonstrated further in Figure 6, which shows the load-displacement plots for all tests at (a) 90 mm, (b) 70 mm, (c) 50 mm and (d) 30 mm lever arm distances. These plots show the detrimental effect of damage on the load-carrying capacity of the junctions, which manifested as a sequence of load drops and concurrent reductions in tangent stiffness. Variability exists not only in the damage *loads* (exemplified by the scatter in moment-shear envelopes), but also in the damage *severity*, as indicated by the magnitude of load drops and tangent stiffness reductions up to failure. The load-displacement plots also point to further inconsistency of the initial stiffness, which one would expect to be identical for all tests at the

253 same lever arm distance. However, at 90 mm (Figure 6(a)) the initial stiffness was clearly greater for the N-
 254 series than for the F-series.

Figure 6: Load-displacement curves for all tests at (a) 90 mm, (b) 70 mm, (c) 50 mm and (d) 30 mm.

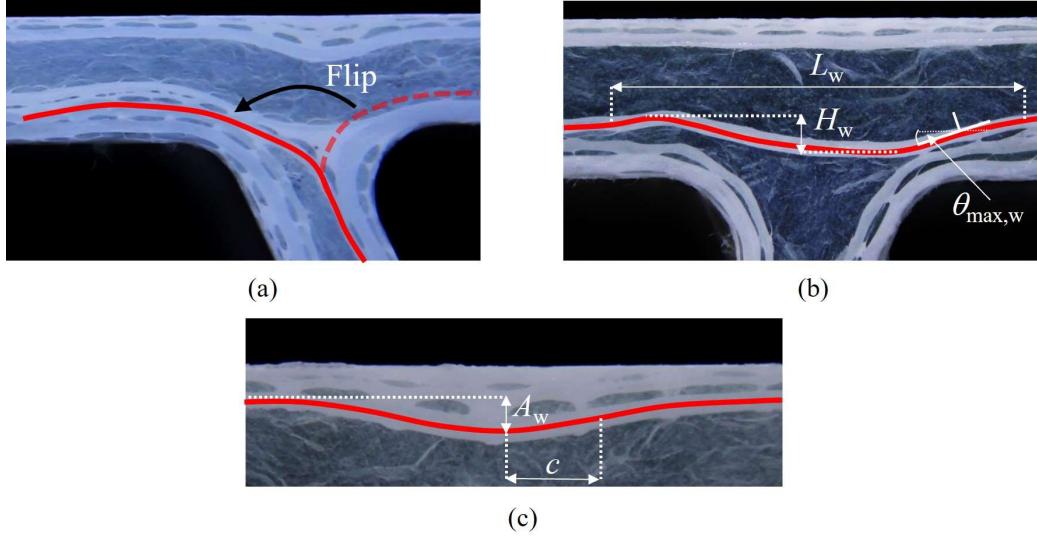
Figure 8: Characterisation of fibre mat misalignments: (a) flip, (b) waviness and (c) near-surface wrinkle.

1. Flip: as shown in Figure 7(a), for the F-series junctions, the end of the triaxial mat layer was flipped from the AAS to the OAS of the junction.
2. Waviness: as shown in Figure 7(b), the biaxial mat layer passing through the middle of the junction exhibited gradual undulations due to the non-uniform distribution of rovings either side of the layer. The severity of waviness was evaluated using the length (L_w), height (H_w) and steepest tangent angle ($\theta_{\max,w}$).
3. Near-surface wrinkles: as shown in Figure 7(c), the top biaxial mat layer exhibited a wrinkle near the centreline of the junction, which took the shape of a Gaussian curve. The severity of near-surface wrinkles was evaluated using the amplitude (A_w), along with the horizontal distance between the peak and the point of maximum tangent angle (c) of the Gaussian curve fit for the wrinkle.

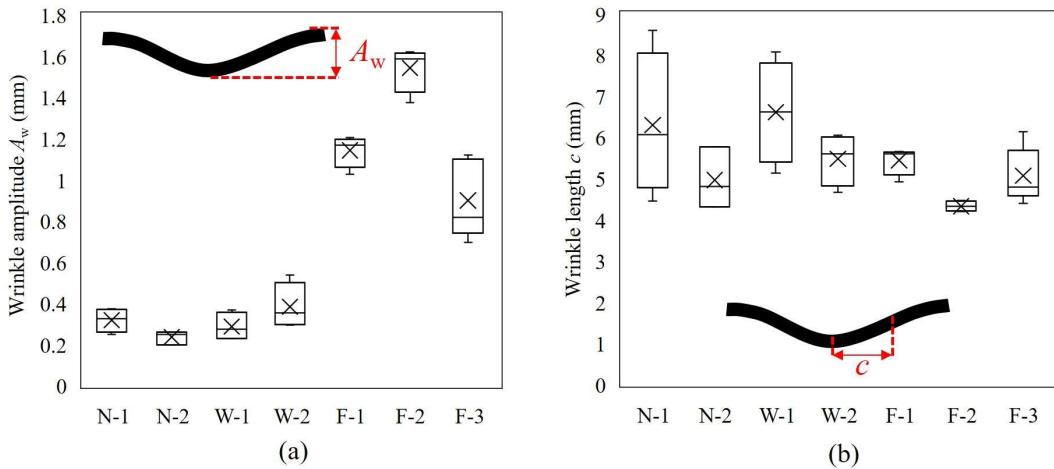
Figure 8(a) shows a box plot of the near-surface wrinkle amplitude for each junction subgroup. On average the N-series and W-series junctions had small amplitudes of 0.28 mm and 0.34 mm, respectively, without any significant change between the specimen subgroups. Conversely, the F-series had a much greater average amplitude of 1.2 mm and there were distinct differences between the subgroups: F-2 had a 72% and 35% greater average amplitude than F-3 and F-1, respectively. This indicates that the F-1, F-2 and F-3 subgroups were produced in different pultrusion batches, all of which contained a flip, which justifies the decision made earlier to separately present data from different junction subgroups. The average wrinkle lengths for each sub-group (Figure 8(b)) did not show any significant trends between the junction types.

Figure 7: (a) Wrinkle amplitude and (b) wrinkle length for each specimen group.

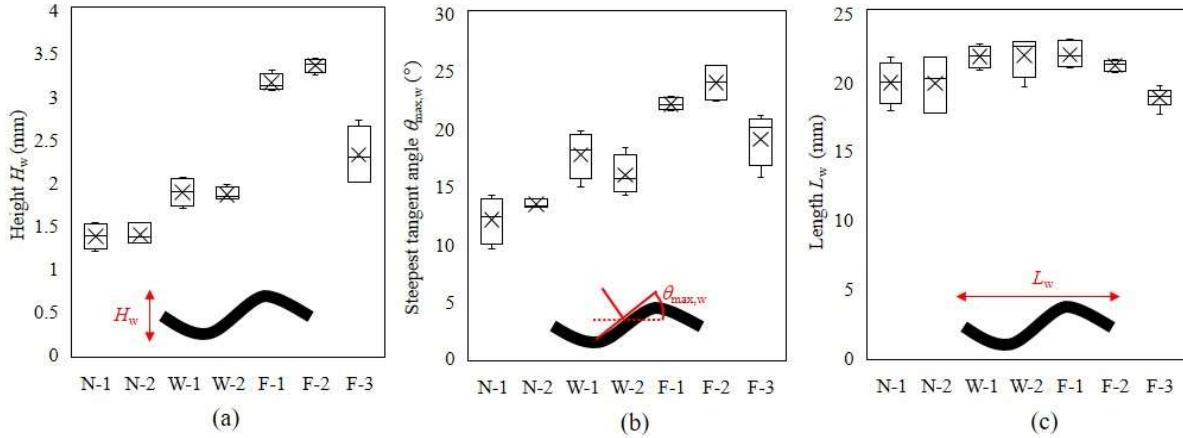
For the horizontal biaxial mat layer passing through the junction, the average waviness height (Figure 9(a)) and steepest tangent angle (Figure 9(b)) were smallest for the N-series, with the W-series having a 36% and 32% increase in the waviness height and angle, respectively, compared to the N-series. Note that the significant waviness of the biaxial mat in the F-series specimens would have been primarily due to the flipped layer. Thus, the average waviness height and angle were 113% and 71% greater than the N-series, respectively. The waviness length (Figure 9(c)) showed no significant trends between the junction subgroups.

Figure 9 : (a) Waviness height, (b) steepest tangent angle and (c) length for each junction sub-group.

The waviness of the biaxial mat layer that passed horizontally through the middle of the junction can be linked to two damage modes: mode D_m (delaminations above and below the layer) and mode K_m (kinking of the mat layer at ultimate). The analysis showed that none of the waviness parameters shown in Figure 9 (height, length or angle) had a significant correlation with the four indices for damage mode D_m . This is likely due to all mode D_m events having a PLD_n of less than 5%, which means that most mode D_m events did not significantly influence the load-carrying capacity of the junction.

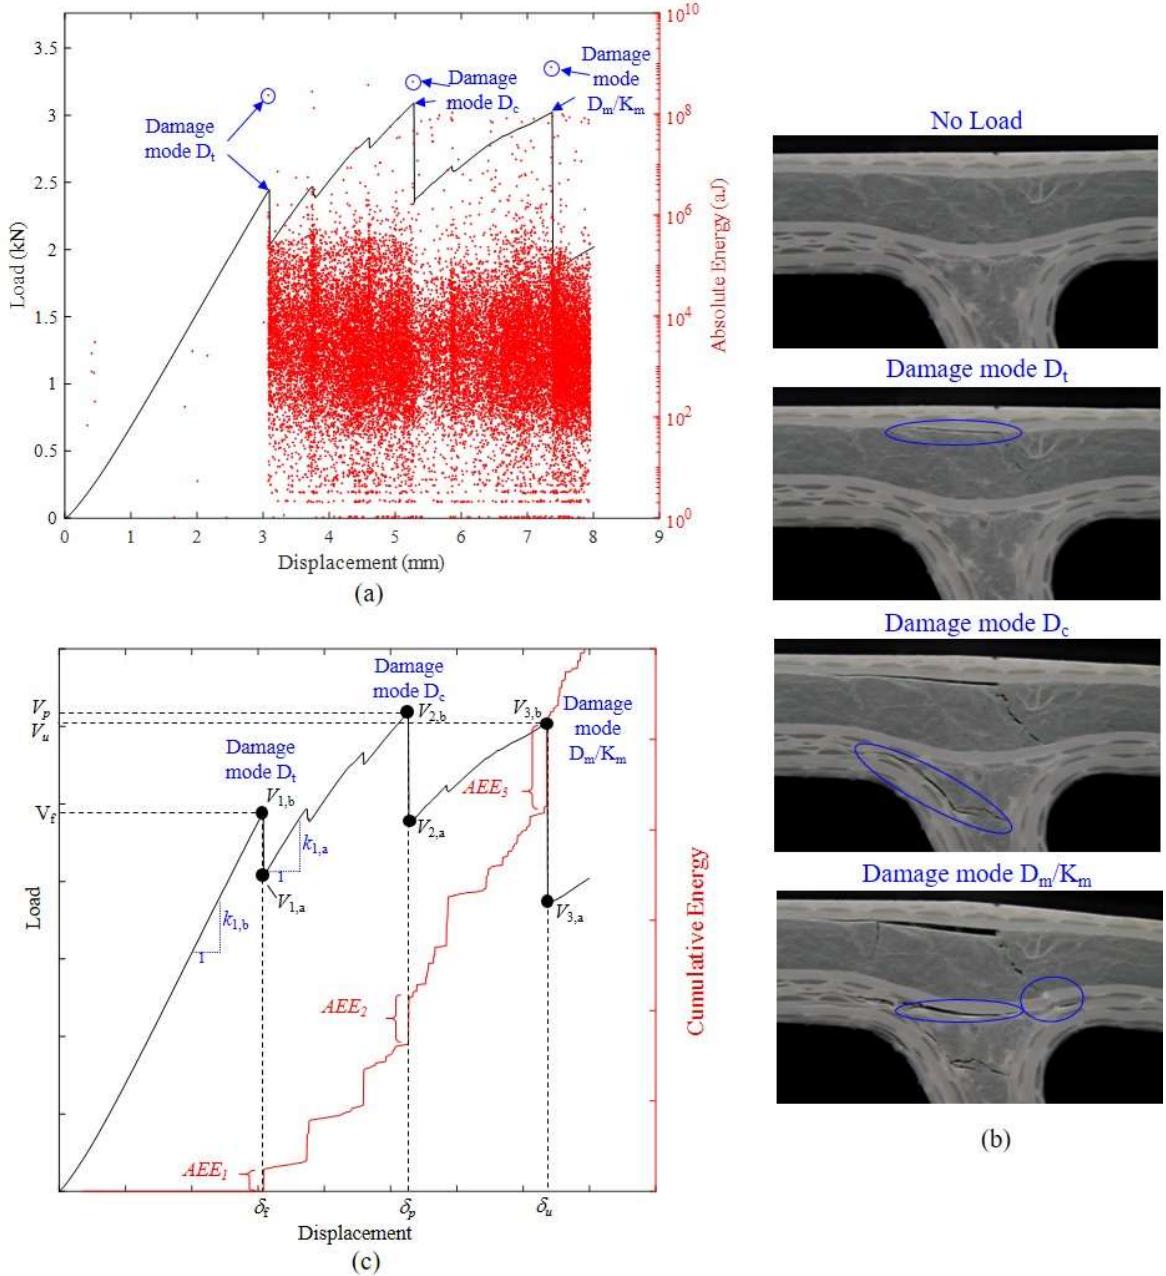
The severity of damage produced within the junctions under load was characterised using three independent sources of data: load-displacement, AE energy and video. As an example, Figure 10(a) shows both load and AE energy separately plotted as a function of displacement for test W-2-50. Four damage modes developed during the W-2-50 test, which occurred in the sequence: mode D_t , mode D_c and then simultaneously modes D_c and K_m . The points at which each mode initiated are labelled in Figure 10(a), and the corresponding images are shown in Figure 10(b). The behaviour can be split into three key stages:

1. Initial linear behaviour with neither visible cracking nor significant AE emissions.
2. Sudden first fracture in mode D_t that produced a significant load drop, reduction in tangent stiffness and a single high-energy AE event (over 10^8 aJ). This was immediately followed by a dense cluster of smaller-energy AE hits, smaller load drops and a gradual reduction in tangent stiffness due to crack propagation. Then, intermediate damage developed in mode D_c that produced a load drop and high-energy AE event similar to those at first fracture.

3. Ultimate failure achieved simultaneously in modes D_m/K_m , which produced the largest load drop and AE energy event up to that point, after which the test was terminated.

Figure 10 : Example data from test W-2-50: (a) load and AE energy vs displacement plots, (b) images of damage modes and (c) load-displacement and cumulative AE energy plots.

The load-displacement plot for this test is reproduced in Figure 10(c), but now with the AE energy more suitably presented as a *cumulative* curve. Labelled on the y-axis of this plot are the first fracture load V_f and ultimate load V_u , and on the x-axis are the corresponding displacements δ_f and δ_u . Using these plots, the first fracture is now precisely defined as the point at which AE emissions above 10^8 aJ were detected. Ultimate is

defined as the load which precipitated a load drop of at least 40%; this load drop sufficiently characterised ultimate behaviour as observed from the load-displacement plots. In the example in Figure 10(c), the peak load (V_p, δ_p) occurred slightly *before*, and so is distinguished from, the ultimate load V_u , whereas in other tests these two loads were the same (i.e. the peak load occurred at ultimate).

From the plots in Figure 10(c), three damage indices were calculated at each damage mode initiation event n (where $n = 1, 2, 3\dots$). These were as follows:

where $V_{n,b}$ and $V_{n,a}$ are the loads immediately before and after event n , respectively, as shown on Figure 10(c).

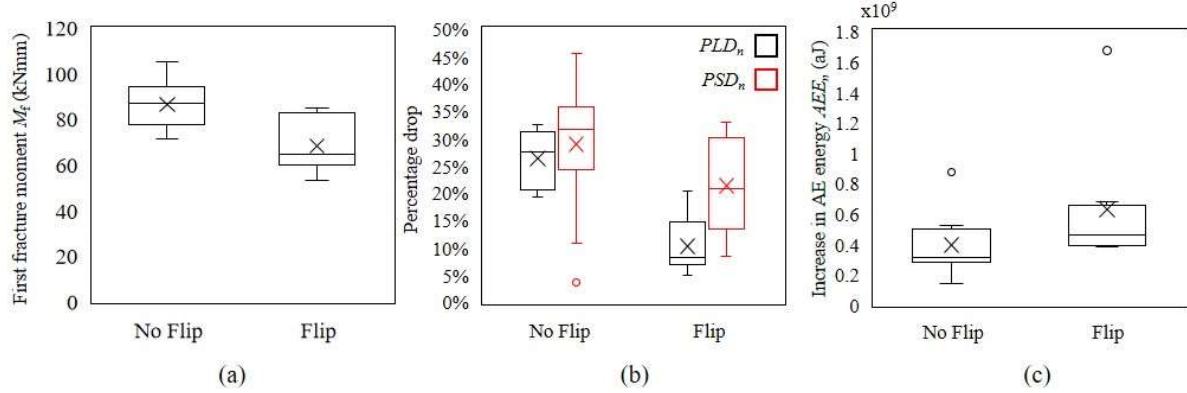
The flipped mat layer in the F-series junctions was adjacent to, and so would have influenced, the mode D_c damage within the OAS of the junction. Hence, Figure 11 shows box plots of (a) the first fracture moments M_f , (b) PLD_n and PSD_n values and (c) AEE_n values, all for mode D_c damage in both flipped and non-flipped junctions.

On average, the flip resulted in a 19% reduction in M_f . There was, however, still significant scatter in M_f for junctions both with and without a flip, which was likely due to variability in the bond *capacity* of the interface along which the mode A delamination occurred. The flip also resulted in a 61% increase in AE energy, but produced a 61% lower average PLD_n and a 26% lower PSD_n than junctions without a flip. This suggests that

while the flip caused damage to initiate at a lower moment, the resulting damage was less detrimental to the load-carrying capacity of the junction.

Figure 11: (a) First fracture moment M_f vs lever arm distance, (b) percentage load and stiffness drop and (c) increase in AE energy. All plots are for damage mode D_c only and compare both flipped and non-flipped junctions.

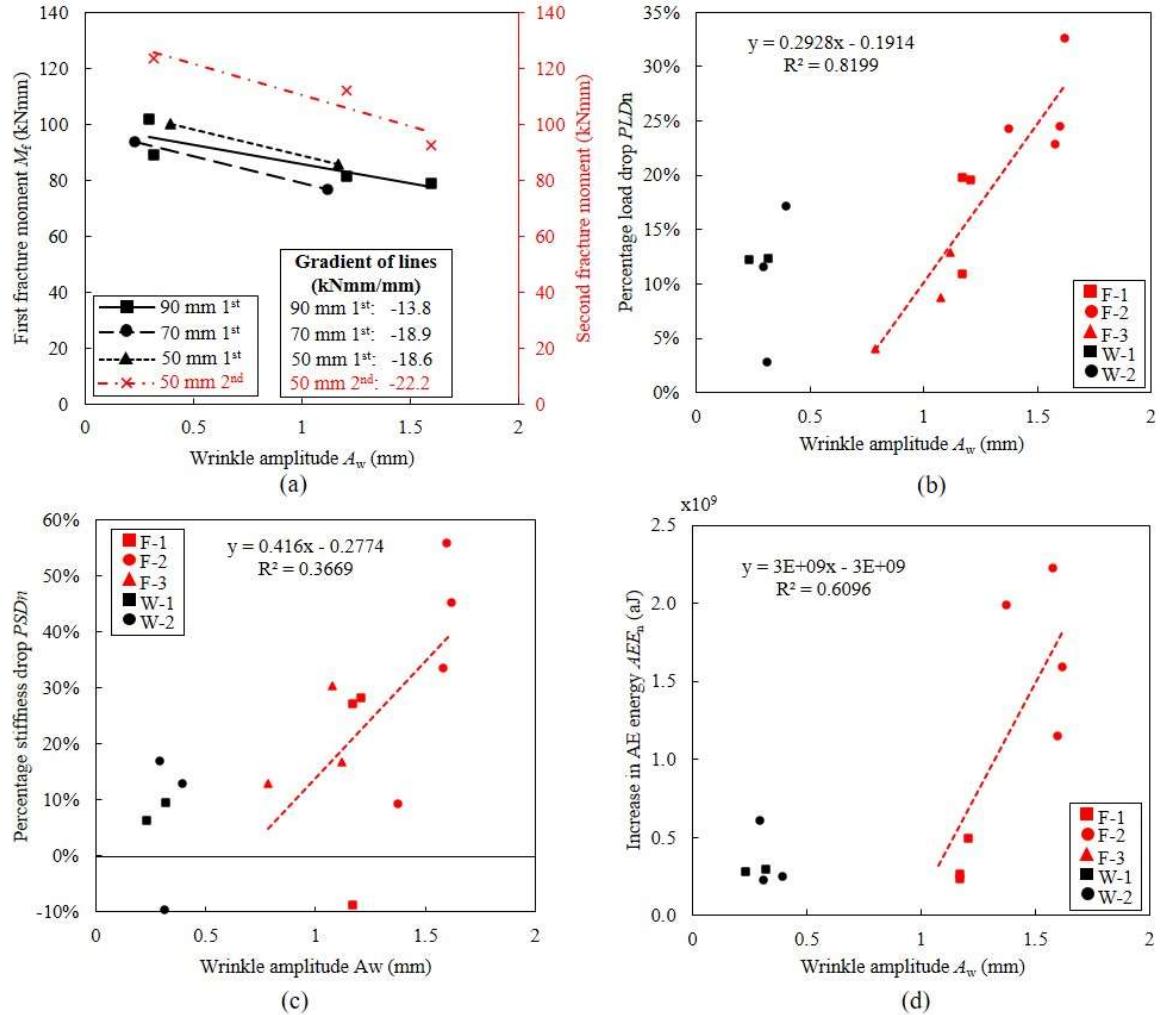
First, Figure 12(a) shows the first fracture moment M_f of damage mode D_t as a function of wrinkle amplitude, with the data grouped by lever arm distance. Three additional points are plotted (in red) where mode D_t damage initiated second (all at 50 mm lever arm distance). In all cases, M_f shows a decreasing trend with increased wrinkle amplitude. Furthermore, the gradients of the linear best-fit lines are all comparable (average of -18.4 kNm/mm). Extrapolating the linear best-fit line for the 90 mm tests backward to $A_w = 0$ shows that a wrinkle amplitude of 1.6 mm (the largest measured value) reduced M_f by 21% compared to no wrinkling.

Second, Figure 12(b), (c) and (d) show, respectively, the PLD_n , PSD_n , and AEE_n values for damage mode D_t as a function of wrinkle amplitude. The PLD_n values (Figure 12(b)) indicate that, above a threshold value of $A_w = 1$ mm, there was a strong positive correlation between PLD_n and A_w (as shown by the linear best-fit line with $R^2 = 0.82$). Similar trends are seen for both the PSD_n and the AEE_n , where the averages for $A_w > 1$ mm are, respectively, 3.0× and 3.4× higher than for $A_w < 1$ mm. Hence, mode D_t damage was consistently more severe for greater wrinkle amplitudes.

Figure 12: (a) First fracture moment M_f , (b) PLD_n , (c) PSD_n and (d) AEE_n vs wrinkle amplitude A_w . All plots are for damage mode D_t only.

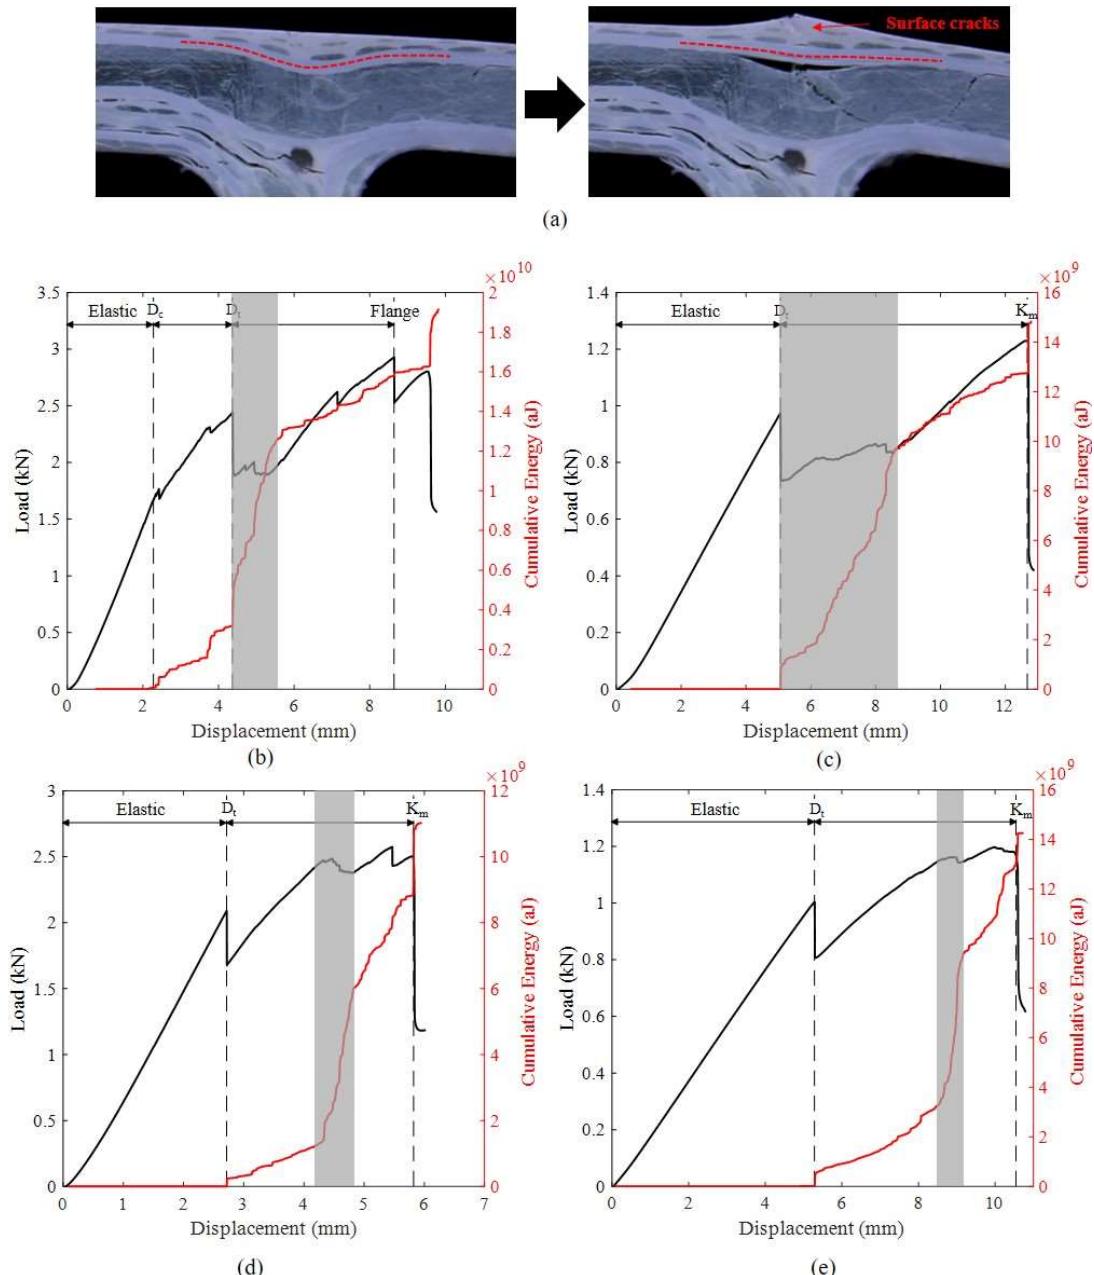
An additional observation of damage mode D_t was a phenomenon called ‘wrinkle-straightening’. For large wrinkle amplitudes ($A_w > 1$ mm), the tensile stresses in the wrinkled mat caused it to straighten out under load, as shown in Figure 13(a). Further insight into the wrinkle-straightening phenomenon is gained by examining the load-displacement and cumulative AE energy plots for tests with the largest wrinkle amplitudes.

To that end, Figure 13(b)-(e) show the load-displacement and cumulative AE curves for four tests: (a) and (b) are for junctions F-2-50 and F-2-90 (average $A_w = 1.5$ mm), respectively, (c) and (d) are for junctions F-1-50 and F-1-90 (average $A_w = 1.1$ mm), respectively. For all plots the wrinkle-straightening zone is shaded in grey. During wrinkle-straightening the load remained almost constant (i.e. the junction displayed near-zero rotational stiffness) and there was a step-change in the cumulative energy curves due to significant AE energy emissions. This burst in AE energy occurred within a finite displacement range during damage mode D_t and the increase was constant for tests at the same lever arm distance.

Figure 13 also shows that the wrinkle-straightening zone in the F-2 junctions (average $A_w = 1.5$ mm) occurred *immediately* after the delamination initiated by damage mode D_t , whereas in the F-1 junctions (average $A_w = 1.1$ mm) the wrinkle-straightening zone occurred near the end of the damage mode D_t phase. Furthermore, the total AE energy emitted during the wrinkle-straightening zone of F-2 junctions was nearly double that for F-1 junctions (1×10^{10} aJ compared to 0.5×10^{10} aJ). This suggests that an increase in wrinkle amplitude caused the wrinkle-straightening mode to occur earlier and emit more AE energy. This is especially problematic given that, as shown in Figure 13(a), wrinkle-straightening causes multiple cracks to propagate to the surface of the GFRP deck, which can act as paths for water ingress and further long-term degradation of the junction.

Figure 13: (a) Wrinkle-straightening during damage mode D_t for test F-2-30. Load-displacement and cumulative AE energy plots for (a) F-2-50 and (b) F-2-90 ($A_w = 1.5$ mm), and for (c) F-1-50 and (d) F-1-90 ($A_w = 1.1$ mm). Wrinkle-straightening zone is shaded in grey.

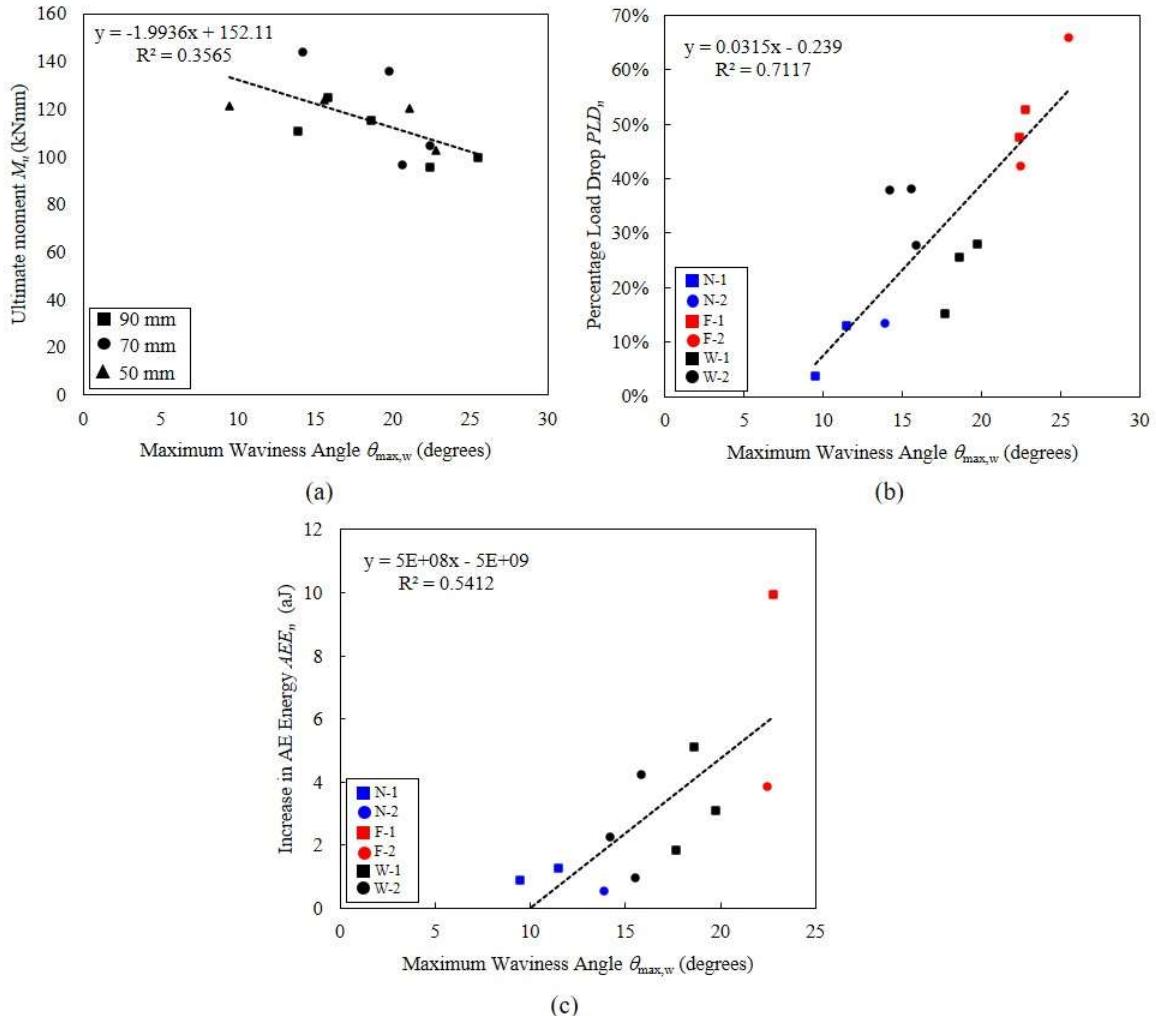
There was, however, a negative correlation between the maximum waviness angle $\theta_{max,w}$ and the ultimate moment M_u within damage mode K_m . This relation is shown in Figure 14(a), where the moments are grouped by lever arm distance and a linear best-fit line has been fitted through all points. Extrapolating the linear best-fit line back to $\theta_{max,w} = 0^\circ$ shows that a waviness angle of 26° (the largest measured value) reduced M_u by 35% compared to no waviness. This value should be viewed with caution, however, given the significant

Figure 14: (a) PLD_n vs maximum waviness angle $\theta_{max,w}$ and (b) AEE_n vs maximum waviness angle $\theta_{max,w}$ for damage mode K_m .

scatter ($R^2 = 0.36$) that is due primarily to the influence of the junctions' damage history on the ultimate moment.

The PLD_n and AEE_n values for damage mode K_m are shown in Figure 14(b) and (c), respectively. There was a strong positive correlation in both cases; the R^2 values from a linear best-fit line were higher for the PLD_n data (0.712) than for the AEE_n data (0.541). It is important to note that the R^2 values for M_u , PLD_n and AEE_n were all higher than equivalent values using either the waviness height H_w or length L_w . This indicates that the waviness *angle* accounts for more of the variance in the junctions' failure. This is to be expected, given that the kinking always initiated at the point of steepest tangent angle. In both Figure 14(b) and (c), the indices significantly increase after a threshold angle of approximately 10° .
