1 **Characterisation of Local Damage in Pultruded GFRP Road Bridge Decks with**
2 **Random Fibre Mat Misalignments**

9 **Abstract:**

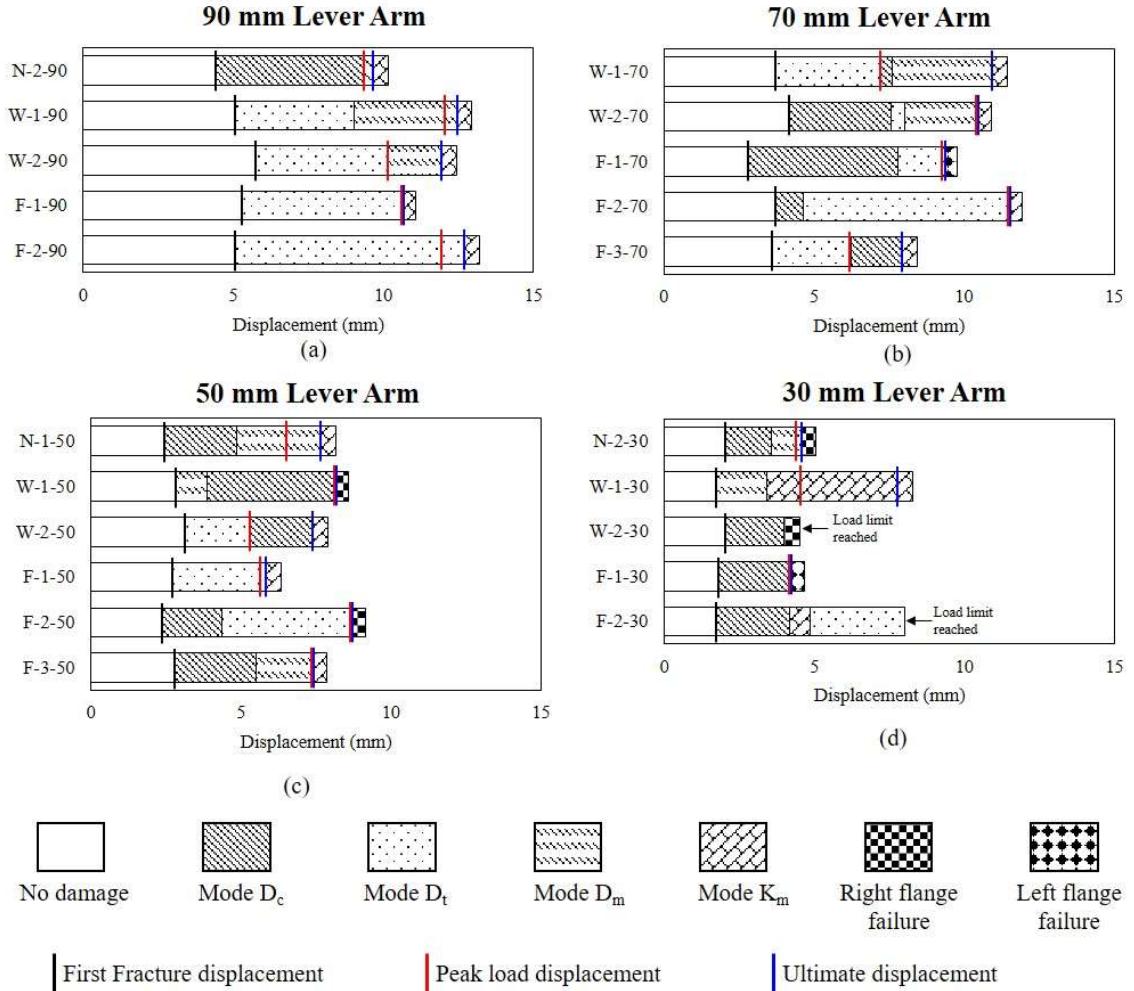
Further evidence of the high bond strength at the complex mat/roving interface of the W-series is seen in Figure 15, which shows horizontal bar charts indicating the displacement at which a specific damage mode initiated during the test. It is seen that first fracture occurred in mode D_c for only 25% of W-series junctions,

compared to 100% of N-series junctions. This again indicates that the W-series had a relatively high bond strength at the location of mode D_c damage, which, coupled with the small near-surface wrinkle amplitude, likely explains the higher M_f for the W-series junctions.

Figure 15: Evolution of damage modes for junctions tested at (a) 90 mm, (b) 70 mm, (c) 50 mm and (d) 30 mm.

Third, Figure 15 also provides insight into why the M_f initially increased and then rapidly decreased as a function of shear, resulting in the ‘n’-shaped envelopes seen in Figure 5(a). Although the damage evolution was highly inconsistent across all tests, at a 90 mm lever arm 80% of first fractures occurred in mode D_t , while at a 30 mm lever arm 80% of first fractures occurred in mode D_c . This suggests a transition from mode D_t at low shear to mode D_c at high shear, although there was no consistent point at which the mode switch occurred. Thus, it is reasonable to conclude that, for damage mode D_t , a small increase in shear force may have *reduced* the stress demand at the interface between the top fibre mat and roving layers, and hence *increased* the moment required to initiate delamination. Further increases in shear, however, switched the dominant damage mode to a delamination within the OAS of the junction (mode D_c), which led to a subsequent reduction in M_f .

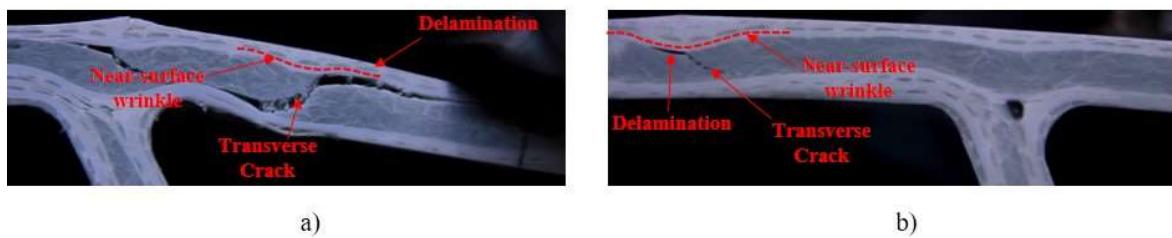
Figure 16: Examples of (a) failure within the right-hand flange of test F-2-50 and (b) failure within left-hand flange of test F-1-70. Note in both cases the right-hand flange was the cantilever.

In 26% of tests, the ultimate state did not occur within the junction, but instead was caused by a fracture within the AAS flange (19% of tests) or the OAS flange (7% of tests). Examples of both flange fractures are shown in Figure 16(a) and (b). It is seen that these fractures were the result of near-surface wrinkles in the top biaxial mat, which led to a delamination between this mat and the rovings, as well as a transverse crack through the rovings. Some specimens had flange wrinkles of amplitudes up to 2 mm, which significantly compromised the deck’s load-carrying capacity and therefore such specimens should not be used in a real structure.

A simplified beam-theory model of the cantilever, which assumes that the junctions provide fully-fixed support conditions and that the GFRP material is homogeneous, predicts that the gradient of the load-displacement curve is proportional to the second moment of area of the cantilever, which, in turn, is proportional to the cube of the flange thickness. This model predicts a 9.8% and 18.9% reduction in the initial stiffnesses of the W- and F- series compared to the N-series, respectively. These reductions are comparable to the measured reductions at a 90 mm lever arm distance (7.1% and 17.8%, respectively). It should be noted, however, that the assumptions made in this calculation are overly simplistic. For example, the transverse fibres are not uniformly distributed, but rather sandwiched either side of the longitudinal fibres. Hence, flanges of different thicknesses will have the same volume of transverse fibres, but the distance between the top and bottom layers will vary. Furthermore, misalignments including those shown in Figure 16 will produce variable mechanical properties along the length of the cantilever.

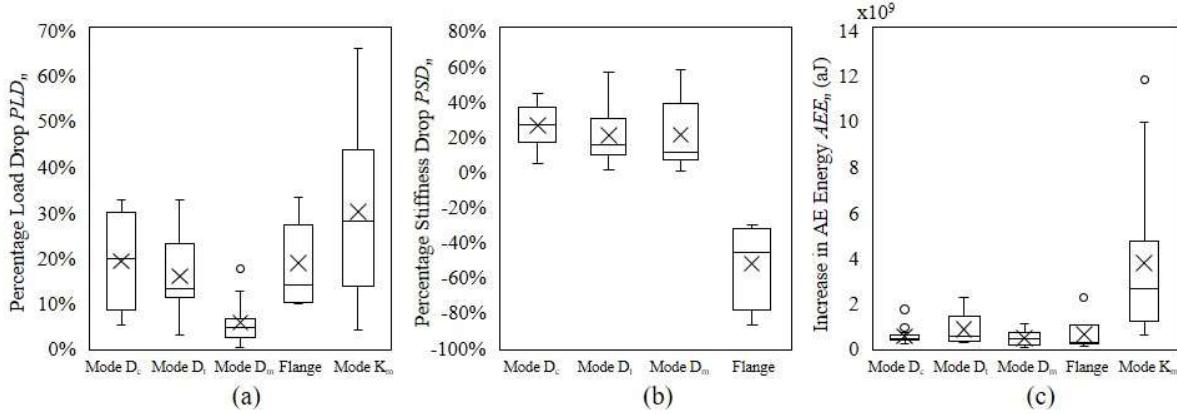
Figure 17: Comparison of (a) percentage load drop, (b) percentage stiffness drop and (c) AE energy burst for each failure mode within the junctions and also for flange failure.

To compare the severity of flange damage to that of the other four modes within the junction, Figure 17 shows box plots of (a) the percentage load drop PLD_n , (b) the percentage stiffness drop PSD_n and (c) the

increase in AE energy AEE_n for damage modes D_c , D_t , D_m and K_m , as well as for the flange damage on the junction's AAS (denoted 'flange').

Figure 17(a) shows that the average PLD_n for flange damage was comparable to modes D_c and D_t . Figure 17(b) shows, however, that flange damage always produced a substantial *increase* in tangent stiffness (52% on average). As an example of this effect, Figure 18 shows the load-displacement data for test F-2-50, and Figure 18(b) provides a magnified view of the region at which flange damage occurred. It is seen that, prior to flange damage, the tangent stiffness gradually decreased from (1) to (2), at which point flange damage precipitated a 14% drop in load to (3). The new tangent stiffness immediately after (3) was comparable to that at (1), where the points (1) and (3) are at the same load. This suggests that flange damage caused a redistribution of stresses that changed the load-resisting mechanism of the cantilever in a way that increased the tangent stiffness.

In addition to some damage events causing an increase in stiffness, Figure 18(b) also shows that a small – but still significant – load drop at (0) caused no reduction in tangent stiffness. Indeed, the data for PSD_n shown previously in Figure 17(b) indicates that many damage events caused no reduction in tangent stiffness. This suggests that the change in tangent stiffness is not a reliable measure of damage.

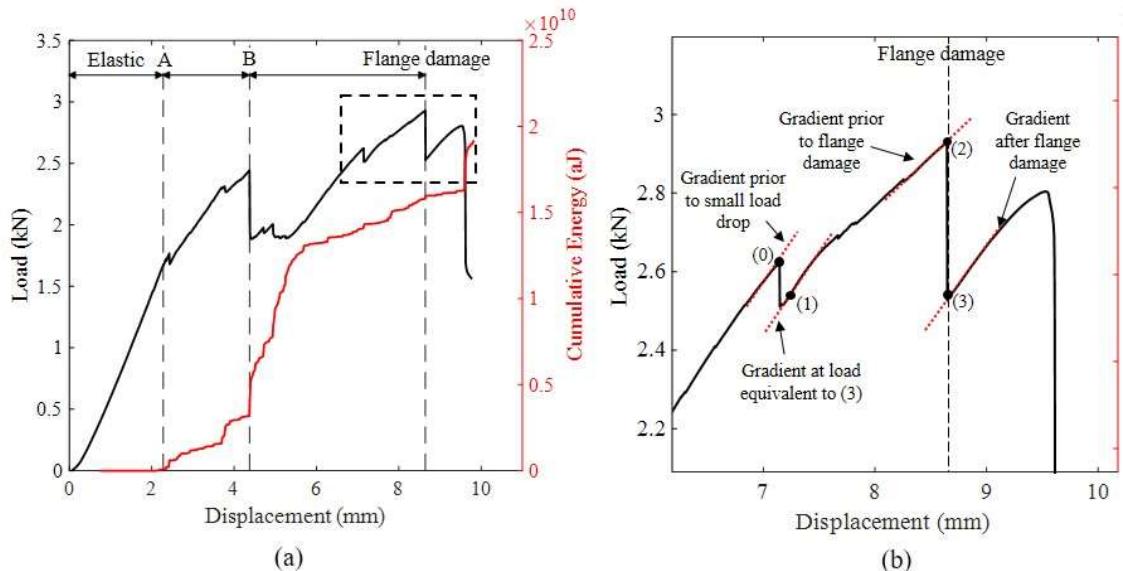
Figure 18: (a) Load-displacement and cumulative AE plots for test F-2-50, (b) magnified plot at location of flange damage.

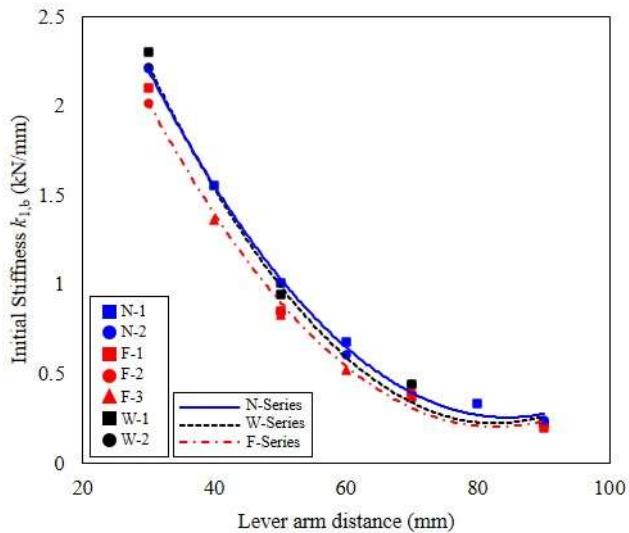
Figure 19 : Initial stiffness vs lever arm distance for all tests.

Figure 19 plots the initial stiffness of all junctions before the first fracture event ($k_{I,b}$) as a function of lever arm distance. The initial stiffness was calculated from the gradient of the load-displacement curve from approximately 50% of the first fracture load up to just before the first load drop. This was to avoid the small ‘bedding-in’ effect observed for some specimens. Figure 19 shows some scatter in the initial stiffnesses from tests conducted at the same lever arm distance, which increases from 90 mm to 30 mm. This is to be expected, given the smaller displacements at shorter lever arm distances, which increases the percentage error in the measurements.

At 90 mm, where there is minimal scatter, the initial stiffnesses of the W-series and F-series junctions were 7.1% and 17.8% lower than the N-series junctions, respectively. These changes in stiffness are mostly explained by the variation in cantilever thicknesses t_c , which were 8.60 mm, 8.31 mm and 8.02 mm for the N-, W- and F- series, respectively. Recall that these changes in thickness were a result of differential displacement of the internal mandrels during pultrusion, which, in turn, were caused by asymmetrical pressures acting on the mandrel due to the fibre mat misalignments [7]. For example, for the junctions containing a flip (F-series), the average flange thickness on the AAS was 8.02 mm and on the OAS was 9.15 mm. This difference is directly attributable to the triaxial mat layer being flipped from the AAS to the OAS of the junction.
