Fire safety in spacecraft: past incidents and Deep Space challenges.

Abstract

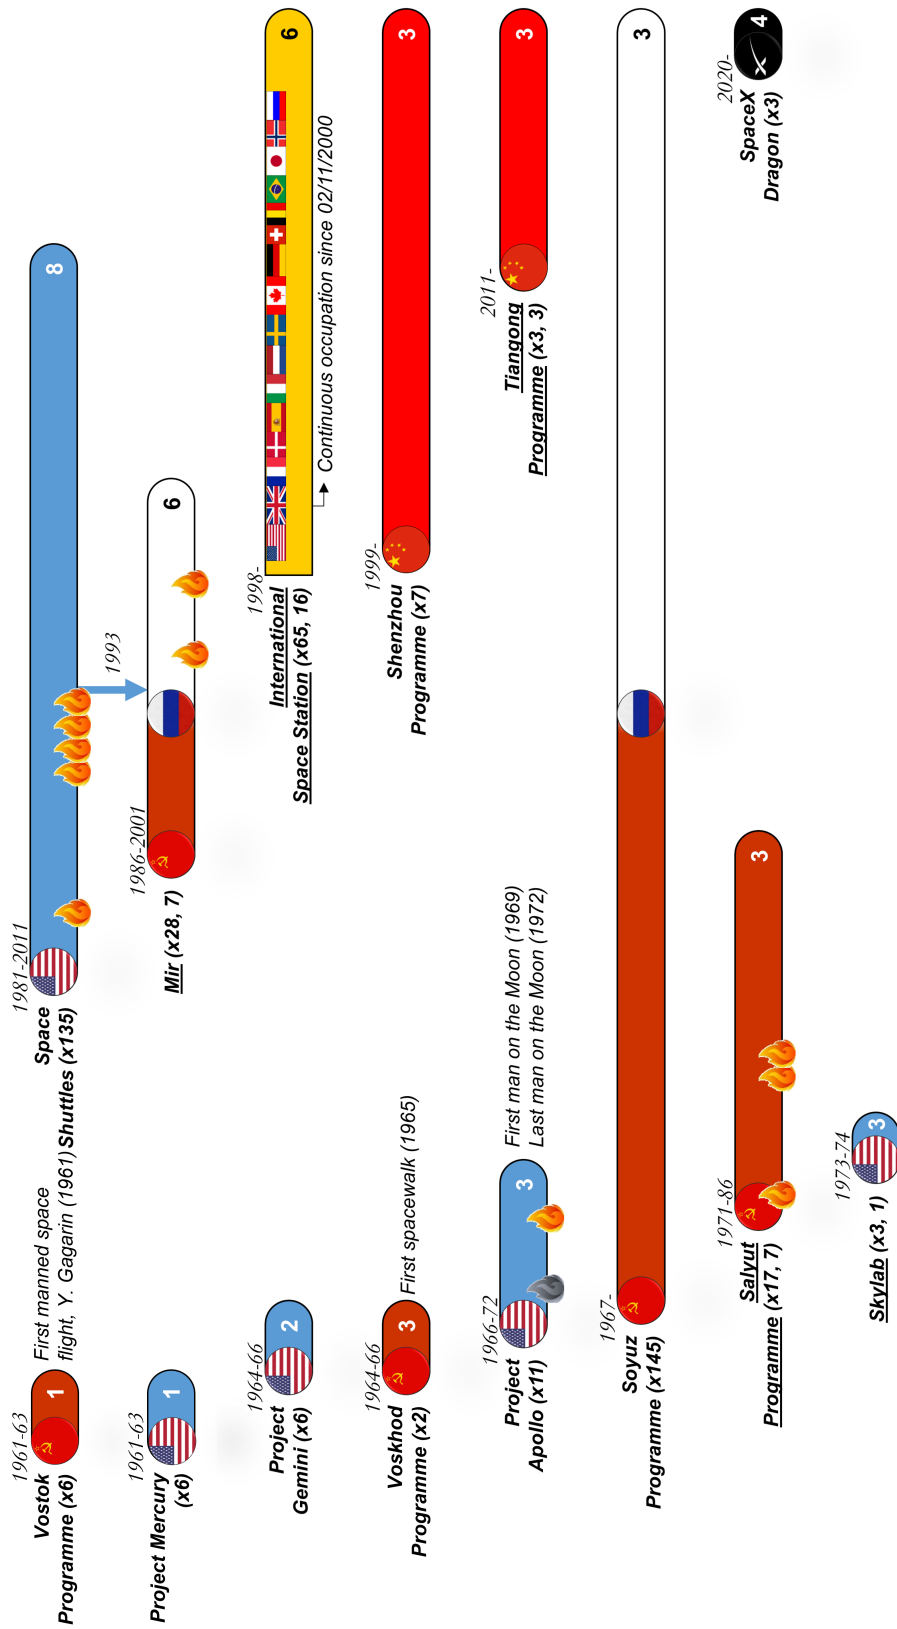
Figure 2: Manned Space Exploration as of 2021. Underlined names indicate space stations; the number into bracket, preceded by a 'x' symbol is the number of missions executed; the number of space stations, or modules assembled in space in the case of Mir and the ISS, is then specified; fire symbols mark the events listed in Table 1. The blue arrow shows the beginning of the Shuttle-Mir Program.

national space exploration displayed in Figure 2. These situations can be contrasted against five different aspects of a fire safety strategy, namely prevention, early detection, training, suppression, and recovery, to summarize the associated shortcomings. By definition, prevention failed in each of the twelve cases because the unsupervised combination of fuel, oxidizer and heat sources is in essence inevitable until material flammability in the absence of buoyant flows has been fully understood. The introduction of a standard test aimed at bypassing this knowledge gap, but the later Space Shuttle and Mir incidents highlight the shortcomings of this approach. In addition, in the three situations where a fire developed to a life-threatening size (Apollo 1, Apollo 13, Mir 1997), it did so before the crew members could effectively intervene, illustrating the potentially disastrous effects of inadequate prevention even in the presence of early detection. Early detection was effective in the nine remaining cases (Salyut I, Mir 1994, all instances of Salyut VI and the Space Shuttles). However, it should be pointed out that none of these detections actually relied on instrumentation, even though dedicated fire sensors were systematically present on board. Again, a lack of knowledge (this time regarding the low-g fire signature) drastically limits the efficiency of any automated detection system. Training, as a key component in the resolution of emergency situations, is designed to provide the crew with an automatic and effective response in a potentially stressful context. In the enclosed volume of a spacecraft, the level of stress when facing a fire can be increased by the possible dense amount of smoke produced (Salyut I, Mir 1997). However, the level of improvisation to tackle the fire identified in four instances (Salyut-I, Salyut-VI 1977, Mir 1994 and 1997) shows the lack of

None of the 5 presently active manned space programs has reported any significant fire issue, as illustrated in Fig.2. Among them, the ISS features the largest pressurized volume (915.6 m^3) and has been continuously operated for more than 20 years. To understand the sustainability of the present situation, its fire safety strategy is evaluated in light of past fire incidents. Capitalizing on the past experience from joint American and Russian space programs, the ISS was built after the plans of the cancelled Mir-2 space station. Its atmosphere is a 21% oxygen, 79% nitrogen mixture at a pressure of 101.3 kPa (14.7 psia) [71]. In addition to providing standard conditions for medical observations regarding the impact of weightlessness on the human metabolism, it enhances fire safety by limiting flammability and fire growth rate compared to oxygen-enriched spacecraft. Oxygen generation relies mostly on water electrolysis, with the Oxygen Generation System in the American segment and Elektron in the Russian segment, but also CO_2 reduction into water and oxygen in the Advanced Closed Loop System in the European segment since 2018. However, frequent failures of these systems require the use of oxygen bottles supplied from Earth as well as lithium perchlorate candles derived from those used in Mir, meaning that high oxygen leakage or buildup above material flammability specification is still possible. This material specification is derived from material standard testing procedures, which have capitalized on the database compiled since the Shuttle program. The various space agencies involved in the ISS project have developed slightly different material testing protocols, but the overall philosophy is the same with single-element tests used as a basis for high-level fire pre-
