Guided ultrasonic waves for the monitoring of hidden fatigue crack growth in multi-layer aerospace structures

I. Najjarre, E. Kostson, and P. Fromme

Department of Mechanical Engineering, University College London, WC1E 7JE, UK

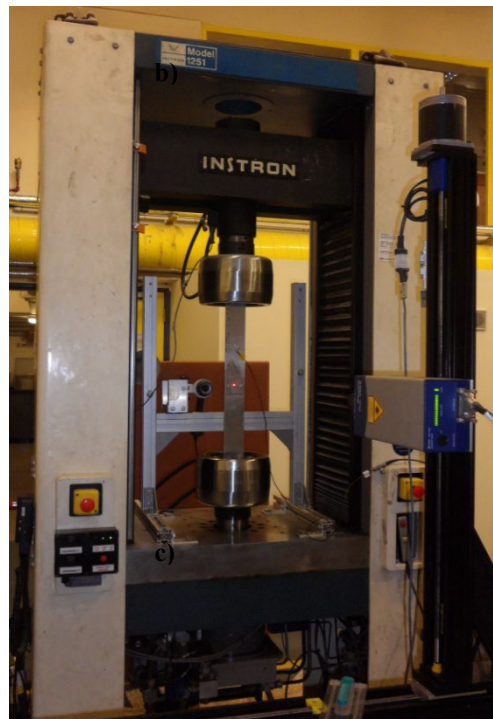
Fig. 1. Experimental setup: multi layer tensile specimen in fatigue testing machine with microscope for optical crack length measurement and laser interferometer.

Fatigue crack growth monitoring at a fastener hole was performed for three multi layer tensile specimens using low frequency guided ultrasonic waves. The specimens (600 mm x 70 mm x 6.2 mm) consist of two 3 mm thick aluminum alloy (2014-T6) plate strips, adhesively bonded with a 0.2 mm thick adhesive layer (HYSOL-9394 EA). A $\frac{1}{4}$ inch diameter hole ($r_0 = 3.17$ mm) was drilled on the center line 290 mm from the specimen end. For the fatigue experiments the specimens were subjected to cyclic tensile loading in a servo-hydraulic testing machine (Fig. 1). The loading axis was parallel to the center line of the specimen. A maximum load of 54 kN was selected so that the maximum stress in the vicinity of the fastener hole reached about 95% of the yield limit (stress concentration factor $K_t \approx 3.1$). The corresponding maximum nominal stress is approximately 125 N/mm². The cyclic loading was performed with a stress ratio of $R = 0.1$ and cycling frequency of 7 Hz. The crack initiation is expected to occur at the hole boundary at an angle of approximately 90° relative to the loading axis. A small starter notch, approximately 0.2 mm long was made at the corner of the hole with the surface of the bottom layer to control the crack location. During fatigue testing the crack initially grew quarter-elliptically from the starter notch before developing into a through-thickness crack in the bottom aluminum layer. No fatigue crack was observed in the top aluminum layer. The cyclic loading was stopped every 1'000 cycles and the maximum tensile load was applied to avoid crack closure. The crack length on the specimen bottom surface was measured optically using a microscope and the ultrasonic monitoring measurements were performed.

A piezoelectric disc (Ferroperm Pz 27, diameter 5 mm, thickness 2 mm) with a brass backing mass (diameter 5 mm, thickness 6 mm) was permanently bonded onto the top surface of the tensile multi layer specimen using two-component epoxy glue 110 mm from the fastener hole. The out-of-plane forcing was chosen to excite a bending mode similar to the A_0 mode in a single layer plate [27]. The excitation signal consisted of a 5 cycle, 100 kHz tone burst in a Hanning window and had narrow bandwidth. The signal was generated using an arbitrary function generator, amplified and applied to the transducer. The wavelength of the excited mode in the multi layer structure is about 18 mm. The amplitude of the guided ultrasonic wave pulse was measured using a heterodyne laser interferometer on the top surface opposite the crack location in the bottom layer. The demodulated output signal obtained from the interferometer was band-pass filtered around the center frequency and averaged 20 times in an oscilloscope. Two types of measurements were performed. The scattered field around the hole (and crack) was measured before and after the cyclic loading to obtain a fatigue crack. The laser interferometer was moved parallel to the specimen surface using a scanning rig on a circular measurement grid (angular resolution: 5 degrees, radial resolution: 0.5 mm) from the hole boundary to a maximum radius of 10 mm. During the fatigue cycling the laser measurement spot was kept in one location approximately 1 mm sideways from the hole boundary and 2 mm in front of the expected fatigue crack location on the hole side of the starter notch. The time traces were evaluated to obtain the maximum amplitude of the envelope of the guided wave pulse using the Hilbert transform in Matlab.

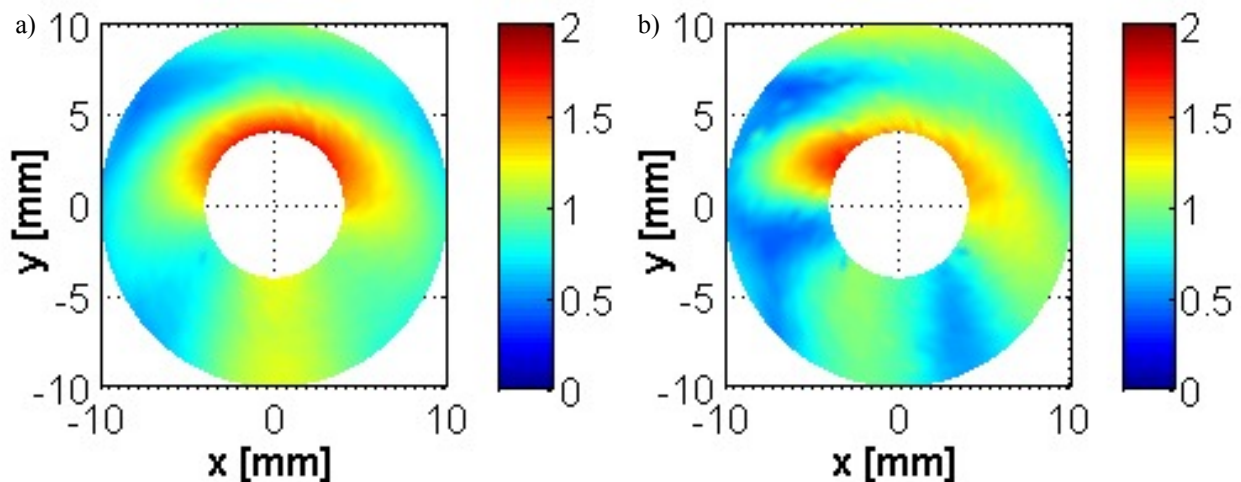
Fig. 2. Measured scattered field, maximum amplitude of guided wave pulse ($f_0 = 100$ kHz) measured using laser interferometer on top surface for one tensile specimen: a) undamaged hole; b) hole with 8.5 mm long fatigue crack on left hand side in bottom aluminum layer.

The scattered field of the guided wave around the fastener hole was measured as described above before the start of the cyclic loading and with a 8.5 mm long fatigue crack visible on the surface of the bottom layer. It was verified from a visual inspection in the fastener hole that the fatigue crack had grown through the thickness of the bottom aluminum layer. Based on previous experience it has to be assumed that the adhesive layer close to the fatigue crack was damaged during the cyclic loading. No fatigue cracking was observed in the top aluminum layer on which the laser measurement was performed.

Shown in Fig. 2a is the scattered field measured using the laser interferometer on a circular grid around the undamaged fastener hole. For each measurement point the maximum amplitude of the envelope of the guided wave pulse was extracted using the Hilbert transform. These are displayed in Fig. 2 color-coded with red corresponding to high amplitude and blue to low amplitude. For the undamaged hole a symmetric scattering pattern can be observed. The high amplitude (red) at the top of the hole boundary results from the reflection of the guided wave incident from the top at the free boundary. The amplitude variation around the hole arises due to the constructive and destructive interference of the incident and scattered waves around the hole. A significant change in the scattered field can be observed in Fig. 2b due to the fatigue crack on the left side of the hole in the bottom aluminum layer. The scattered field is not symmetric anymore and an increase in amplitude can be observed before the fatigue crack. Reduced amplitude of the guided wave behind the fatigue crack location is due to the scattering of the incident guided wave.

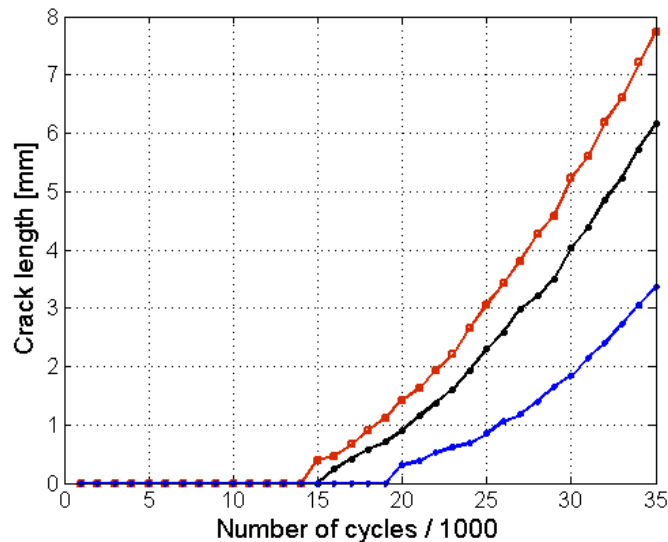
Fig. 3. Optically measured crack length plotted against number of cycles for three fatigue tests of multi-layer tensile specimens.

Based on the evaluation of the scattered guided wave field it was decided to place the laser measurement spot during the fatigue cycling just in front of the expected fatigue crack location in the bottom layer. Cyclic loading of three multi layer tensile specimens was carried out as described above. For all three specimens the fatigue crack was first observed visually between 15'000 and 20'000 cycles. The optically measured crack length on the bottom surface is shown for the 3 specimens in Fig. 3. From the starter notch the crack grew with quarter elliptical shape in the bottom layer. Reaching the thickness of the bottom layer (3 mm), the crack continued to grow in length as a through crack in this layer. No cracking of the top layer was observed. Similar crack growth rates can be observed in Fig. 3 for the 3 specimens even though crack initiation varied slightly.

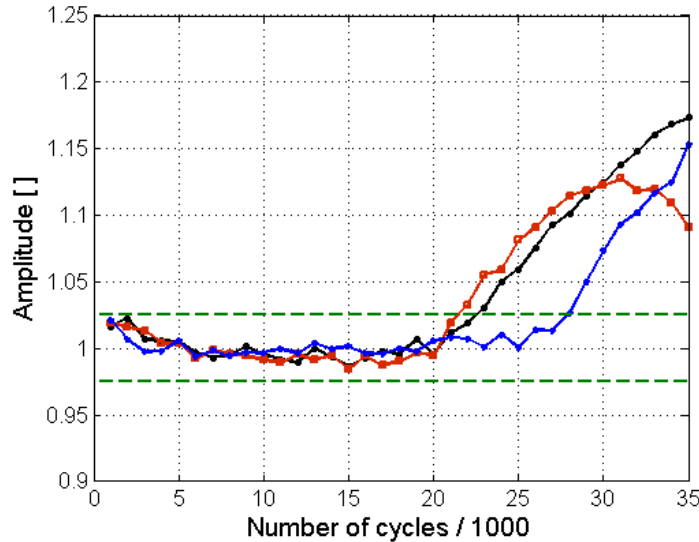
Fig. 4. Amplitude ratio of low frequency guided ultrasonic wave pulses against number of cycles for three fatigue tests of multi-layer tensile specimens (black, red, blue), $f_0 = 100$ kHz; green dashed line: 2.5% amplitude variation.

Shown in Fig. 4 are the maximum amplitudes of the guided wave pulses during the fatigue crack growth. The cyclic loading was stopped every 1'000 cycles and the maximum tensile load was applied to avoid crack closure. The monitored amplitude was normalized for each specimen with respect to the amplitude measured with no crack present. A small drop of the amplitude during the first 5'000 cycles can be observed with rather constant amplitude until approximately 20'000 cycles for all specimens. The maximum variation before the crack was observed visually was quantified as less than 2.5% for all specimens and is shown as the dashed green line in Fig. 4. An increase in the measured amplitude above that level can be seen at 22'000, 23'000, and 28'000 cycles respectively for the 3 specimens. Comparing to Fig. 3 this corresponds to a fatigue crack length of between 1 mm and 2 mm. In order to evaluate this, the observed amplitude ratio was plotted against the crack length in Fig. 5. The amplitude of the guided wave at the monitoring location in front of the crack increases as expected with increasing crack length. For a 5 mm long crack through the bottom layer the average measured amplitude increase for the three specimens was about 17%. This measured change in amplitude of the guided ultrasonic wave is significantly larger than the variation observed during the fatigue experiments of less than 2.5%.

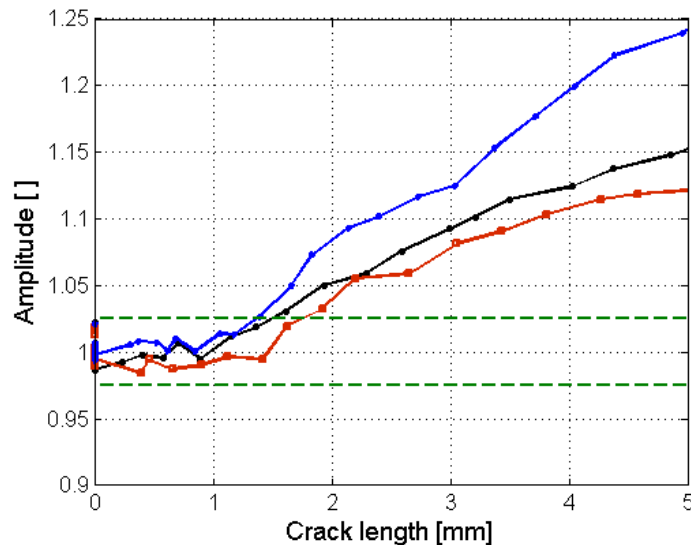
Fig. 5. Amplitude ratio of low frequency guided ultrasonic wave pulses against optically measured crack length for three fatigue tests of multi-layer tensile specimens (black, red, blue), $f_0 = 100$ kHz; green dashed line: 2.5% amp. variation.
