# Virtual unrolling of spirally-wound lithium-ion cells for correlative degradation studies and predictive fault detection†

A spirally-wound LG 18650 MJ1 lithium-ion battery was imaged in 3D before and after 1061 cycles using X-ray computed tomography. The battery's capacity had faded to 79% of its initial value and some of that fade was attributed to delamination in the innermost region of the 'jelly-roll' structure. A method for virtually unrolling the jelly-roll and analysing it in different coordinates is presented. The method allows efficient comparison of the position and shape of the electrodes at different times and highlights imperfections present in the jelly-roll before cycling which were shown to nucleate the delamination of the electrode.

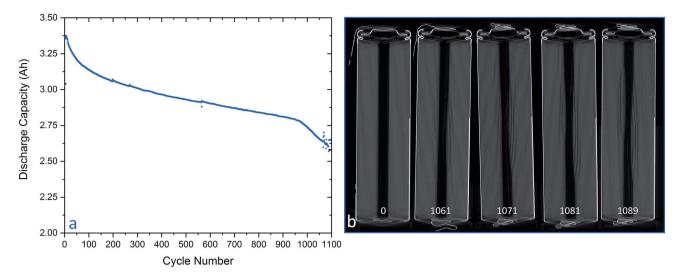
Fig. 2 (a) Capacity fade of the MJ1 cell over 1097 cycles. (b) A series of orthoslices of the cell over time, showing the gradual increase in the size of the large deformation on the inner portion of the jelly roll.

Fig. 2(a) shows the capacity fade if the MJ1 over the first 1097 cycles and Fig. 2(b) a series of orthoslices from tomograms at times between 0 and 1089 cycles. When comparing these two images it is clear there is a strong correlation between the

amount of deformation in the centre of the jelly roll and the capacity loss experienced by the cell.

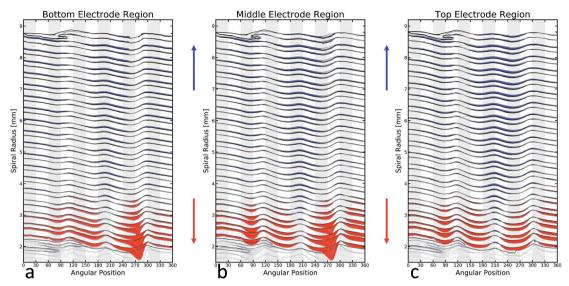
regions of significant deformation during cycling. Red regions show inward movement, such as the 'kink' visible after cycling while blue areas indicate a net outward deformation. The shape of these deformation patterns helps explain the nature of these processes within the cell. While cycling the individual electrodes expand and contract as a function of state of charge. Theoretically at a given state of charge the electrode position should remain identical, regardless of cycle number, but this is not the case. Over extended cycling, architectural anomalies within the cell (for example the current collector tab), act as anchor points, constraining 'jelly-roll' movement. By contrast, other features (for example the free volume in the centre of the cell) provide freedom for electrode movement; consequently there is a differential displacement depending both on angular and radial position. We would expect that these irreversible deformations would form faster for a battery being cycled at higher rates and slower for a battery cycled at lower rates.

Fig. 6 Deformation patterns in three different regions of the cell after cycling. (a) The bottom electrode region, (b) the middle of the electrode and (c) the top. Blue regions indicate net outward deformation and red net inward.

Fig. 6 presents the deformation patterns in the jelly-roll for the bottom Fig. 6(a), middle Fig. 6(b) and top Fig. 6(c) of the cell. The electrode position before and after cycling are presented in black and grey, respectively. The coloured areas represent

The major changes in the jelly-roll can be seen most clearly through the red and blue regions in Fig. 6. The jelly-roll irreversibly deforms outwardly (blue) into any space left available during the initial winding of the battery. These spaces are created by inconsistent surfaces external to the jelly-roll. The bottom of the battery imaged here is being influenced by two of these features. The first is the external current collector, visible at 270 degrees. On either side of the collector, there is significant outward deformation in the jelly-roll. The second feature is the end of the spiral electrode, which is visible between 90 and 120 degrees, near the top of the figure. Again, after cycling the electrode migrates and deforms into this space. In the top of the cell, the external current collector is no longer present but still has a significant effect. While not an inconsistency in the manner described above, the end of the current collecting tab is a very significant discontinuity in the electrode, and its abrupt termination leads to a very significant void to expand into. Wherever the electrode was unable to deform outwardly it will deform inwardly (red). This leads to the most significant inward deformation to be located in line with the anchor points described above. If sufficiently high forces are applied to inward deformation, a delamination event will occur, as is clearly evident in the cell demonstrated here. This will occur where the highest stresses are being generated which will likely be in line (radially) with the current collector.
